## Damage to a CDG boat during locking

18/02/2020

Sablons (ISÈRE)

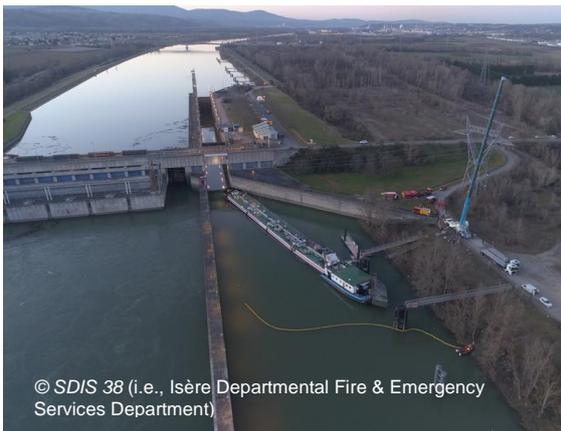
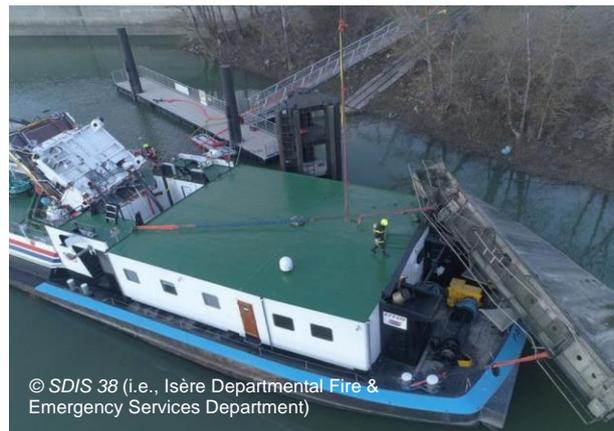
However, as the chamber was 2/3 filled with water (height of water: approx. 8m), the 2<sup>nd</sup> and probably 3<sup>rd</sup> sections down from the top of the gate gave way. Despite the captain starting the boat’s motors at high speed, the boat’s mooring lines did not withstand the draft and the boat was ejected from the chamber, ripping off the top section of the gate (23t), which remained embedded in the stern of the boat. The wheelhouse collided with the lock structure and was ripped off. It fell on the pipes located on the boat’s bridge, which were connected to the VCM tanks. The boat’s hull was cracked and leaking. As the motors remained switched on after the barge’s ejection and in spite of the crew reacting quickly to turn them off, the barge collided at low speed with the guide wall downstream from the lock. The NMC, which watched events unfold by video link, called the emergency services. The crew members smelt gas vapours. Equipped with gas masks, they moored the boat downstream from the lock, then, using rafts and a rope, headed to the pleasure pontoon then the bank via a gangway.

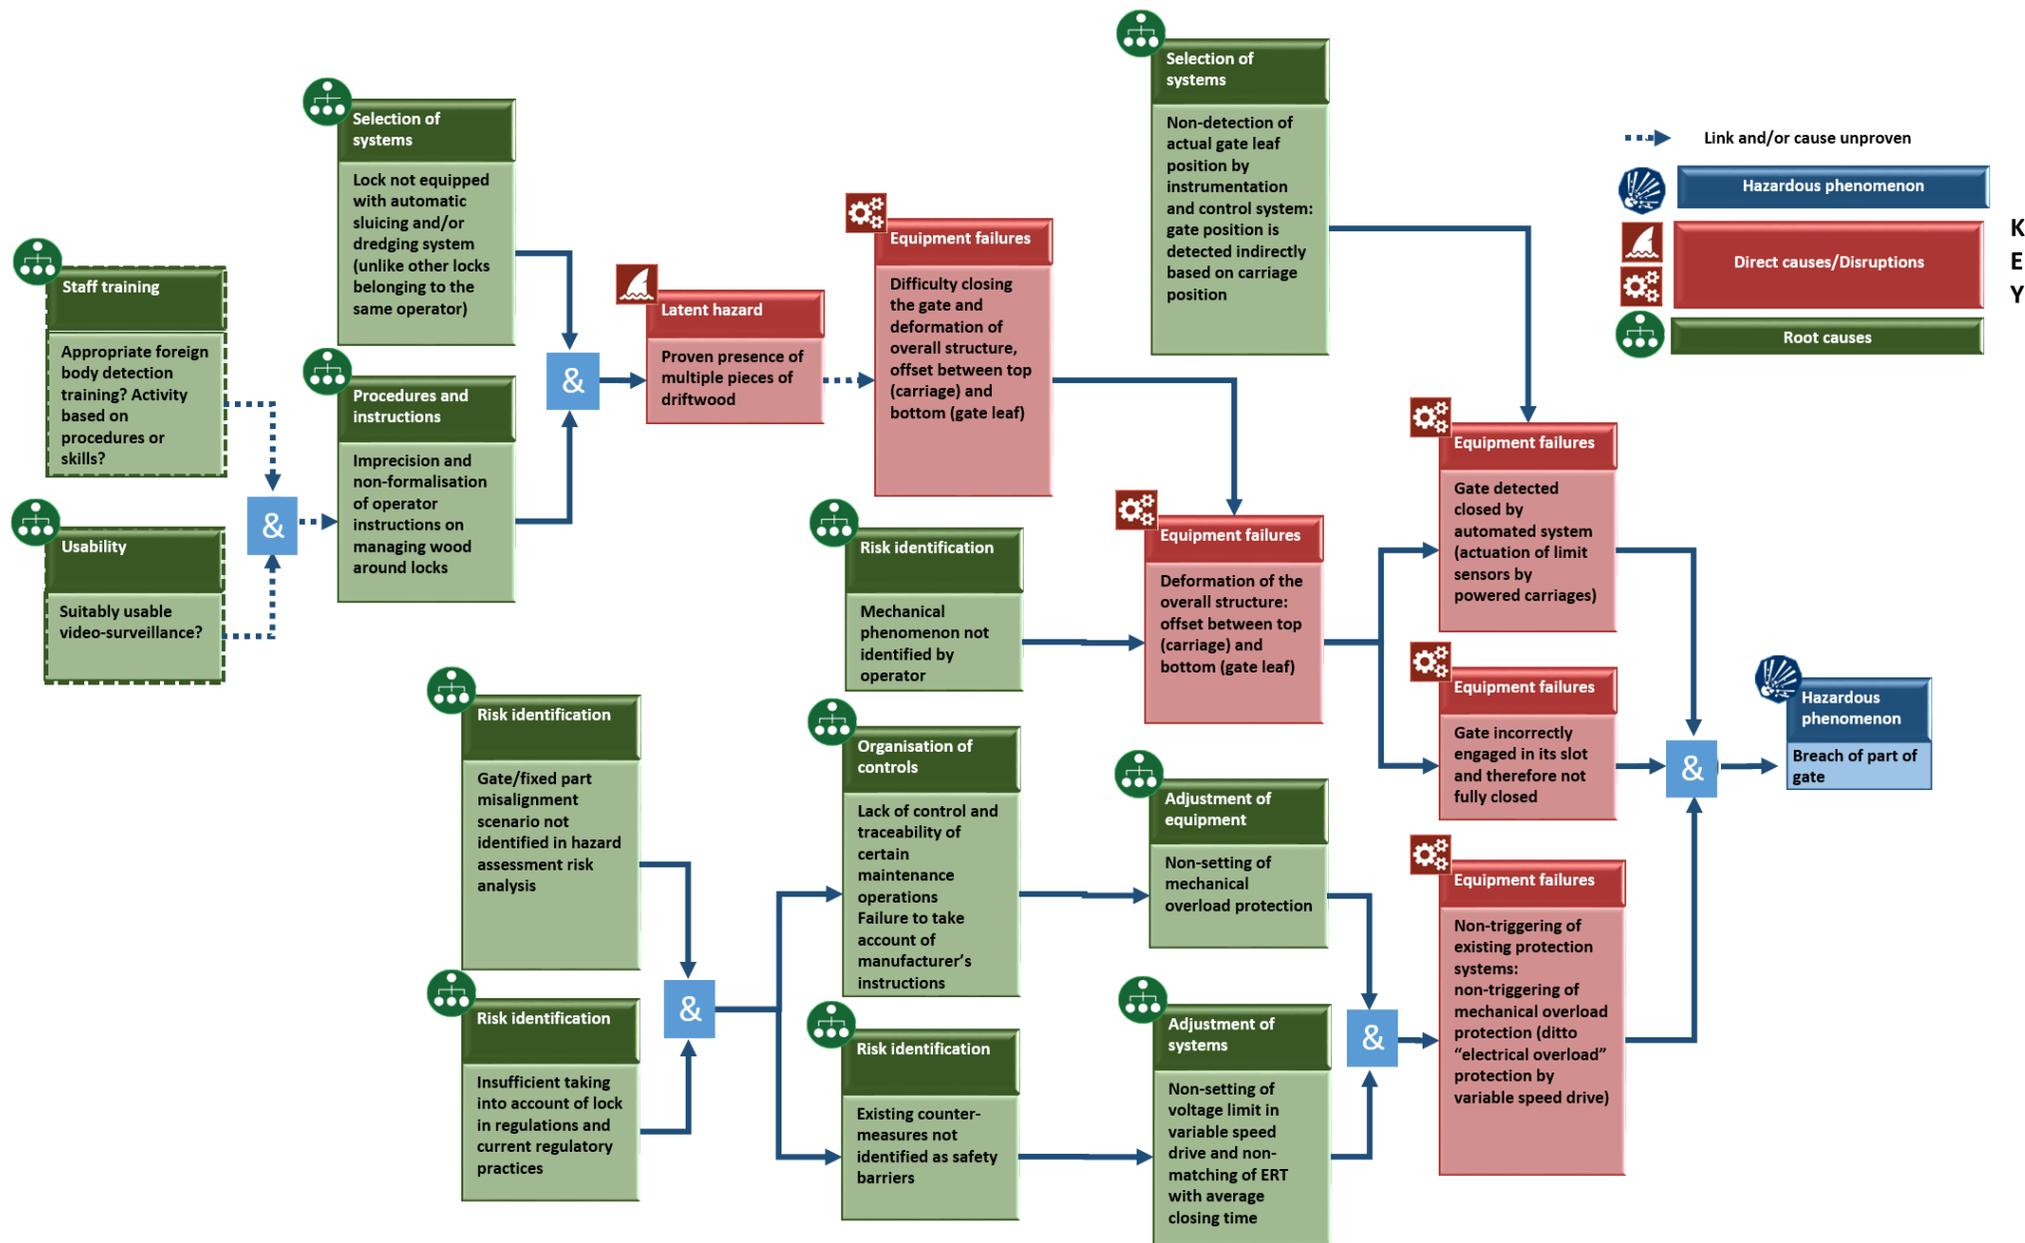
Based on the operator's investigations (examination of recovered parts, kinematic and mechanical studies, video-based photogrammetric analysis), it was concluded that the gate (N.B. "suspended" gate) was considered closed by the automated systems even though there was up to 40cm play from the nominal situation (top section potentially correctly engaged but bottom section either only very slightly or not at all engaged). This blockage may have been caused by the presence of a floating object. The lock gate breach scenario, due to incorrect engagement of the gate and a closure failure, was not taken into account in the site's Safety Report (SR).

All the automated systems detected the gate was closed. The gate's closed position is indirectly detected based on the position of the small carriage on which mechanical tilt sensors are positioned. Therefore, if the carriage reaches its "closed" position, it does not actually reflect the gate's position in the event of mechanical stress. Three systems could have contributed to preventing such a situation, but they proved ineffective:

- mechanical overload designed to limit tensile strain for the gate operating hoist: its setting was unknown to the operator and no monitoring or maintenance traceability was available;
- gate operating time via monitoring of "Excess Run Time" (ERT): its setting was inappropriate. It was set to 3min 35s, but the average operating time is 1min 42s. For the accident, it was 12.5s higher than the average time;
- voltage limitation for the motor's variable speed drive: investigations revealed that a major strain exerted by the hoist does not necessary trigger this limitation.

Firstly, these systems were not set up for safety purposes, and secondly, were not considered as safety barriers in the SR drawn up by the operator in 2013.

- identified two of the “counter-measures” as safety barriers (mechanical overload and Excess Run Time). It updated its SR taking account of the gate breach scenario, i.e., gate did not correctly reach its closed position, even though it was detected as closed by the instrumentation and control system;

- studied how to best characterise the presence of floating objects and the measures to be taken, both locally and remotely;
- studied how to directly identify gate position, separately from carriage position;

- reset the mechanical overload protection, Excess Run Time (ERT), and variable speed drives’ internal voltage limitation thresholds;
- studied putting in place an automatic emulsion system in the groove into which the lock downstream gate slots when closing, as well as a new filling valve for downstream sluicing;
