## Fire in a cement plant

07/09/2020

### Montalieu-Vercieu (ISERE)

Fire  
Scaling  
Maintenance  
Extinguishment

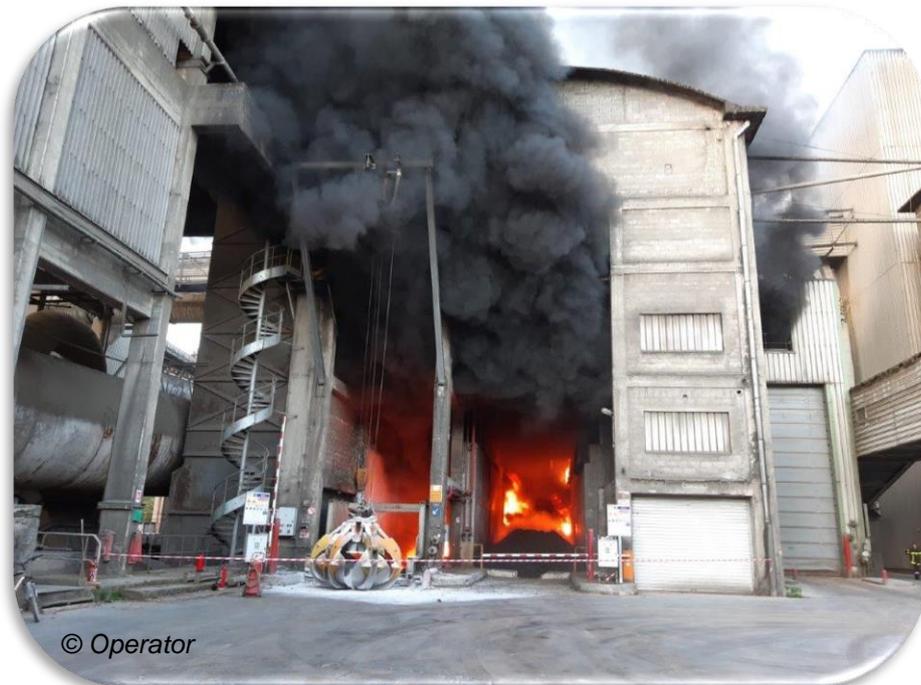
The production team got the small fire at the entrance to the pit under control but could not do anything about the second fire, which was totally inaccessible for them. The fire spread very quickly, including to the adjoining storage zone where impregnated sawdust was stored (called "zone 2") and to an unused zone (called "zone 3" and adjoining zone 2) which contained dust from operations in zone 2 that had built up since it was opened.

A thick plume of black smoke rose above the building.

At 7.45 a.m., the first SDIS teams reached the site. They decided to protect an adjacent silo adjoining the building that was filled with approx. 20t of animal meal. The firefighters set up a foam hose to manage the incident and a water hose to protect the silo.

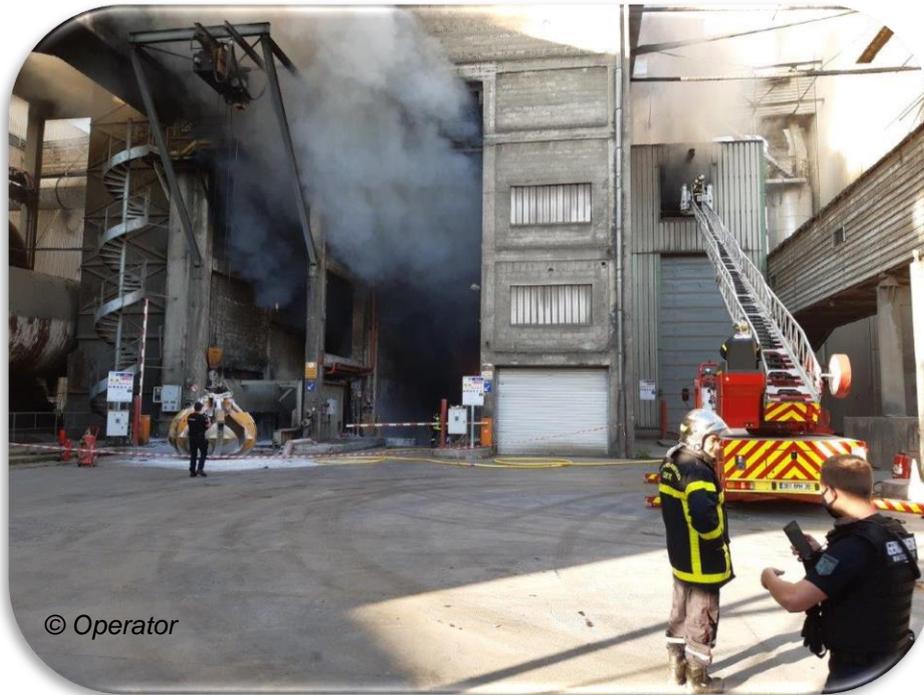
At 8.15 a.m., more than ten firefighting and emergency response vehicles were on site. A command post was set up. Staff were evacuated, rounded up, and counted.

At 08.20, entry to the site was prohibited for all lorries (including vehicles coming to load cement).

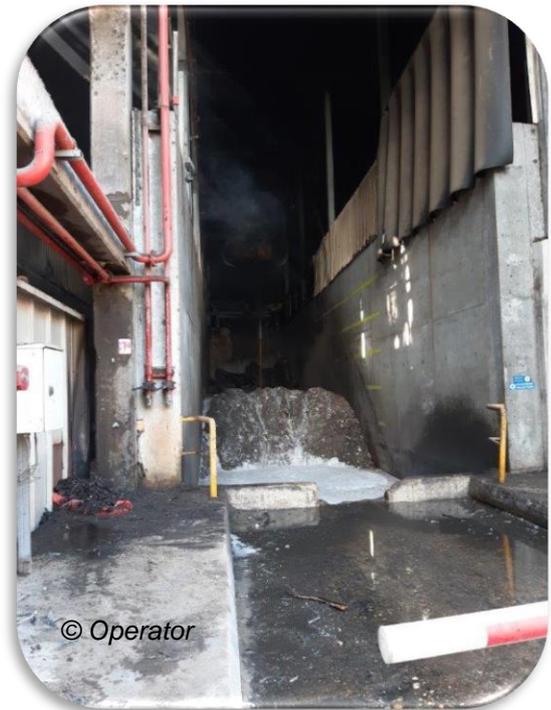
The fire generated a large volume of waste. The firefighting and emergency response teams recommended quickly clearing out the waste and emptying the pits. So, the stocks sprayed with foam were emptied out mechanically, without exposing staff to any emissions.

Damaged property included:

- equipment, structures and electrical systems in the ASR and sawdust storage and distribution zones (unavailable for several months);
- electrical systems for unloading animal meal (unavailable for several weeks).

The estimated amount of damage exceeded €2.5 million.

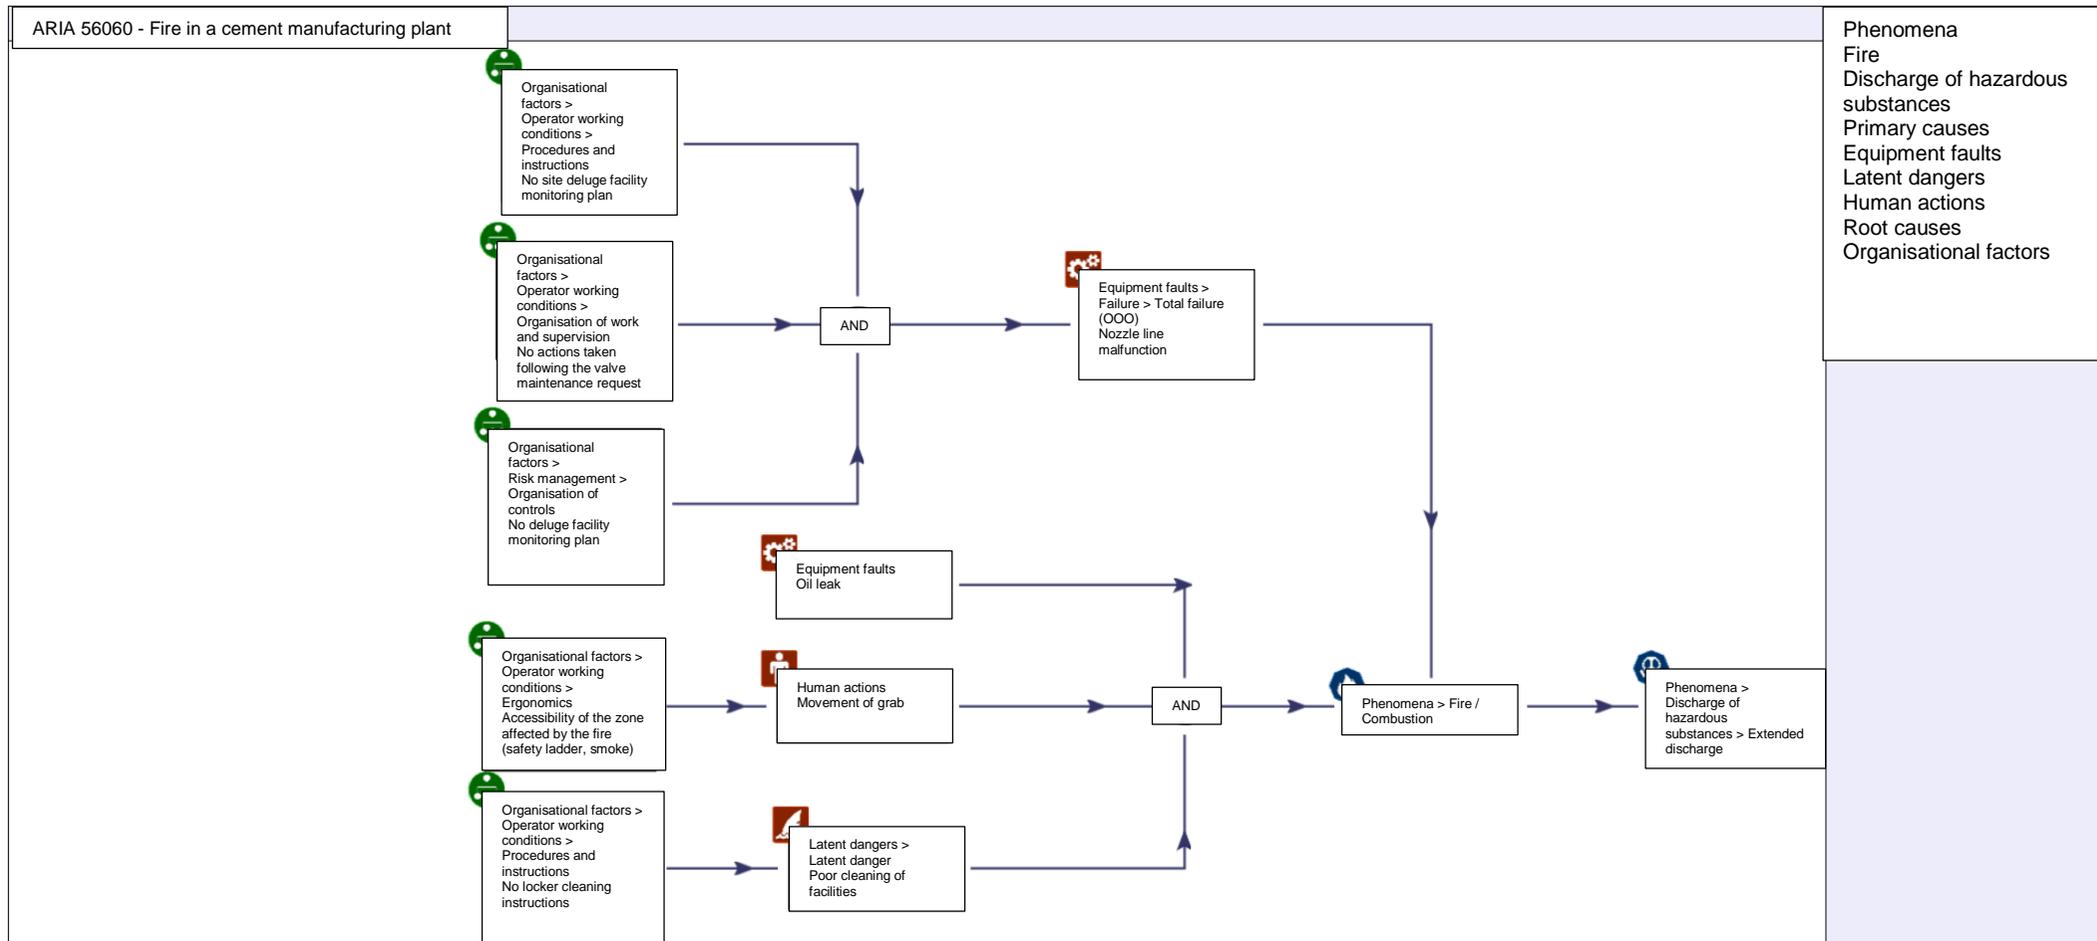
The incident originated from an oil leak from the grab's hydraulic system positioned above the ASR storage pit. The type of failure that led to the leak (electrical, mechanical, etc.) has not been determined.

Furthermore, the inability to access the top of the pit to extinguish the fire (access only via the safety ladder and presence of potentially toxic smoke) and the absence of operational fixed systems to extinguish the fire by the grab led operators to move the grab. Moving the grab above the waste pit caused burning particles to fall, spreading the fire.

Furthermore, the non-activation of the firefighting systems set up over the pits caused the fire to spread from pit to pit. This was due to the inaccessibility of the manual valves to douse the pits located in the hazard zone, malfunctioning of nozzle lines, and failure of the valve supplying the deluge system. This failure was due to there being:

- no plan to monitor the site's deluge systems (regular checks, testing);
- no action taken following a request to service the deluge system valve submitted 9 months earlier.

Finally, failure to clean the facilities led to the build-up of combustible substances in a supposedly empty pit.

- tested all the fixed firefighting systems within a month and set up periodic tests. The performance of a functional test of the installations after work has also added to the organization procedures;

- drew up a fire safety plan within 2 months for each facility on its site where combustibles are found (products, waste);
- reviewed its maintenance procedures. In particular, the following measures were implemented once a week for the grab: checking the oil levels, checking for leaks, blowing out the cart and the grab pump well. Weekly cleaning was also carried out in the fuel dosing room;;

- setting up a temperature monitoring system in the pits (8 thermal imaging cameras with different alert thresholds);
- instrumenting the grab's on-board equipment;
- adapting the firefighting system to different possible scenarios;
- reporting the location of and identifying valves on the fire safety system;
- planning escape routes in emergency response zones.
