Catastrophic explosion of a cyclohexane cloud

June 1, 1974

**Flixborough
United Kingdom**

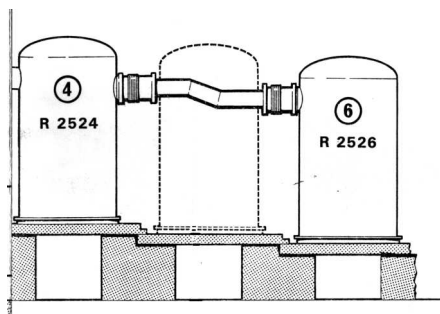
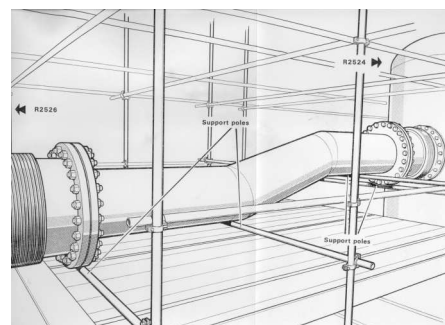
Diagram of the bypass between Reactors 4 and 6

By the next day, this detected crack was already extending a full 2 meters in length; the installation was closed and Reactor no. 5 withdrawn for inspection. In order to resume production as quickly as possible, it was decided to build a bypass between Reactors 4 and 6 and then implement the modified configuration without any specific preliminary study, based on a drawing produced on the shop floor.

On April 1st, following a leak test, the unit resumed operations with a 20-inch (508-mm) diameter elbow pipe connecting the two 28-inch diameter expansion bellows on Reactors 4 and 6 via a plate and flange, with the entire assembly being supported by scaffolding placed so as not to interfere with pipe movement.

According to the investigation report, failure at the level of the two connecting bellows on the temporary 20-inch pipe placed between Reactors 4 and 6 caused a massive leak of hot and pressurized cyclohexane. The 40- to 60-ton cloud of cyclohexane created then ignited 25 to 35 seconds later, when making contact with the reforming tower of the hydrogen unit located 100 m from the leak, thereby causing the explosion and ensuing fires.

For the commission, the 20-inch pipe would have burst during just a single phase, as a result of internal temperature and pressure conditions that, while remaining within the unit's operating range, would have been more severe than is customary. These conditions would have induced the torsion of both connecting bellows followed by the violent sandwicing of the pipe, thus causing the pipe to break. The experiments conducted on full-scale assembly reproductions have moreover shown that the torsion of bellows depends on their axial stiffness as well as on the number and position of supporting struts and the distance between them.

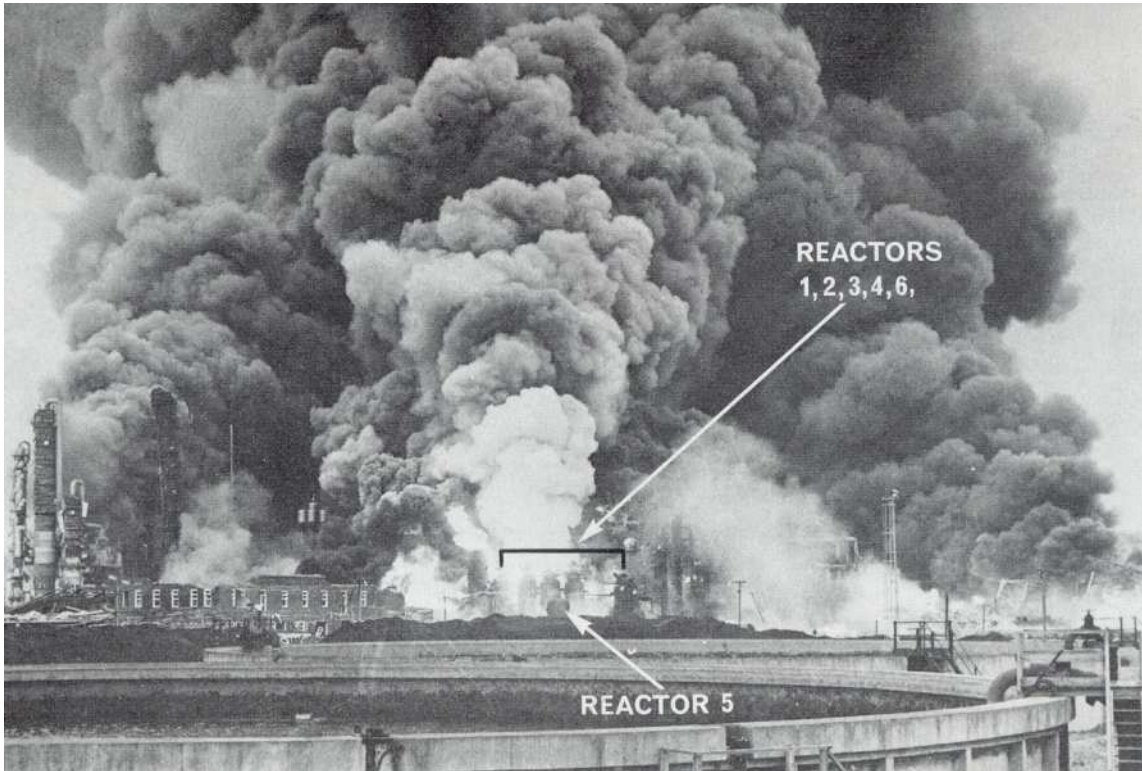
At 4:53 pm, a deflagration noticeable up to 50 km away practically levelled the entire site. In many sectors of the plant, intense fires ensued, with flames flaring 70 to 100 m high. The instantaneous jump in pressure at the epicentre of the explosion, calculated at over 2 bar, destroyed all stationary fire protection equipment, further complicating the work of emergency and rescue services; the main sources of ignition would not be extinguished until two and a half days later.

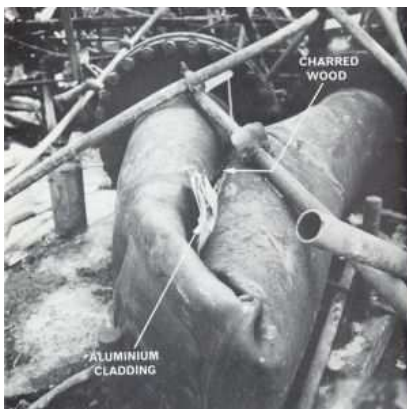
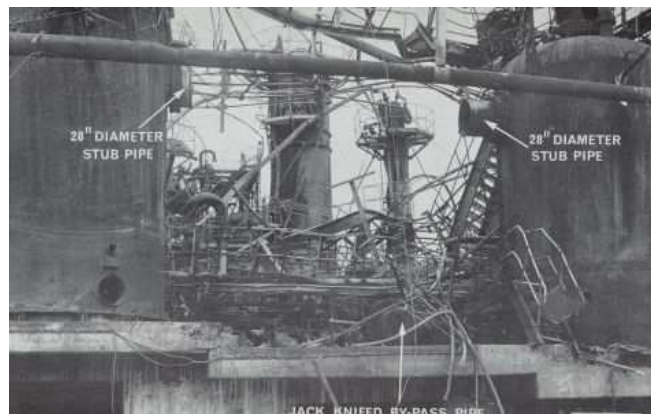
However, the real cause of this accident was indeed the "amateurism" shown by removing Reactor no. 5 and by constructing the bypass in the first place; this risky sequence was not specifically examined in any of the studies or tests undertaken. After the commission's findings, no verification of actual operations was conducted; only a nitrogen test at 9 bar, but this test was designed to assess the leak and not safety (the valve adjustment pressure was set at 11 bar).

- no calculation was carried out and no one voiced concern over the structural strength of these bellows and the bypass, despite the forces being exerted due to the hydraulic thrust of cyclohexane, assembly torsion movements, etc.;
- no reference was made to standards or guidelines in effect at the time, or to the bellows manufacturer's published user's guide;
- no column or other means were employed to prevent bypass movement.

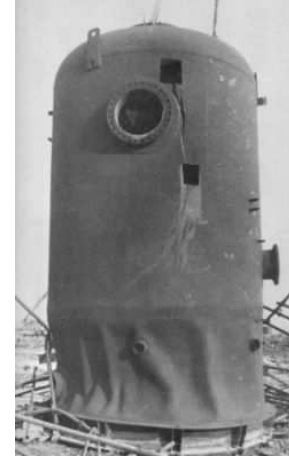
At the origin of the accidental sequence, the deficiency of Reactor no. 5 stemmed from cracking corrosion caused by nitrates contained in the water used in the past to spray the small cyclohexane leaks, in an effort to limit the risk of ignition. This water had penetrated into the insulation and, during evaporation, deposited nitrates onto the equipment steel.

The cause of the leak on Reactor no. 5 should have been analyzed prior to any unit reactivation and the other reactors should have been verified with respect to the degradations sustained by Reactor no. 5. Such an approach however would have required shutting down the plant for a few days; the concern over minimizing plant downtime and production losses actually motivated the stopgap configuration that eventually gave rise to the accident.

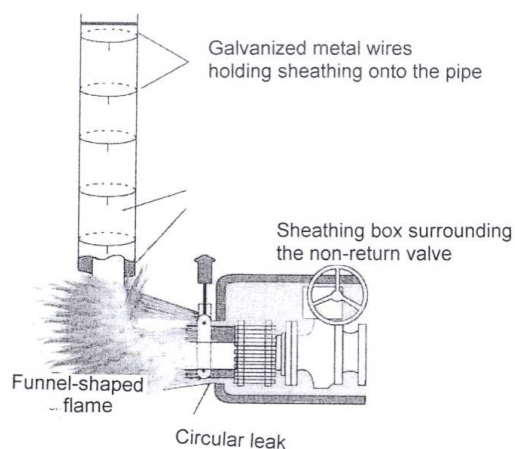
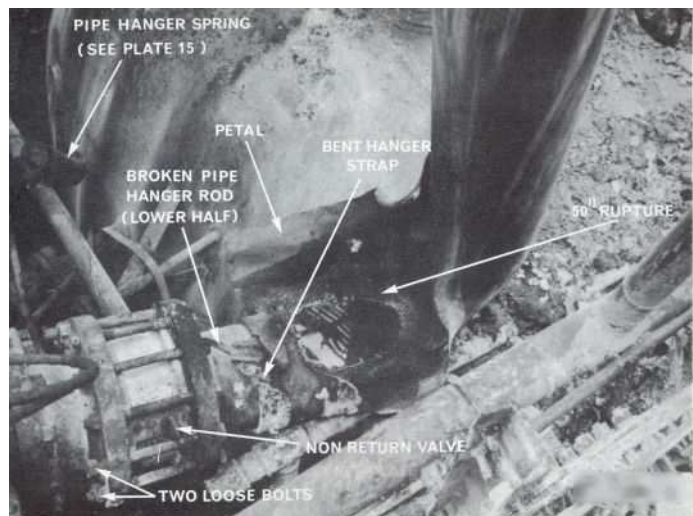
According to Cox, a break in the seal on the backflow prevention valve, due to poor clamping of both bolts on the valve flange, would have been the source of a small ignited cyclohexane leak heading towards an elbow in the 8-inch pipe section, thereby destroying its sheathing. The contact with zinc contained in the metal wires holding the sheathing with the steel of the 8-inch pipe would have immediately generated a 3-inch crack; the ignited double leak would then have heated the pipe elbow to a temperature of 950°C for at least 4 min, causing a creep-induced break over more than a meter (50"), in the shape of flower petals, as could be found in the rubble. The cyclohexane discharged in this manner would then have produced an explosion at the level of a winged cooler of the unit, which would have engendered a downward force acting upon the 20-inch bypass, which lies at the origin of its failure.

View of the 50-inch break on the 8-inch pipe
 Source: Secretary Of State For Employment (1975).
The Flixborough Disaster. London: HSMO.
