Explosion of 2 heavy fuel oil tanks

10 March 1992

Verdun – [Meuse]

France

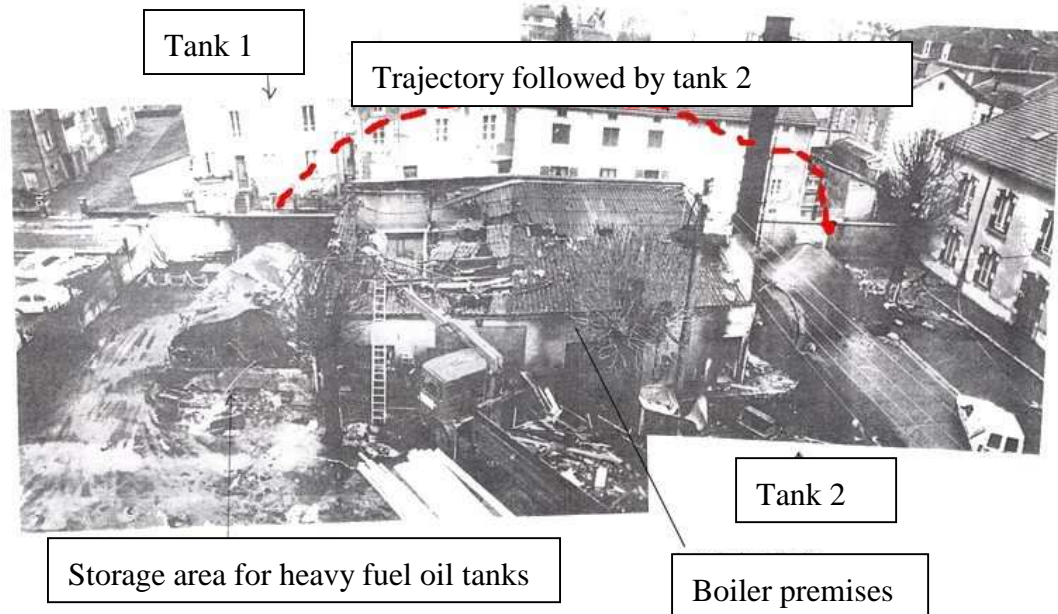
At 6h07, tank no. 1 explodes. The seam weld between the shell and the bottom had completely ruptured. The tank was thrown not very high off the ground and landed on the building of the boiler room. The fuel oil in the tank spilled on to the dike and caught fire.

Thirty seconds later, the second tank exploded. It was detached from its bottom the same way and took off like a "rocket" to a height of 50m according to some witnesses. After hitting the upper portion of the chimney, it landed on the other side of the building and spilled its content.

The electric pin protruding from the fuel oil was found with strong traces coking, which proved that very high temperatures had been reached.

The cold night coupled with the low thermal inertia of the fuel oil lead to a massive heating requirement by the control system and to the frequent activation of the electric heating system. The electric resistance temperature very close to the fuel oil surface increased due to poor heat exchange (metal-gas contact instead of metal-liquid). This caused the parts of the surface of the fuel oil to over heat and boil with a beginning of coking born out by the presence of pitch on the electrical resistance. In these conditions, the air-hydrocarbon vapour mixture on the surface is too rich to cause the tank to explode. When the electric back-up system was stopped, the convection effect caused the air to enter into the tank via the vent creating explosive conditions. When the system was switched on, the resistance was far enough from the fuel oil level to rapidly heat up and reach the self-combustion temperature in a mixture conducive to combustion and thus resulting in an explosion.

The control system common to the two tanks caused the second tank to overheat. The air in the second tank was rich in inflammable vapours. The fiery projectiles coming from tank no. 1 could enter tank no. 2 through the unprotected vent or set fire to the vapours escaping through the vent resulting in the second explosion.

An initial flaw in the design of the facility and inadequate analysis of its safety: there was no safety system insulating the electric pins in case of very low fuel oil levels. The vents were not protected by flame arrestors;

The operating guidelines of all boilers in the barracks were made more clear. They require a minimum level of fuel oil in the tanks to keep the resistances always submerged and display of safety guidelines in the premises where the operating staff work.

The electric heating of the strainer was removed from all places where there was no strict requirement. Lastly, flame arresters were installed on the vents of each tank. All operating units were also reminded that the cloudy sky above the tanks could contain inflammable vapours.
