EXPLOSION AND FIRE IN THE TAR EXTRACTOR OF A COKING PLANT

20/11/2020

Dunkerque (Nord)

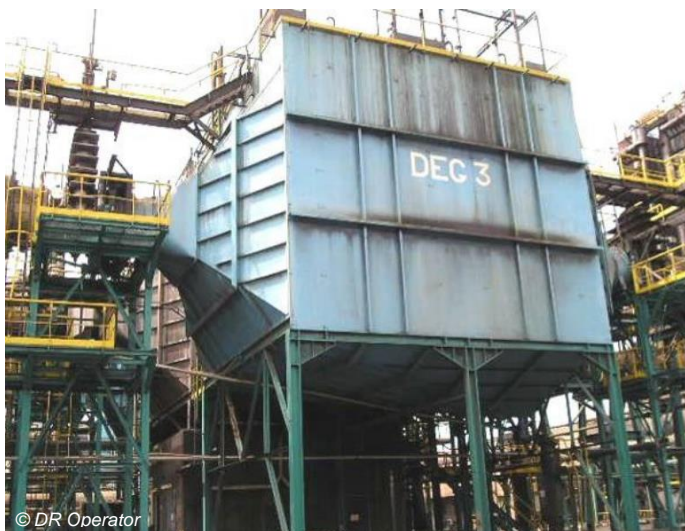
Figure 5: Initial state of tar extractor DE3 before the explosion

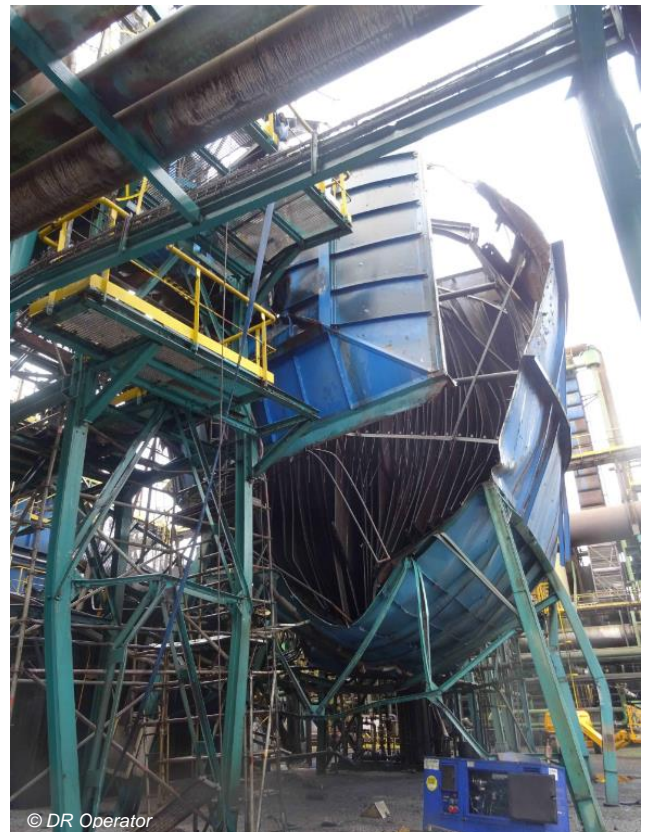
The maximum quantity of material having reacted in the explosion of the tar extractor was evaluated at an equivalent of 170 kg of TNT. It was indicated that the raw coke gas from coal distillation was burned by the flare stacks (torches above the oven batteries) for nearly 5 days, the time required to put the gas treatment facility back into service (the destroyed tar extractor and the H₂S scrubber were isolated from the coke oven gas treatment and remained unavailable for several months). An estimated 3,776,600 Nm³ of coke oven gas was sent to the flare stacks.

The reconstruction of the tar extractor took several months. **Property loss was estimated at €10M and production losses at €9M.**

Figure 6: Condition of the tar extractor DE3 after the accident

Flaring of the coke oven gas continued for 90 days until the tar extractor was replaced.

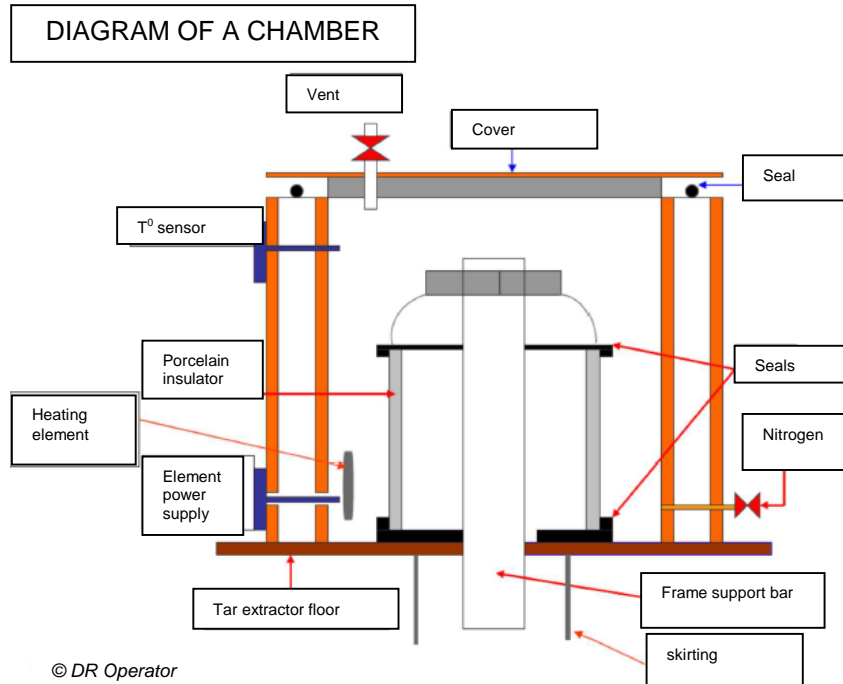
- an anomaly had been detected on an isolating shell 2 days before the accident. A high-temperature alarm had been triggered, and a pressure of -15 mbar had been recorded instead of a nitrogen pressure of +30 mbar on the shell during regular operation. The porcelain of the insulator was very probably cracked. The nitrogen was most likely escaping from the shell through the insulator. If all the nitrogen was purged from this shell through the leak in the insulator, an air supply could have made it possible in the event of a loss of tightness defect in the walls of the shell housing this same insulator;

- **The shells housing the insulators:** on 18 November 2020, a pressure defect was detected on one of the insulator shells (inerted with nitrogen). This defect suggests that the porcelain of the insulator was most likely cracked. An influx of air could have been made possible by an additional leak between the insulator and the tar extractor chamber. This is unlikely to be the case;

Figure 7: Diagram of the shell receiving the insulators

- Washing and dewatering operations are now performed under nitrogen pressure to expel the coke oven gas and to avoid any influx of air,
- Tar extractor maintenance includes an annual inspection of all the earthing systems and an annual inspection of the shell to ensure to check the fasteners of the various elements.
