Watercourse pollution resulting from the release of liquid manure from a pig farm

02/04/2021

Taulé (FINISTÈRE)

Farming operation
Effluents
Piping
Disconnection
Overflow
Environmental impact

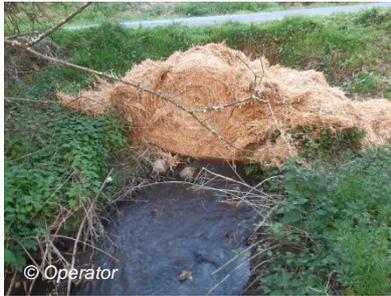
On 2 April 2021, at around 3:30 p.m., the driver who was making trips back and forth between the slurry receiving pit and the various fields being sprayed, noticed that the pit was overflowing. This pit had a total capacity of 2,808 m³.

Having been warned by the driver, the operator asked his crews to search for the overflow source, reduce the level in the receiving pit, stop the influx of effluents from the 2nd site and increase the spreading rate. The overflowing liquid manure made its way to the stream located just 30 m below the pit via openings in the site's berm enclosure. The operator estimated the release to be between 50 and 100 m³.

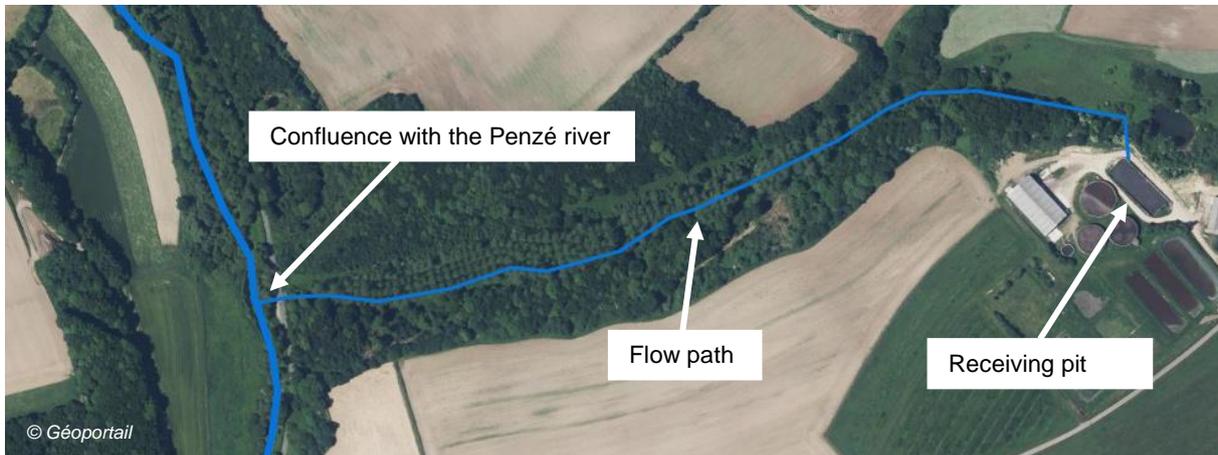
The distance between the effluent receiving pit and the confluence of the PENZÉ river is approximately 820 m. The confluence is located approximately 1.5 km from the sea.

To limit the site's environmental impact, the operator has installed a filter (straw) upstream of the confluence with PENZÉ.

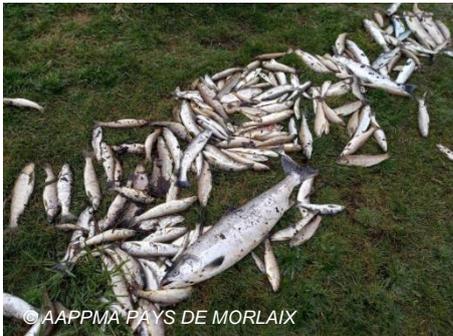
Fishermen and people close to the port of Penzé observed foaming, abnormal colouration in the watercourses, and a powerful smell characteristic of liquid manure (an ammonia smell). The following day, the French Office for Biodiversity (OFB), accompanied by two approved associations for fishing and protection of aquatic environments (AAPPMA) and the French Fishing Federation, went to the site to assess the environmental impact along the PENZÉ (1.5 km between the confluence with the stream involved and the sea) and the KERJEAN tributary (over approximately 1 km). Amongst the several hundred dead fish collected or remaining on the river bed, mortality of endangered and red-listed species

was also noted: brook lamprey³ (*Lampetra planeri*), brown trout⁴ (*Salmo trutta*) and Atlantic salmon (*Salmo salar* - not found dead in the environment by the OFB on 03/04/2021 but collected by fishermen and displayed). The brook lamprey and the brown trout are protected species at the national (Orders of 08/12/1988 and 23/04/2008) and European levels (Annex II of the EU Habitats Directive).

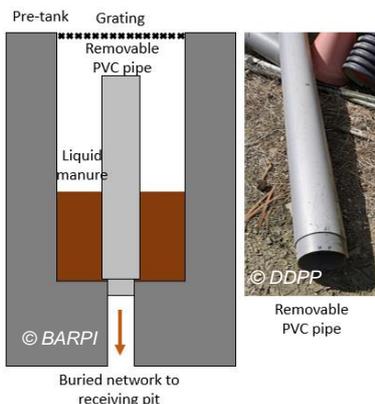
On the morning of the release, an employee emptied pre-tanks under a building equipped with 14 pre-tanks. To perform this operation, he had removed the PVC pipe blocking the drain opening in the bottom of the pre-tank to allow the effluent to flow by gravity to the receiving pit via an underground network. However, as the piping was plugged, the employee attempted to clear the transfer network using a “snake” connected to a high-pressure cleaning pump. At the same time, since early morning and in preparation for sowing corn, a driver had been performing slurry spreading operations. Every 15 minutes, he would travel and forth between the liquid manure receiving pit and the fields, with a spraying rate of approximately 100 m³/h. Due to the obstruction in the network, the farm manager asked the employees of the fattening site (located 500 m away) to supply the receiving pit so that the slurry spreading operations could continue. The driver was not worried by the increase in the pit’s level. At around 3:30 p.m., he noticed the overflow on his way back to the pit and alerted his manager. In the meantime, the pipe had become unplugged, and the slurry had spilt into the receiving pit.

The operator located the origin of the unexpected discharge of slurry into the pit at the drain of the building’s two pre-tanks for which the unplugging operation was performed. The removable PVC pipes used to keep the pre-tanks separate from the underground network leading to the receiving pit were no longer in position. During the unplugging operation, an influx of air was created upstream of the pipe, causing the pipe to shift out of place; the connector (male/male) on the orifice showed a risk of becoming disconnected. Although there is a guillotine valve close to these 2 pits to close off the network, it is not automated.

It was estimated that 300 m³ of excess slurry was released into the receiving pit. The PVC pipes used to close off the pre-tanks were put

- modify the shut-off/communication system between the pre-tanks and the underground network with the receiving pit. The PVC pipes that exited their seating have been replaced, in all the buildings, by a custom-made plug consisting of a cone and stainless steel piping;
- servo-control of shut-off valves on the transfer network with level measurement in the receiving pit (valves held in the closed position when not in transfer mode);
- create an additional ditch below the farrowing building and the other site;
- create a run-off water collection and transfer network to a new retaining pond for each site (no connection between the stormwater and slurry networks).

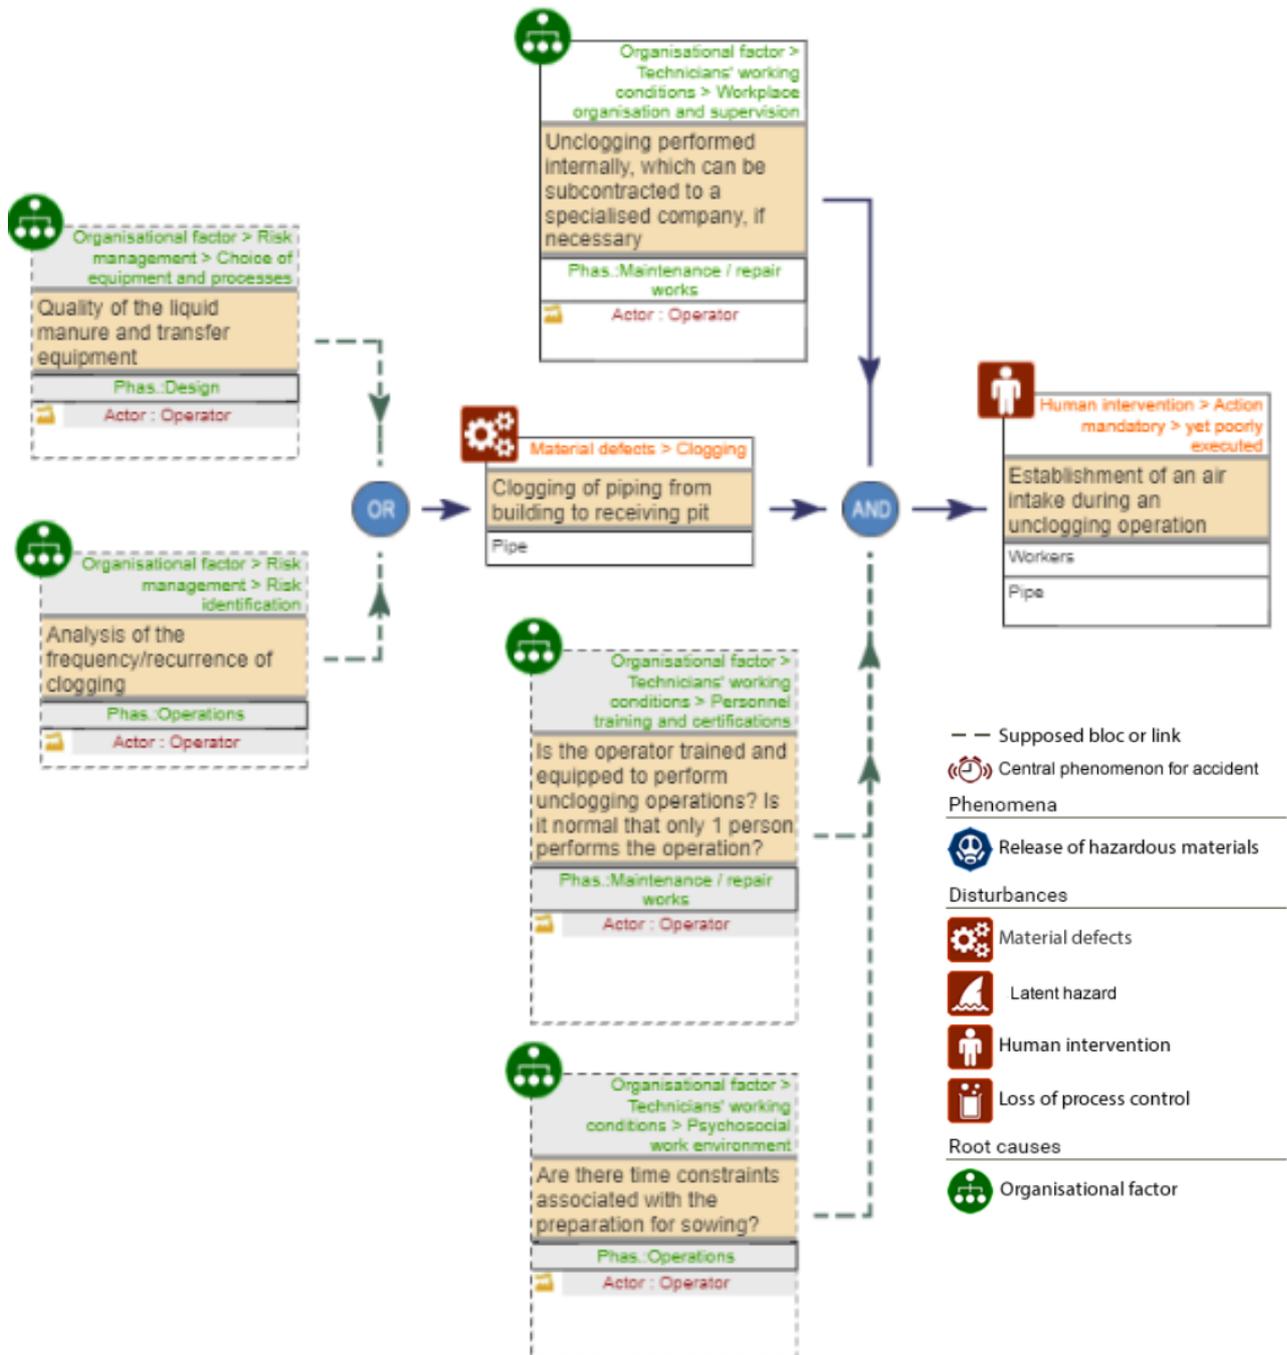
Origin of the discharge from the pre-tanks

The operation to unplug the pipe was performed by an employee. The operator plans to call upon a specialised company if the employees cannot resolve the situation in the future. The blocks and links shown with dashed lines are assumptions made by BARPI in its accident analysis. They are to be considered points for reflection, and their root causes are to be sought.

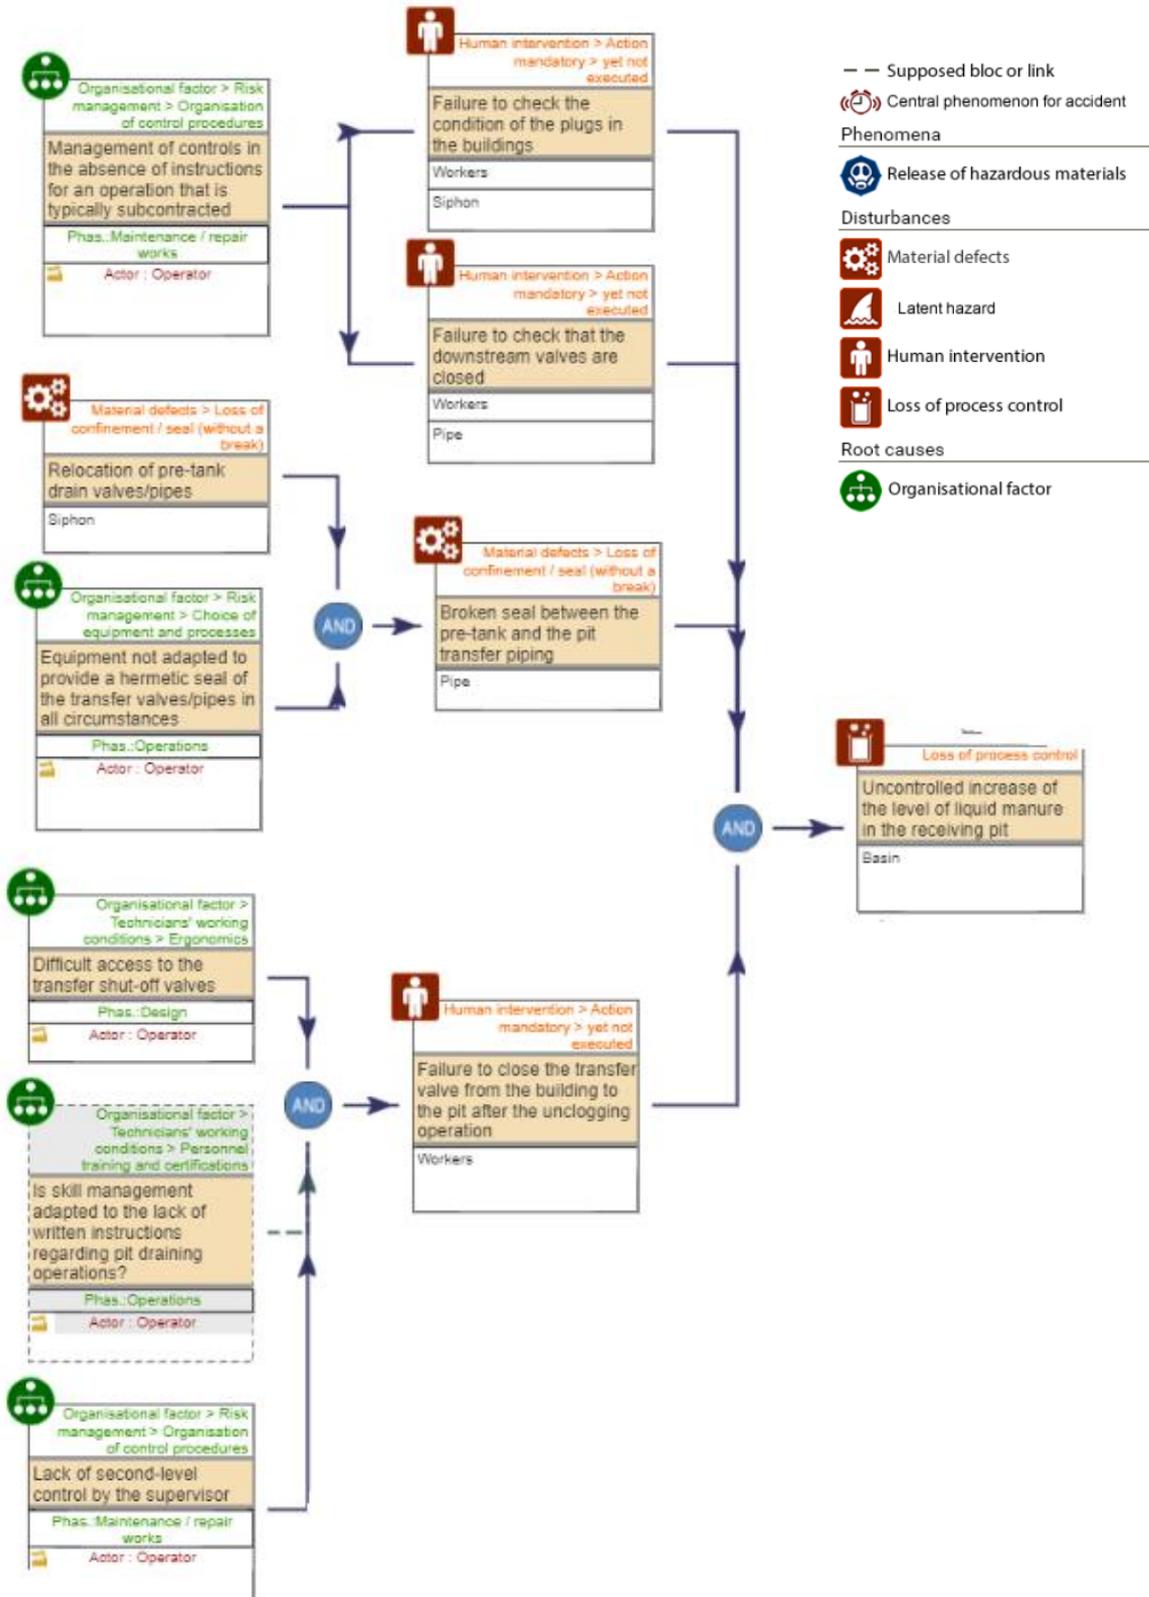
Uncontrolled increase in the receiving pit's level:

The increase in the pit's level was caused by the untimely drainage of the 2 pre-tanks. The inflow of 300 m³ of slurry was made possible by unsuitable equipment (removable PVC pipes with male/male connections for emptying pre-tanks and a guillotine valve that was not easily accessible and not servo-controlled) and the absence of control/verification of the correct positioning of this equipment following a sensitive operation (unplugging of a pipe).

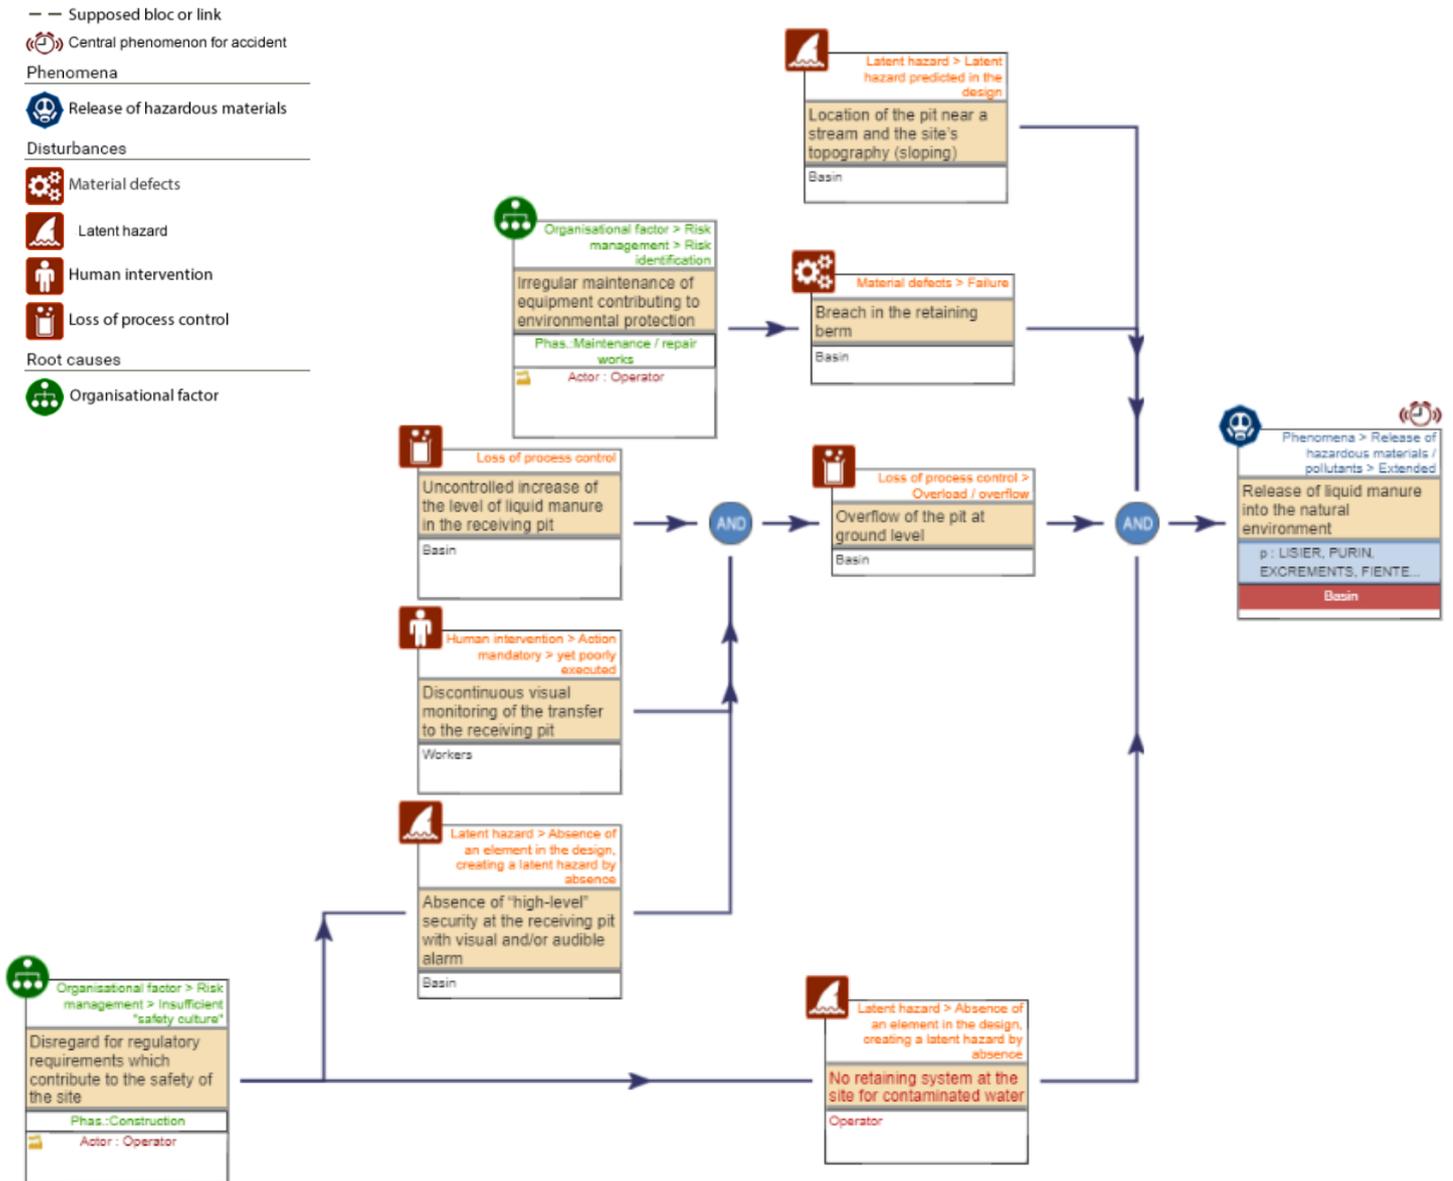
Overflow of the receiving pit and environmental impact

The overflow of the receiving pit leading to the discharge of liquid manure (slurry) into the natural environment is a consequence of an uncontrolled increase in its level. The overflow, and the subsequent impact on the natural environment, was rendered possible by the lack of mitigation/recovery measures for the degraded situation, some of which were regulatory obligations and attributable to poor maintenance of the only existing barrier (a breached retaining berm).

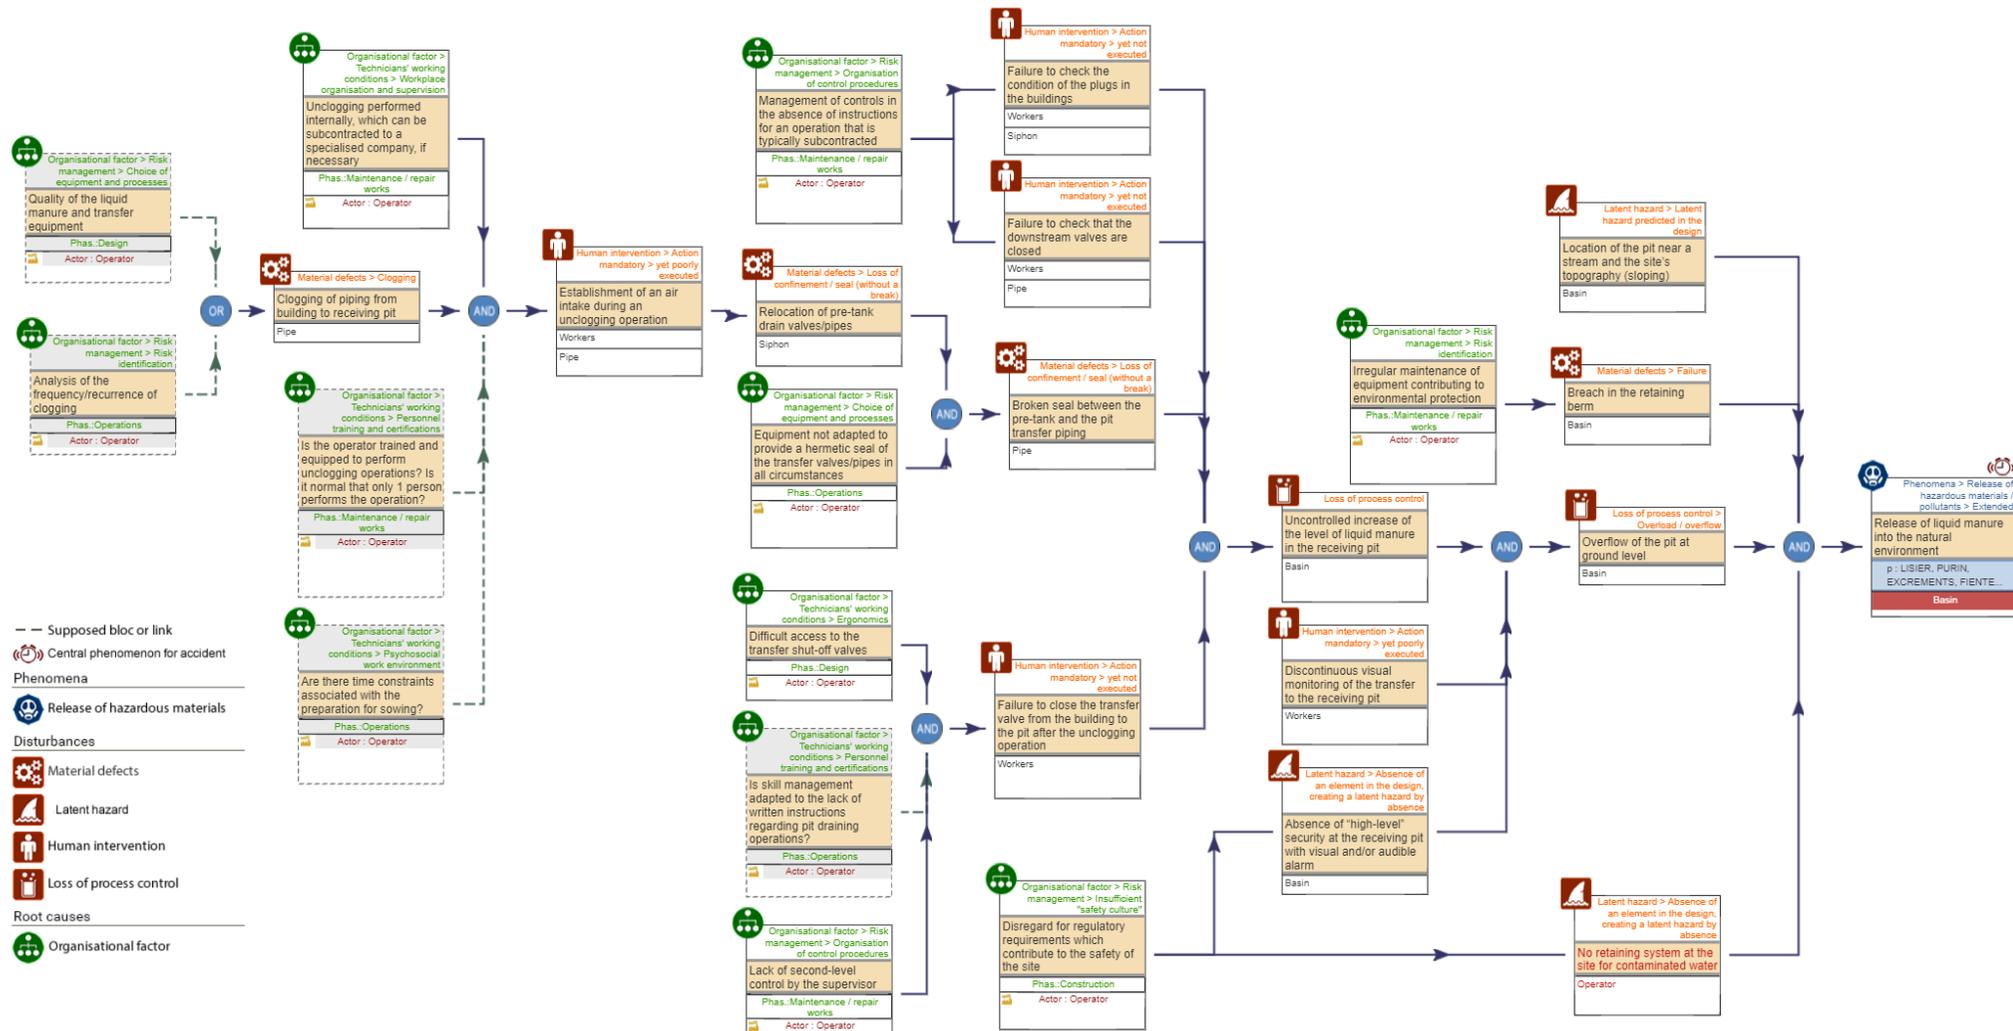
Graphic modelling of the disturbances and root causes of the accident:

The following page shows the entire graphic model and provides an understanding of the causal links between the emptying of the pre-tanks, the uncontrolled increase in the receiving pit's level, its overflowing and the impact on the natural environment.
