HAZARDOUS WASTE INCINERATOR FURNACE WALL FIRE

01/10/2021

Saint-Vulbas (Ain)

Fire
Scaling
Extinguishment
Training

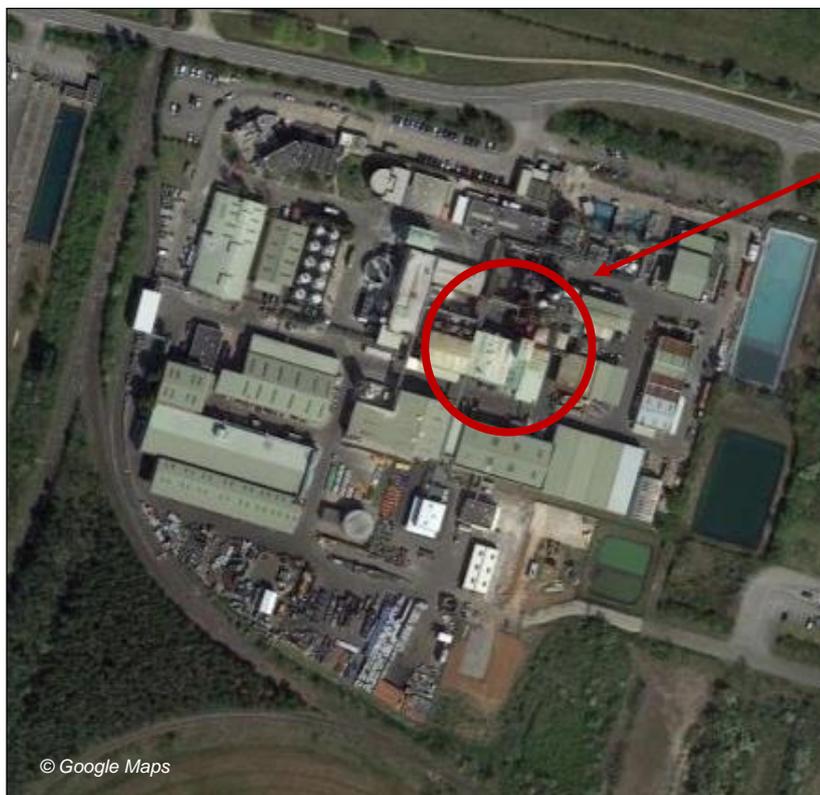
Incident zone

The incident occurred on the rotary furnace's after-burner wall. This is authorised to treat 35,000t/year of hazardous waste: solid, semi-liquid, liquid, gaseous, high calorific value (HCV), low calorific value (LCV), and oil waste

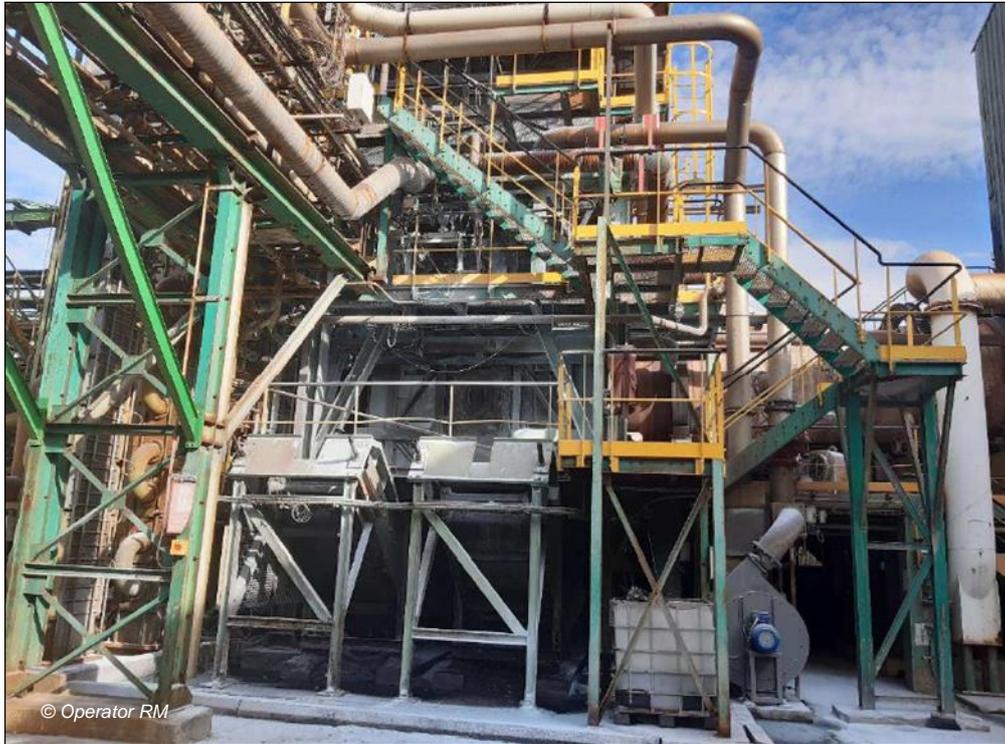
On the evening of Friday 1st October 2021, a fire broke out on the rotary furnace after-burner wall.

The operator identified the origin of the fire. A splash of fuel oil caught fire on the external wall of the afterburner. It was hot (estimated temperature: approx. 80°C).

However, as the hose was destroyed by the fire, the operator was not able to precisely determine the cause of the splash. Several hypotheses are possible: hose disconnected, leaky seal, or leaky fuel oil hose.

The operator also made technical modifications to their facility. They moved the combustible fluid pipe / valve / flow meter groups away from the after-burner wall.

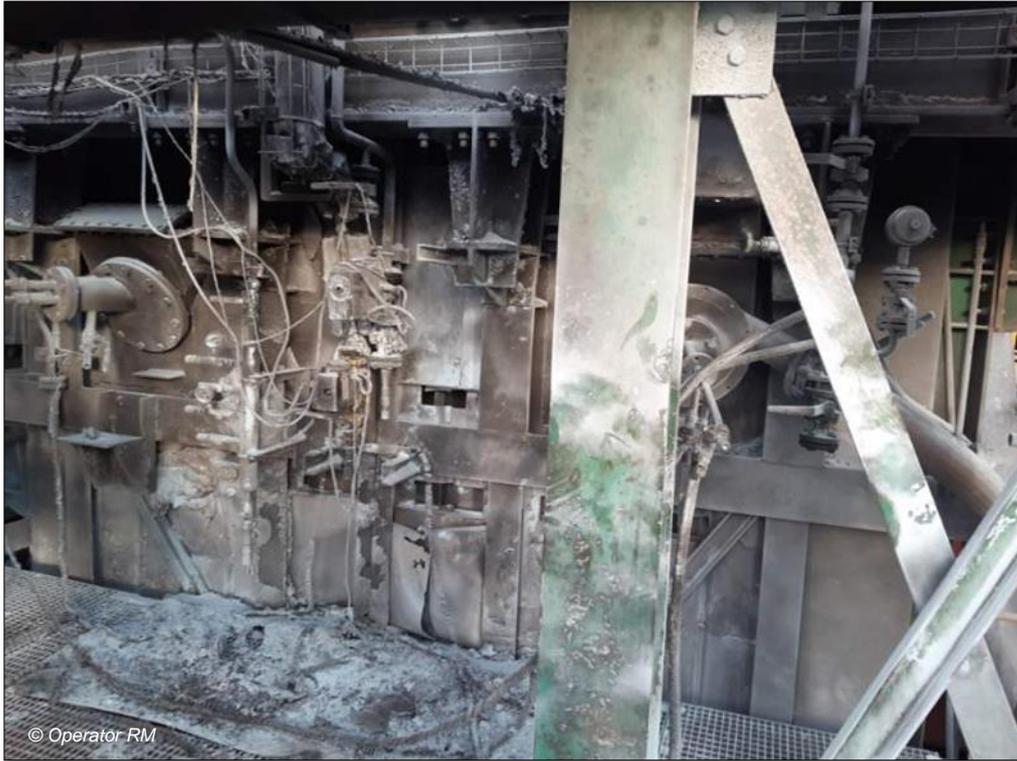
Property damage to the facilities was observed, including damage to both the burners and the injection lines on the after-burner structure.

The after-burner structure underwent an expert assessment by an inspection firm, demonstrating that (a) it was not damaged by the outbreak of fire, and (b) the stability of the installation's metal weight-bearing structure was unaffected.
