FIRE IN A GOODS SHIPPING BUILDING

01/10/2021

Crissey (Saône-et-Loire)

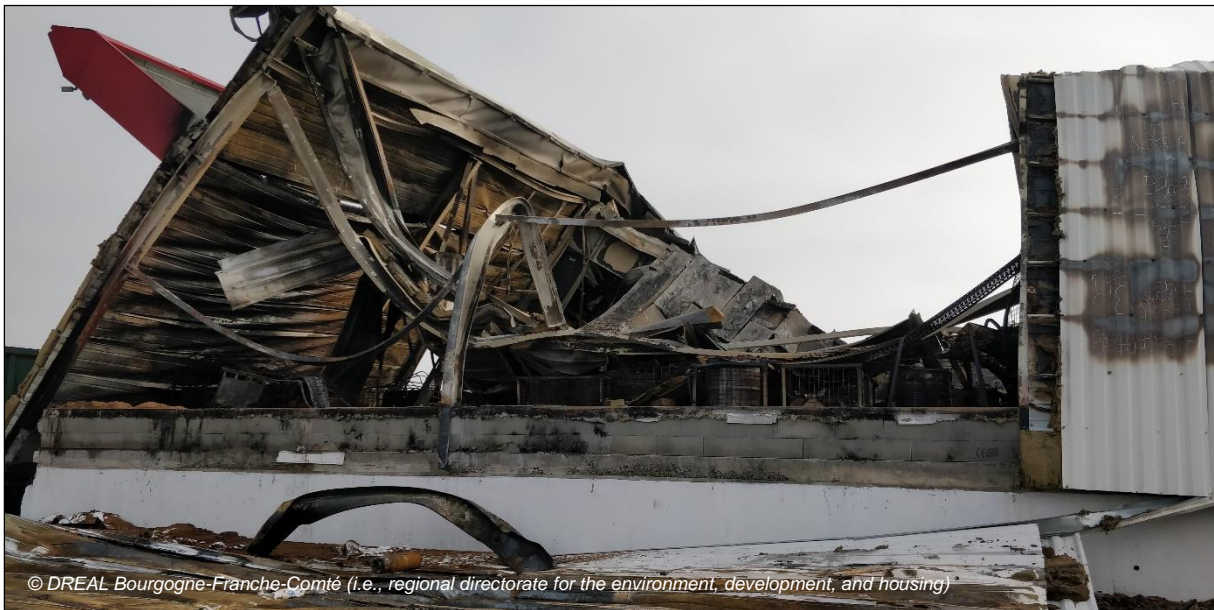
Major damage to the building was observed. On the eastern side, no damage to the gable was observed. However, on the western side, the gable was seriously affected by the heat. The southern side of the building was also seriously affected. In terms of the roof, the central zone and the western zone collapsed but the eastern zone and the offices zone sustained no or only minor damage. Overall, the operator estimated that 85% of the hub was destroyed. N.B.: on the north-western side of the building, a 12m length of cladding fell flat on the tarmac. This type of wall is usually expected to collapse inwards.

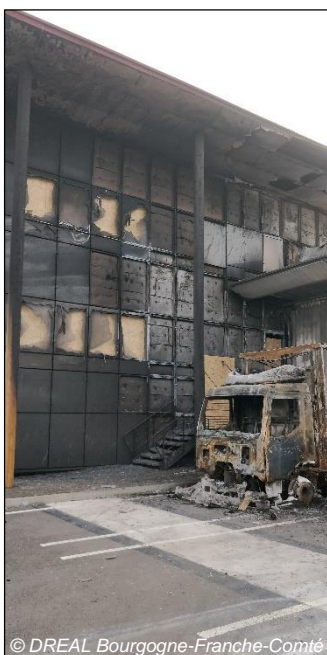
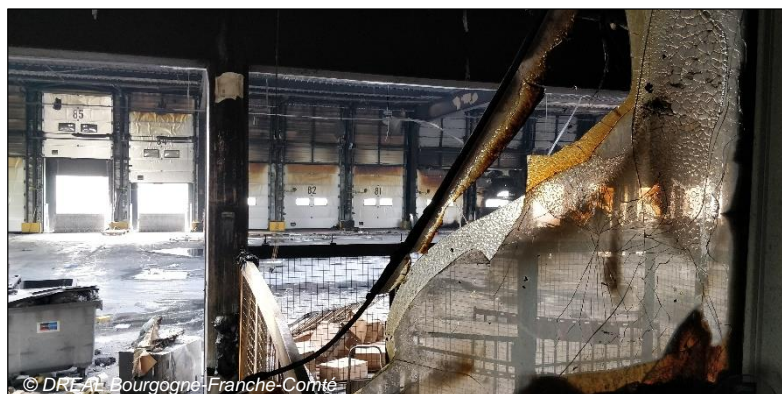
Damage was also observed in the administrative and operations offices, rendering them unusable in their current condition.

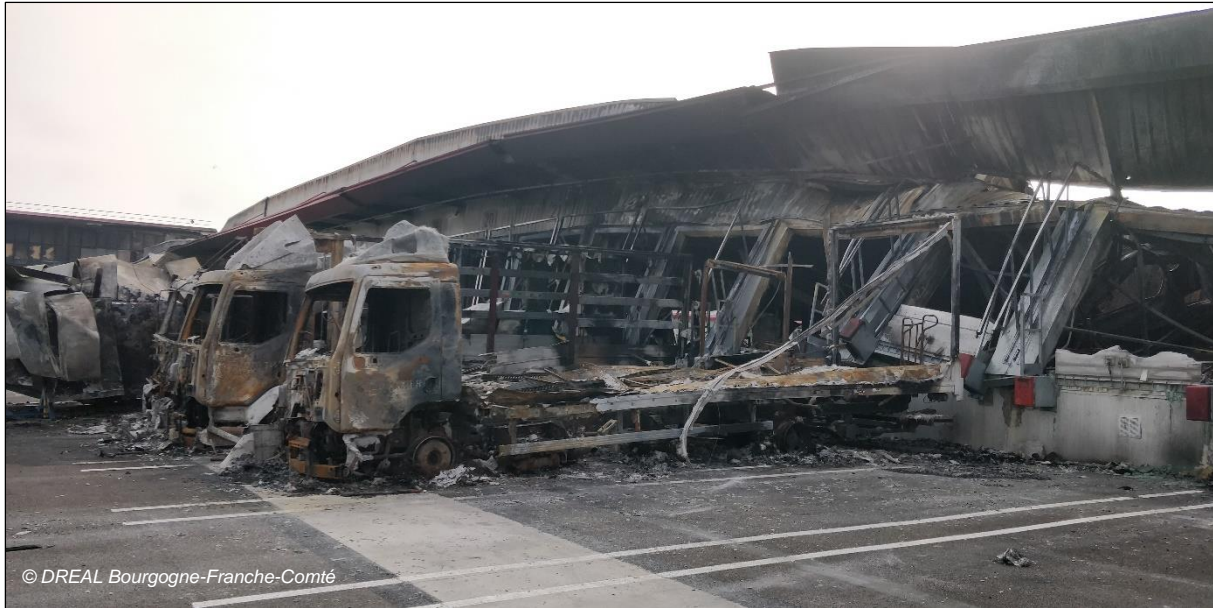
Twenty-two 12T trucks and seven HGV trailers were destroyed. N.B.: a certain number of vehicles were not docked but out for delivery.

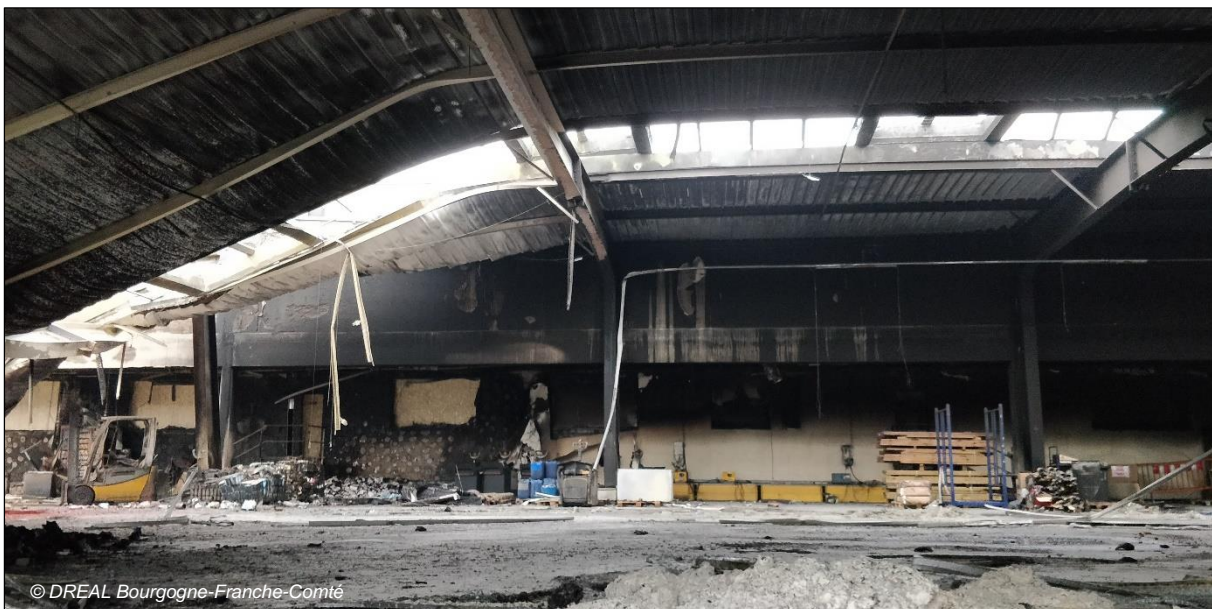
All the goods at the transit hub were destroyed during the incident. As the fire occurred on a Saturday, the docks were under maximum load but there was still some free floor space. N.B.: on this hub, freight is placed on the floor rather than being stacked. The computer records demonstrated that more than 250 tonnes of varied goods were on site during the incident, including 3.7 tonnes of hazardous substances (particularly including flammable liquids).

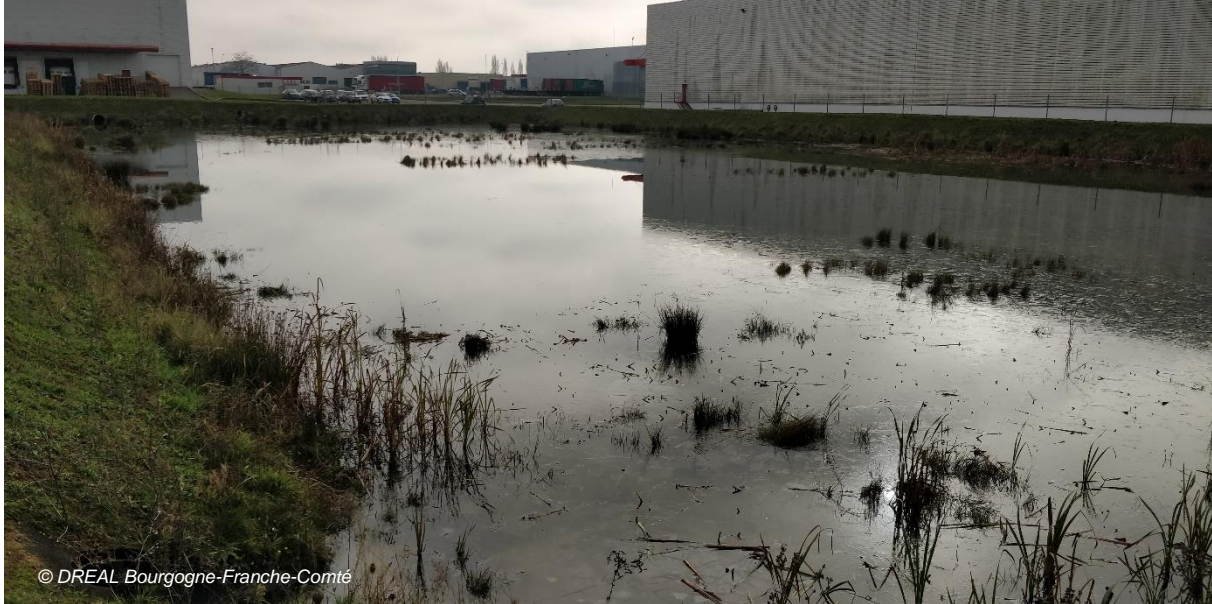
In terms of environmental effects, the firefighting water did not generate any impact on the external environment. As a matter of fact, the valve to shut off the main firefighting water retention basin was closed very quickly after the start of the incident and the basin covered with a geotextile, and a watertight geomembrane meant that the firefighting water could be contained.

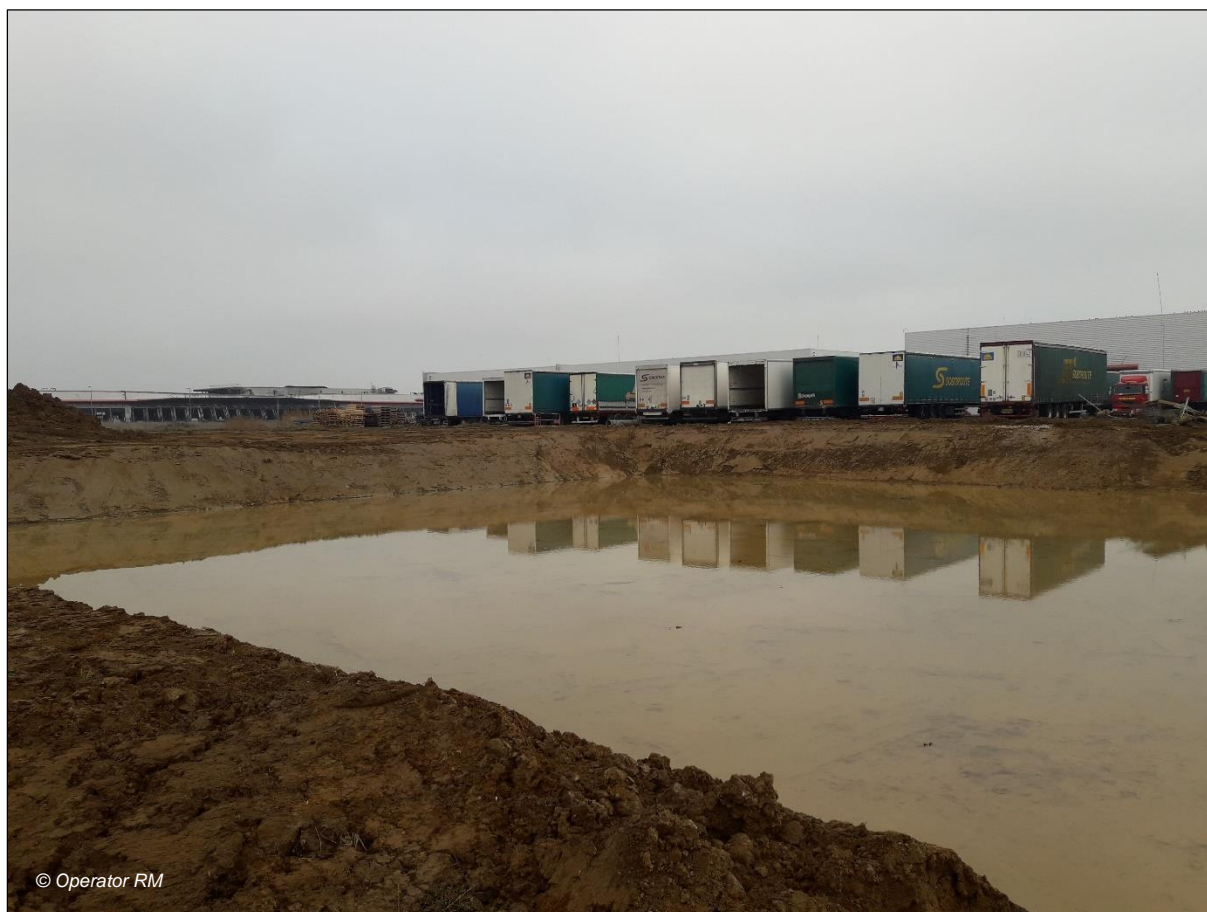
Following the event, the site encountered a rainy episode, which caused on-site issues over how to manage the firefighting water. As a matter of fact, the firefighting water was contained in a basin used not only to regulate discharges of rainwater into the external environment, but also as a basin to retain firefighting water and, as appropriate, retain pollution due to storage of hazardous substances.

As a result, the operator decided to create a new buffer basin to collect and channel uncontaminated rainwater. The scaling of this basin took account of the most unfavourable rainy episodes, and a flow restrictor was fitted to the basin's outlet to guarantee the expected leakage rate. In case of an exceptional rainy episode, an overflow means rainwater can flow into the main basin.
