Ammoniac leak during unloading of a railway wagon.

16th December 1994

Mazingarbe – [Pas-de-Calais] France

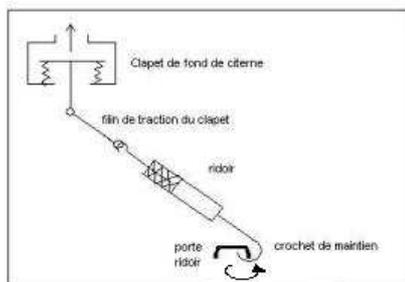
The valves were maintained in the open position by a turnbuckle hooked to one side of the valve cable and on the other side by the turnbuckle support. This latter was equipped with a pneumatic control, its operation was automatic. Thus the lack of air in the chamber with the gas strut caused the rotating turnbuckle support to swing around by 90° causing the unhooking of the turnbuckle and the closing of the wagon's internal security valve.

- **Failure of the system to free the turnbuckle activating the bottom valve of the wagon**

Following the order to disconnect the unloading arm, the bottom valve of the wagon did not close on account of a malfunction of the turnbuckle and its activating pneumatic system. This occurred for two reasons:

- One mechanical reason, the turnbuckle remained blocked on the catch of the turnbuckle support, doubtless on account of the acute angle between the turnbuckle and its support.
- A second reason linked to the problem of automation: the order to switch the turnbuckle is maintained only during the closing of the security valve of the sphere (around 3 s) by design of the automatic sequences of the security automation. The turnbuckle holder returned therefore to the blocking position as soon as the valve on the sphere had been closed.

- Installation of fail-safe pneumatic safety turnbuckles in place of the "turnbuckle + turnbuckle support" system and instructions given for regular testing of the turnbuckles to regularly verify their correct operation (1 test per point for 8 h / unloading point).

- Placing of two 15 m cables on the turnbuckle, allowing, in the worst case, for remote manual activation of the bottom valves of the wagon.
- Disconnection of the transfer arm would be henceforth limited to the only event of the movement of a wagon being unloaded, in order to limit the possibility of unexpected disconnection.

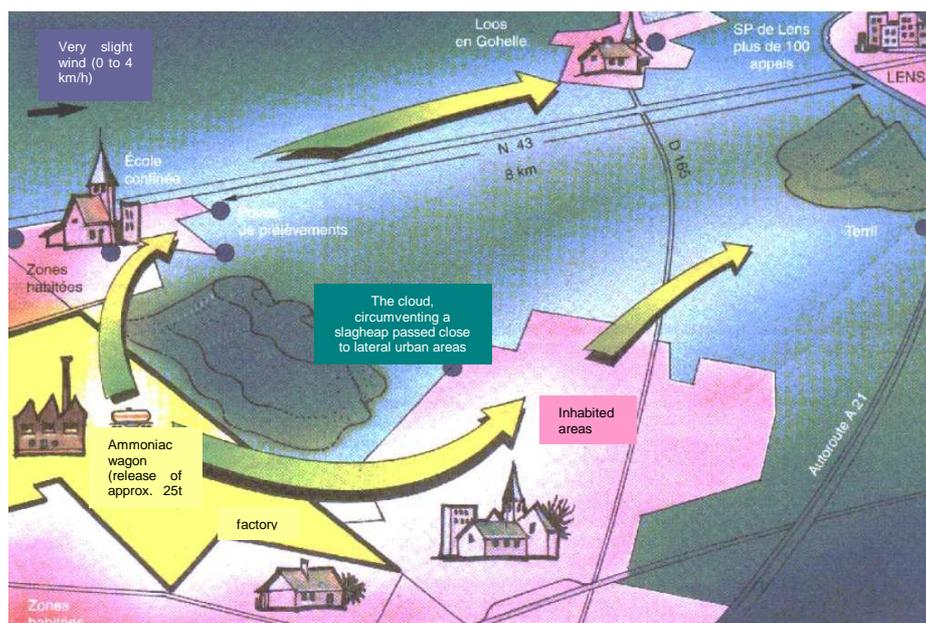
When the accident occurred, the meteorological conditions were very unfavourable as regards the dispersion of the ammoniac cloud.: very slow dispersion (thermal inversion) unstable wind from the north by north-west... According to the first witness statements, a dense fog was formed at about 3m above the ground and rose slowly into the atmosphere. The cloud then moved towards a national road (RN 43) and the closest houses.

The wagon contained initially, 48t of ammoniac, 18 t were found in the tank after the accident. Approximately 27 t of toxic substance were thus released to the atmosphere in 37 mm (average flow rate of 12 kg/s).

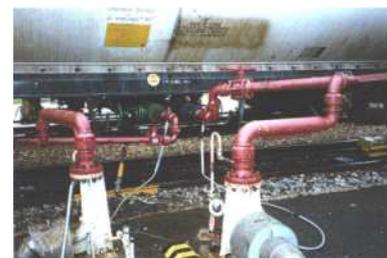
- **The initiating element: anti-collision detection**

For an unknown reason, (vibration, shock on the wagon, passing by of a person...) the sudden activation of the anti-collision system provoked the

disconnection of the loading arm of loading point 3. On the track serving this loading point, the manoeuvre consisting of distancing two empty tank wagons which had previously been unloaded had just commenced. Subsequent checks of the anti collision pedals did not reveal any malfunction.

- Padlocked swinging Scotch blocks making it materially impossible for accidental collisions between unloading and other moving machines, to replace the disconnection pedals used at the time of the accident with the tank-wagons.

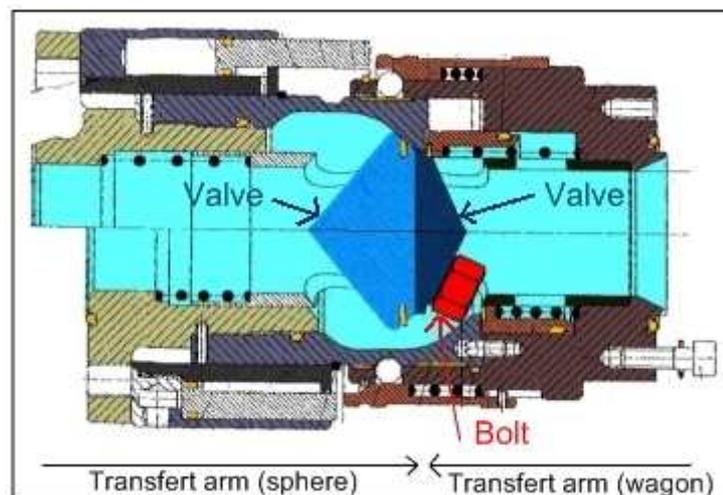
- **Failure of the valve (wagon side) of the disconnection system of the transfer arm**

The valve of the disconnection system mounted on the transfer arm (on the wagon side) only partly closed, blocked by the presence of a foreign body: a bolt of unknown origin and different from those used to attach the straps on the unloading installation (see figure below).

- Placing of a filter at the end of the liquid phase arm on the wagon side, to prevent the intrusion of foreign bodies.
