Pollution of the Rhone River by phenol

26th February, 1993

Roussillon (Isère)

Phenol
Sensors / Redundancy
Loading-unloading (station)
Maintenance / repairs
Training
Organisation / Procedures

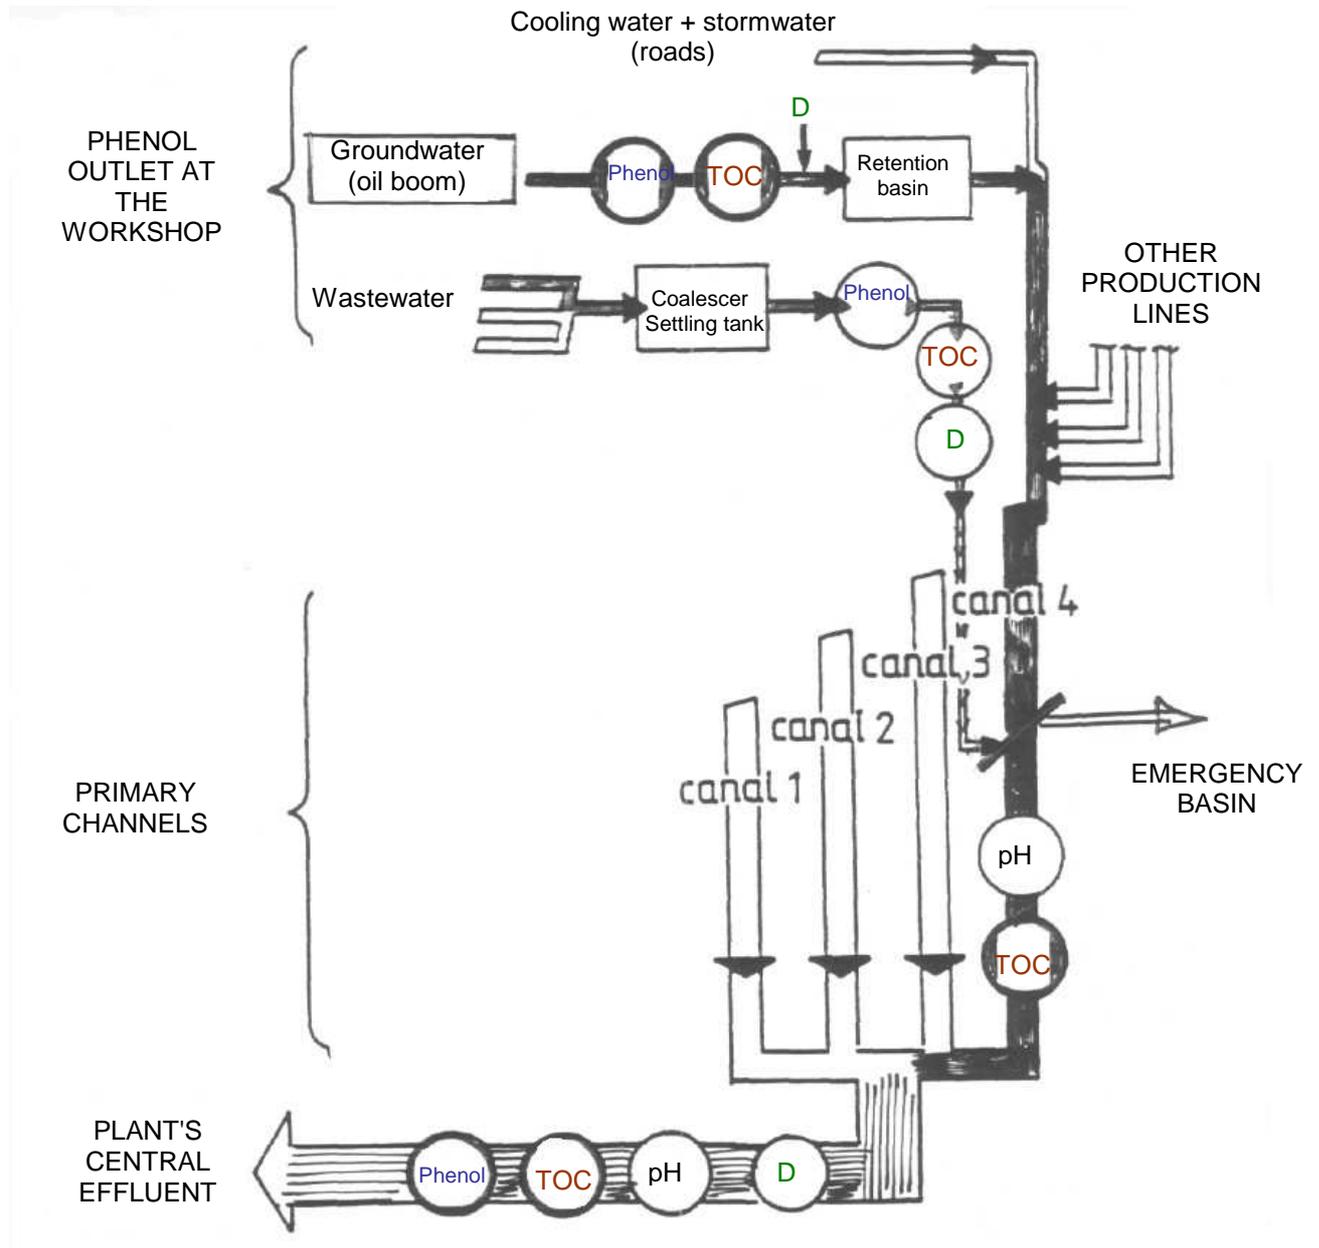
TOC detection at the level of Channel 4 displayed 600 ppm. Subsequent to a production incident, the TOC meter positioned at the phenol workshop outlet also detected a concentration (10 ppm) during this period. The phenol meter placed at the retention outlet on the transfer station, despite its defective operations, still showed a small phenol content (30 ppm). In making a poor interpretation of the contrasting values output by detectors and no doubt in overlooking the incident that had occurred the previous day, control room technicians attributed the pollution in Channel 4 to the phenol workshop. At 8:10 am, they isolated this workshop's discharges by closing a stop valve and diverting water (from the workshop phenol + loading station) to the emergency basin.

The TOC meter on Channel 4, which had been operating continuously, was only able to record one measurement every 10 min. Located downstream of the phenol workshop shut-off valve, this meter stopped relaying warnings as of 8:30 am since the water was being diverted to the emergency basin. The stop valve was then reopened and closed again 15 min later following a new TOC warning.

The discharge of toxic materials into the Rhone River stemmed from a combination of technical and organizational deficiencies: faulty and/or poorly positioned detectors; lack of internal information circulation on incidents; inadequate personnel training; absence of comprehensive procedures and guidelines, especially regarding the degraded mode of operations (poor interpretations by technicians of erroneous data, etc.).

- TOC: TOC meter
- D: flow meter
- pH: pH meter
- Ω: conductivity meter
- T: temperature probe
- Phenol: phenol meter
- Redox: redox tank

The facility operator repaired the faulty detection equipment on the lorry transfer stations and proceeded to equip the corresponding railcar devices. The TOC meter controlling Channel 4 effluent was moved to a different spot.

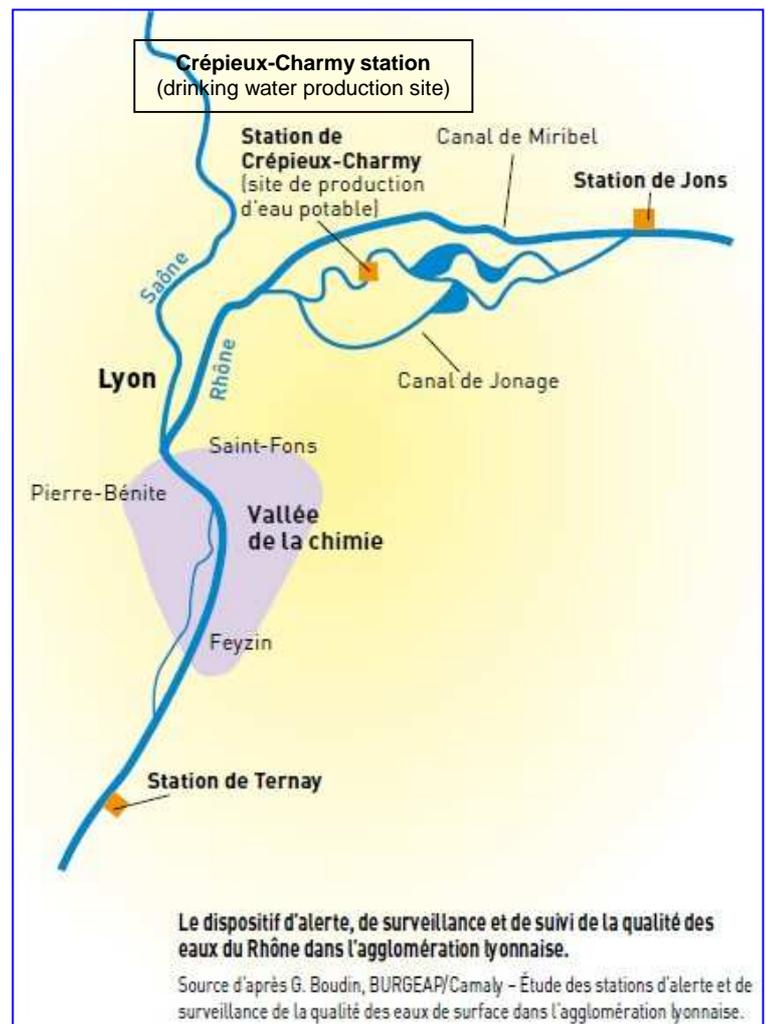
The warning, monitoring and tracking system dedicated to Rhone River water quality within the Lyon Metropolitan Area

The station located in Ternay continuously measures some 15 physicochemical parameters, including several heavy metals; it also features a hydrocarbon detector and a test (with fishes) quality meter to act as a biological system warning.

A data validation procedure along with an on-call service had been instituted for cases when an alarm threshold is exceeded, for the purpose of informing the relevant bodies and authorities. An alert protocol served to codify all of the targeted actions. Each partner was provided direct and permanent access to analytical data on an ongoing basis.
