Explosion of a hydrogenation reactor

27th December, 1995
Le Pont-De-Claix (Isère)
France

Chemistry
Toluenediamine / Dinitrotoluene
Reactor explosion / Fire
Washing
Human error
Organisation / procedures / control
Victim

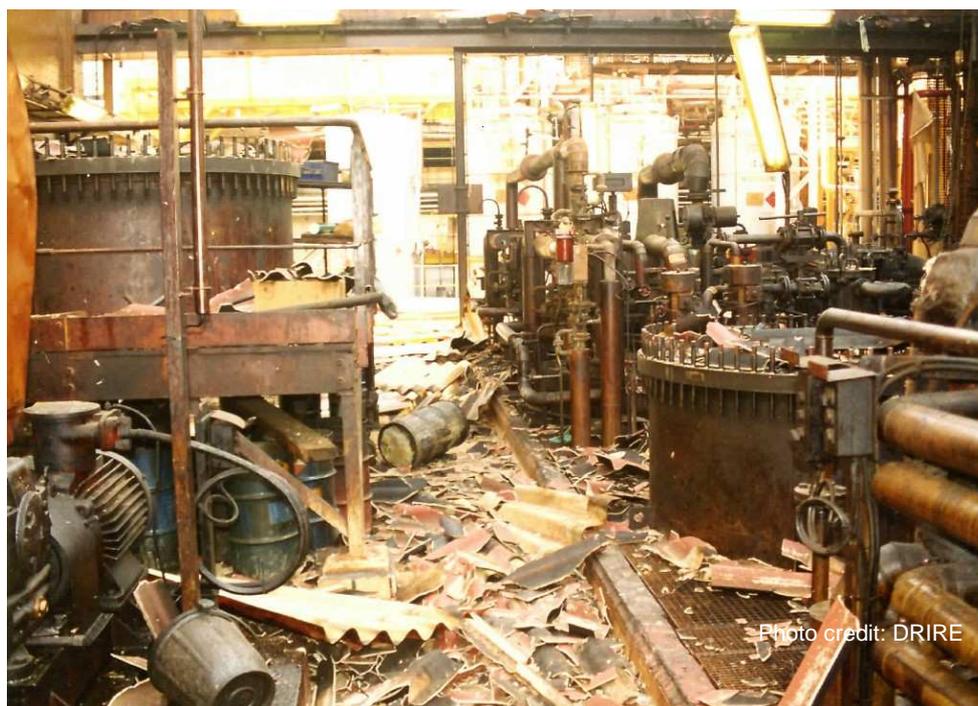
5:08 am: explosion of reactor G901a.

The explosion of a pressurised device most often leads to a rupture of the capacity with little or no spraying of debris; in the present case however, this reactor fragmented into some 15 pieces. The clean breaks on this device suggested that it had been exposed to a pressure considerably above the 240 bar test pressure and undoubtedly in excess of 1,000 bar.

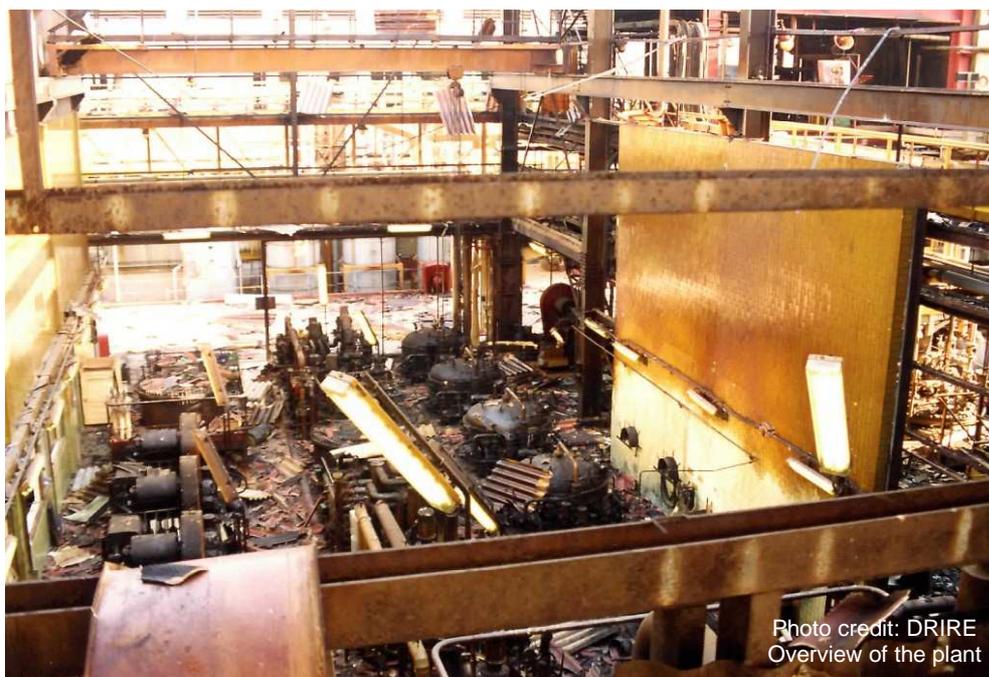
Property damage was very extensive: the TDA plant was unusable; the control room severely damaged; the reactor and a portion of the other facilities located in the bunker were destroyed. The masonry, showing signs of complete rupture in spots, along with twisted rebar attest to the violence of this explosion.

The blast of the explosion and projection of metal fragments resulting from the reactor destruction deformed the bunker insulating the chemical installation. Fragment projections outside the bunker reached adjacent facilities, as the shockwave destroyed a wall made of breeze block inside the catalyst preparation zone while deforming the control room building structure and cracking walls.

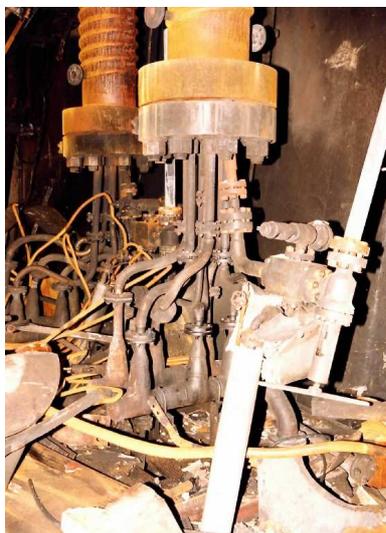
Close-up of the damaged reactor

Lastly, given the reactor's appearance after the explosion (ripped into 15 pieces, with clean breaks) and the high pressure attained, a number of metallurgical analyses were conducted on the recovered parts.
