Explosion in a malt house silo

October 18, 1982

Metz (Moselle)

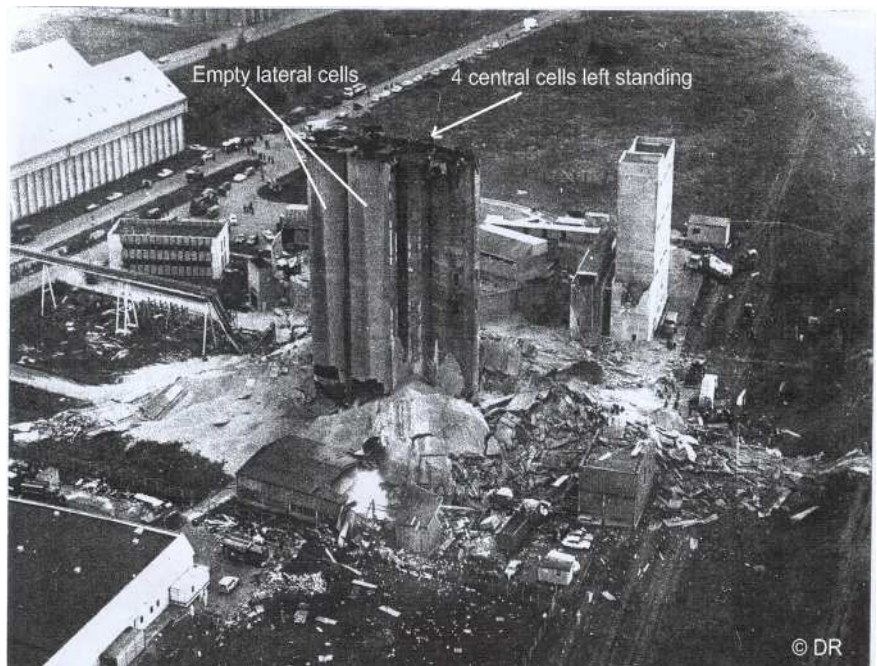
The installations collapsed. The operational tower fell on top of the rail spur leading to the malt house, spanning a distance roughly equal to its height. Moreover, 8 of the 14 cells were completely destroyed; 2 empty cells were heavily damaged over their lower part but remained upright, as did the other 4 cells (along with their contents), all positioned in the silo's middle row. The instability of residual structures plus the tremendous pile of concrete rubble and spare equipment covered by grain strewn by the explosions severely complicated the work of emergency responders. A total of 600 rescue personnel, including canine units, were mobilised in the hope of finding survivors; two cranes capable of lifting 150 and 300 tonnes were brought onsite.
