Explosion during the destruction of munitions

May 21, 1996

BEINE NAUROY [51]

France

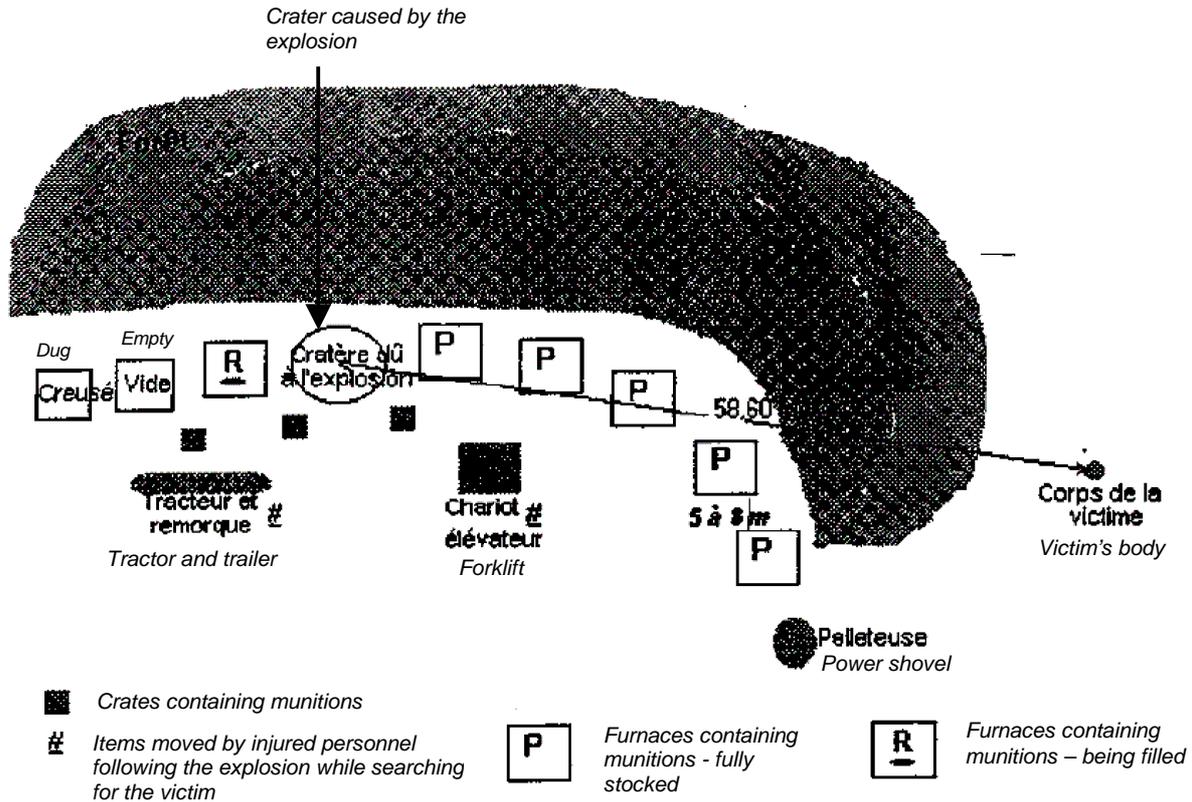
Diagram of the installation

The rather rudimentary munitions destruction zone contained a series of holes or "furnaces", dug using a power shovel and surrounded on two sides by a barricade (see diagram below).

In order to destroy the ammunition by "setting off", the company used dynamite. Since such an approach could not ensure the total destruction of munitions packaged in crates, onsite personnel were required to empty the contents into the furnaces and then remove the crates.

These operations, performed by 5 staff members, consisted of preparing the holes and then filling them with the ammunition intended to be destroyed. A technician at the bottom of the hole was responsible for unloading the ordnance (i.e. opening crates, removing contents). Two other technicians would hand to the first one the full crates and then recover the empty packaging at the rim of the hole. The last two employees outside the hole were responsible for stacking the empty crates onto a trailer.

These handling operations increased the risks during preparation of the holes :

- the technician, working at the bottom of the hole, was in direct contact with the munitions and ran the risk of accidentally stepping on live ammunition, to an even greater extent when filling the furnace opening;
- all crates had to be opened and emptied, thus generating a significant shock risk.

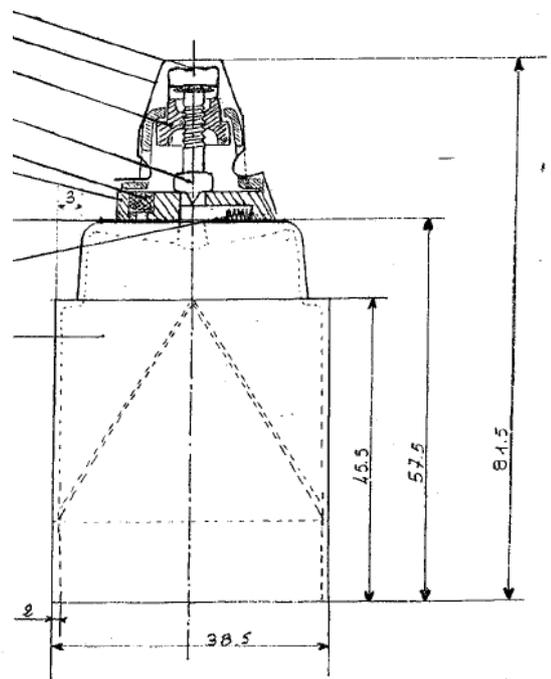
**SHAPED CHARGE: 155 m/m
CARGO BOMBLET SHELL**

The shaped charges, stacked on rollers, displayed on one side of the crate fabric braids, which were held in place by a clip that served to "pull the pin" on the charge, thus triggering the charge.

The inside of the crates was padded along the edges by expanded polystyrene. The mine removal unit provided a detailed examination of the contents of one of the crates: the majority of charges whose "heads" were placed against the polystyrene wall padding had lost their safety clip, which when in its proper position holds a "drawer" containing a fuse.

In the safe position, the fuse is offset with respect to the striker. Once the clip has been removed, the drawer spring is actuated and the fuse assumes a position next to the striker. If a half-turn is carried out on the ballasted nylon braid, the striker moves onto the fuse: a shock on the fuse head then triggers the explosion (see diagram opposite, provided by the mine removal unit).
