## Propane leak in an LPG depot

October 23, 1989

Le Blanc [Indre]

France

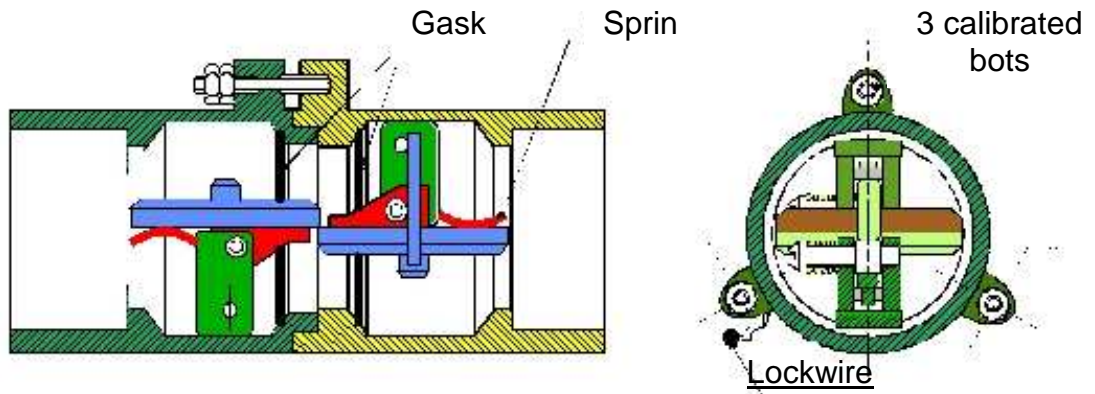
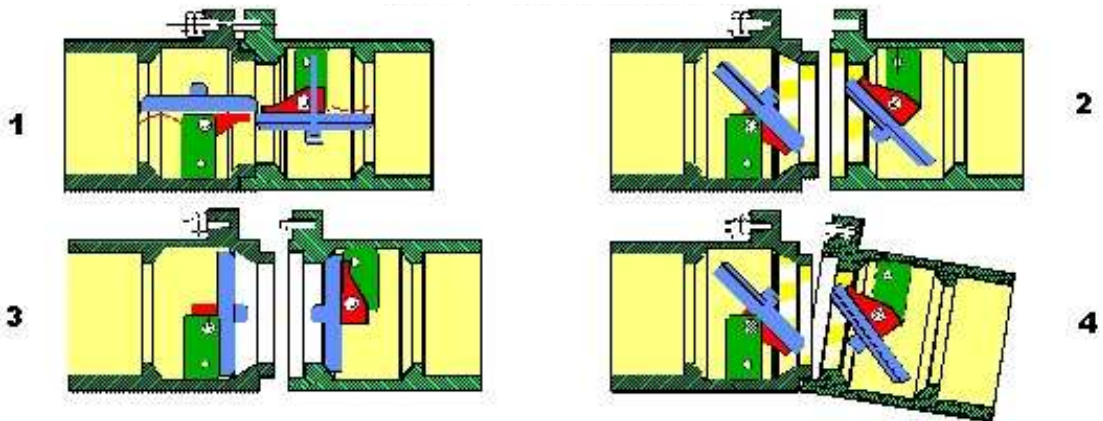
**1<sup>st</sup> device :**

The accident resulted from the rupture of only 2 of the 3 rupture blades equipping the device described earlier. The 3<sup>rd</sup> blade was folded but did not break, the 2 housings were spread only partially without disconnecting completely, thus preventing the springs from releasing completely and sealing the valves. The gas in liquid phase was released by the partially closed valves for about 8 minutes.

Considering the design of the device used, the aperture angle between the 2 half-bodies of the double rupture valve was not sufficient to allow the 2 valves to close completely.

OPERATION OF THE DUAL RUPTURE VALVE  
(manufacturer's documentation)

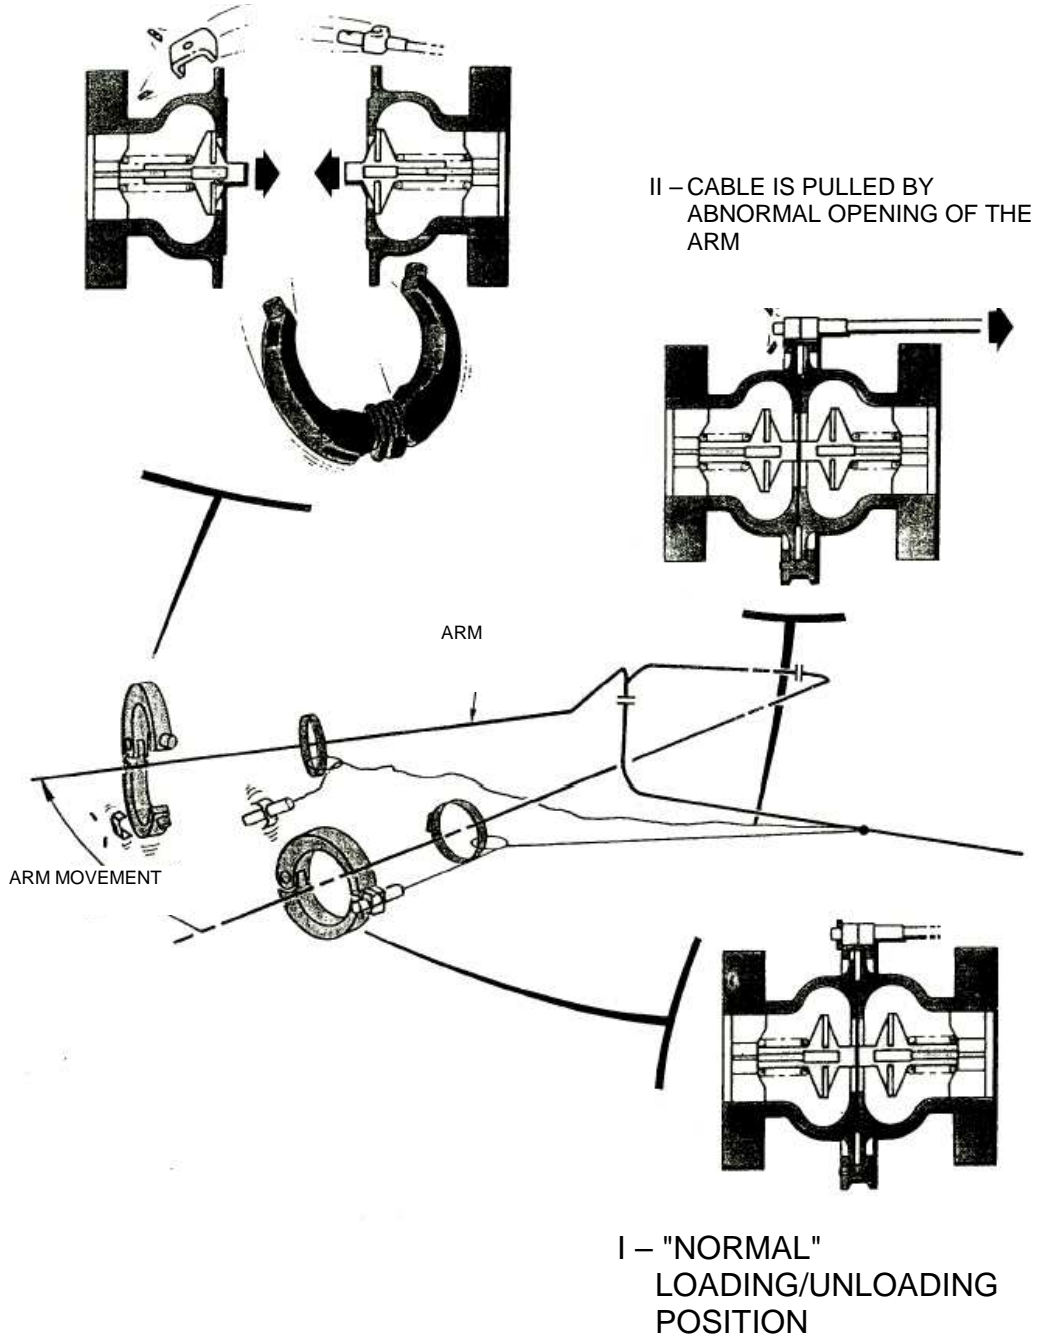
**2<sup>nd</sup> device :**

*Device modified after the incident.*

**III - PIN RUPTURE,  
SEPARATION AND IMMEDIATE  
ACTUATION OF THE TWO VALVES**
