## Rupture of a heated fuel tank

25 December 1988

Berre l'Etang (Bouches-du-Rhône)

Structural rupture

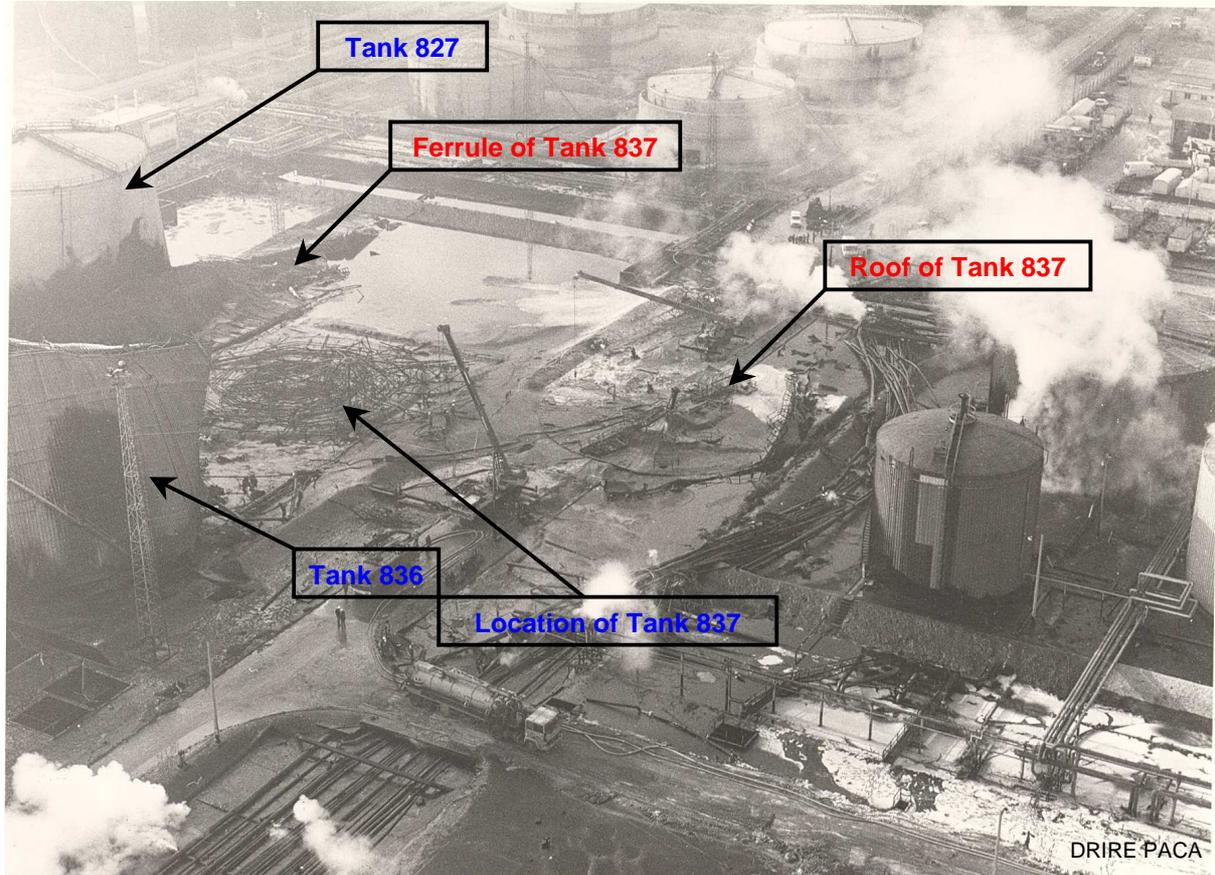
The wave of hydrocarbon product from the tank heated at 127°C (density: 0.95) rolled well past the confines of the retention basin, extending some 8 ha inside the plant and covering many of the installation's internal roads. Damage was caused to one of the adjacent tanks (T836), with low-sulphur residue, completely deforming it and lifting it onto its base.

The shell fitted to the T837 tank fell onto the adjacent T827 tank, which was storing high-sulphur distillate, in turn deforming several ferrules and partially stripping the roof. Afterwards, the tank located diagonally opposite (T826), in the same common basin with a straight-run low-sulphur residue, was displaced. Carried by the power of this hydrocarbon wave, the roof of tank T837 along with 4 pieces of ferrule that had remain attached drifted 45 m from their original location.

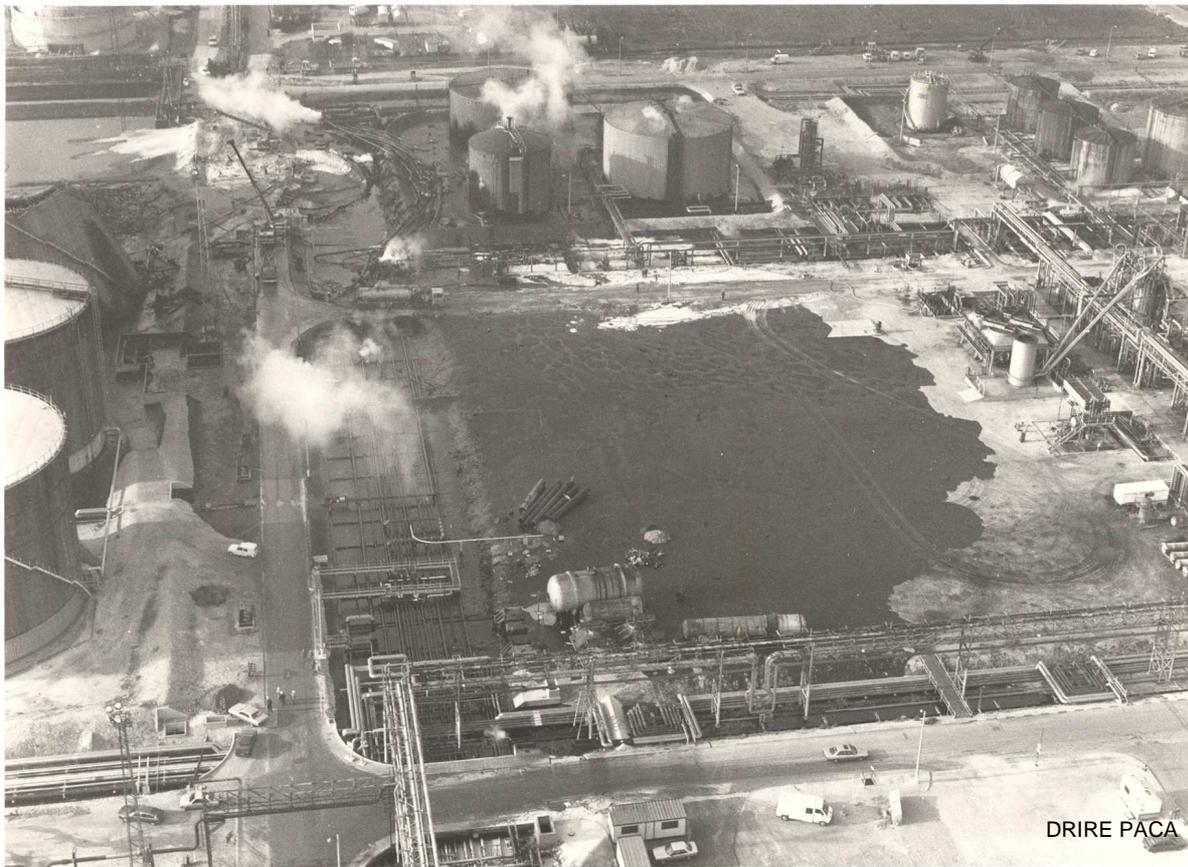
Pollution was prevented from entering the nearby *Berre Pond* by means of installing a floating dam to help channel residual water containing hydrocarbons to a 20,000-m<sup>3</sup> stormwater basin. Moreover, this product congealed very quickly inside the refinery and retention basin, making it much easier to confine.

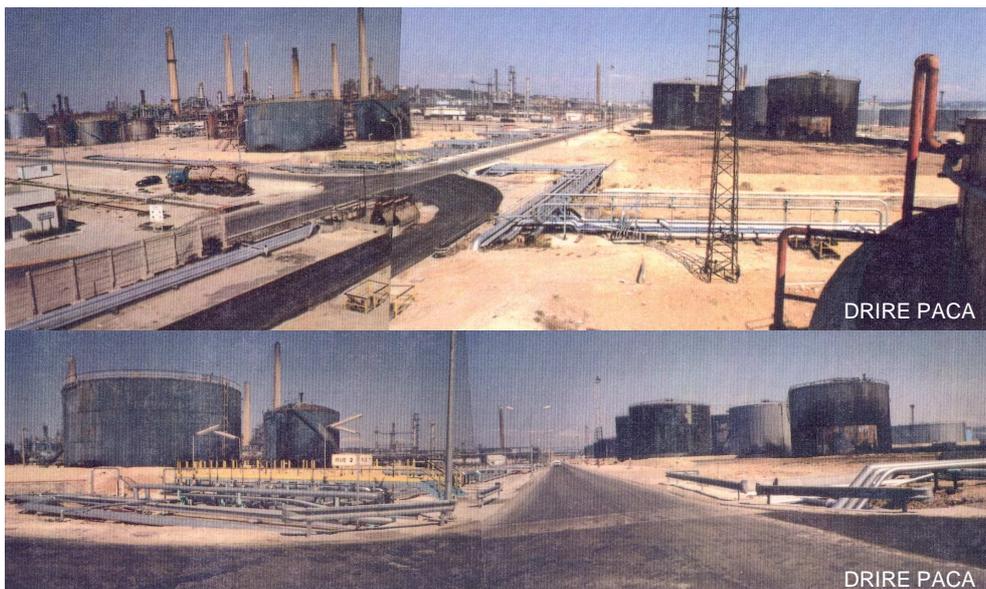
Photographs taken on March 30, 1990 during site rehabilitation works

Repair works were undertaken following the accident for the purpose of reinstating the site for service in 1990.
