Explosion of an alcohol-tank in a sugar factory/distillery

24 July, 2000

Villette-sur-Aube (10)

Explosion
Sugar factory /
Distillery
Storage tank
Alcohol / Ethanol
Lightning
Flame arrestors

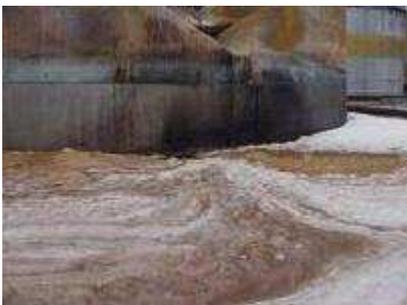
Photo DRIRE Champagne-Ardenne

An explosion occurred, the roof blew off and fell onto the tank. A fire broke out. The tank shell remained intact and the fire does not propagate to the other storage tanks. However, the valve at the base of the tank cracked as a result of the impact.

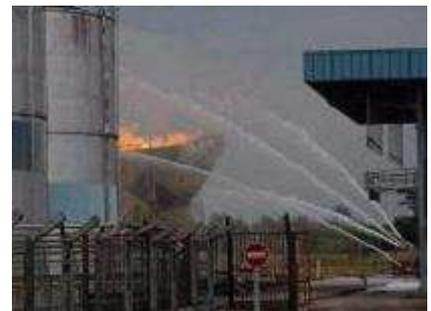
Photo DRIRE Champagne-Ardenne

The bound did not catch fire thanks to the pouring of foam concentrates. The tanks located nearby were sprayed down, in order to cool them down. The fire was considered to be extinguished at about 7.45 p.m.

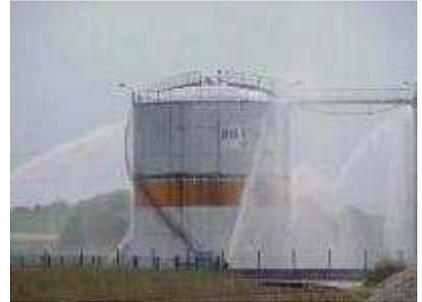
Photo DRIRE Champagne-Ardenne

The tanks were sprayed down until 11 p.m., at which time the fire brigade were called off. The on-site storage of 23,000 litres of foam concentrates was sufficient to extinguish the fire. The extinguishing water was retained in the bund.

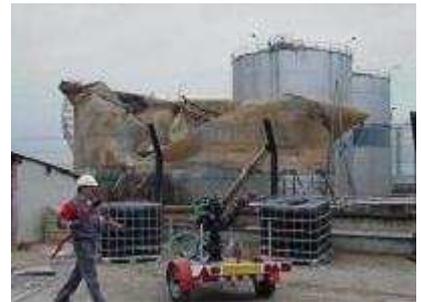
Photo DRIRE Champagne-Ardenne

The damage caused as a result of the accident is estimated to be more than 15 million French francs, i.e. 2,29 million euros.

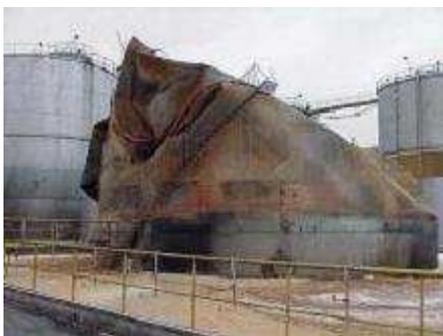
Photo DRIRE Champagne-Ardenne

Lastly, it should be noted that 23,000 litres of foam concentrates and 7,000 m³ of water were used during this accident.

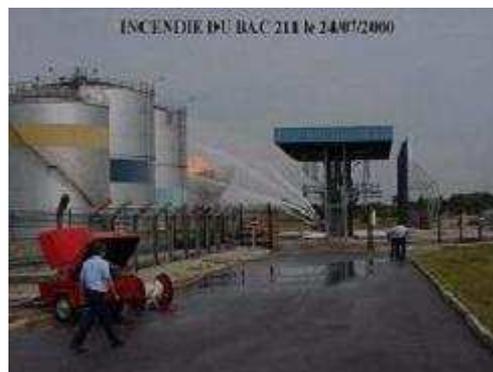
Photo Internet Press

- ✓ Checking of the soundness of the tanks (hermetic seal, strength), as the 3 tanks of 2,500 m³ capacity that were next to the damaged tank had been subjected to a high amount of thermal radiation.
- ✓ Checking of the electrical installations, by a qualified agency before the restart of any activity, in the whole storage farm.
