## Explosion of a hydrocarbon storage tank

20 February, 2001

Lespinasse (31)

France

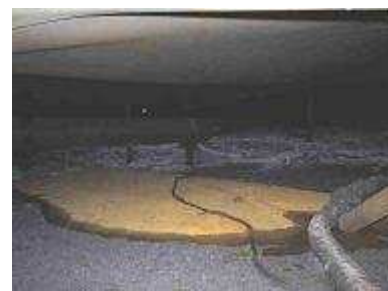
The operations, conducted by employees from an external company, consisted in scraping the floor to remove residual deposits. The tank's screen was at a height of approximately 1.2 m. In this case, the working space was limited.

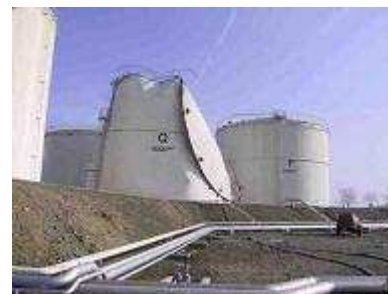
Photos: DRIRE Midi-Pyrénées

At roughly 4 pm, an explosion occurred while the 2 contractors were inside the tank.

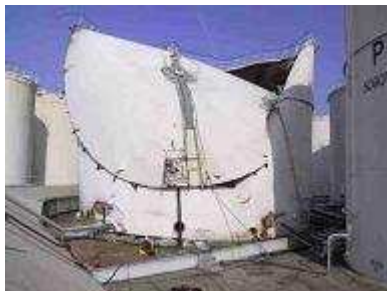
Photo : DRIRE Midi-Pyrénées

The 2 contractors were seriously injured: they were able to exit the tank by themselves and were subsequently hospitalised when the emergency rescue team arrived. They are both burnt, one of them seriously.  
 The tank was totally destroyed. Activity at the depot was stopped for approximately 2 months.

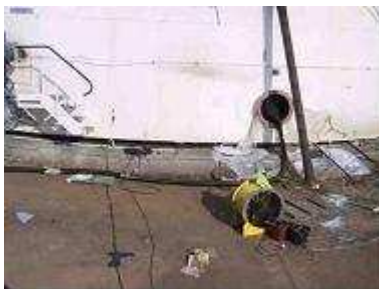
Photo : DRIRE Midi-Pyrénées

The tank involved by the accident was equipped with only one manhole. Configuration during the cleanup operations:

- ✓ all of the vents were not open,
- ✓ the ventilation used to remove fuel fumes was stopped for the intervention,
- ✓ operations were started before reaching a gas concentration lower than 10% of the LEL (lower explosive limit).

The hypothesis of a spark created by one of the worker's tools (boot soles points, metallic scraper, steel snaphook, etc.) is the most plausible. Within an explosive atmosphere, this could have caused an explosion.

- ✓ Modification of the procedure for maintenance/servicing inside a hydrocarbon tank:
  - compilation of procedures adapted to the site and to the tanks (all tanks are not identical in terms of equipment, which changes the precautions to be taken prior to the operation)
  - cleaning/degassing operations are to be performed only after validation by the depot manager or an assistant.
  - vapour concentrations (explosive atmosphere) specified in the procedures are to be reached before the start of any maintenance/servicing in the tanks (no anticipation).
  - improvement of the ventilation by opening branch connections, removing valves, or opening manholes, ...
  - maintain forced ventilation throughout the entire operation
- ✓ Reminder of intervention principles for external companies performing tank maintenance/servicing operations
