**BLEVE in an LPG storage
Facility at a refinery
January 4, 1966
Feyzin (Rhône)
France**

- BLEVE
- Fire
- Domino effects
- Refinery
- LPG
- Purge valve
- Instructions
- Organisation of emergency
- Victims
- Material damages
- Projectiles

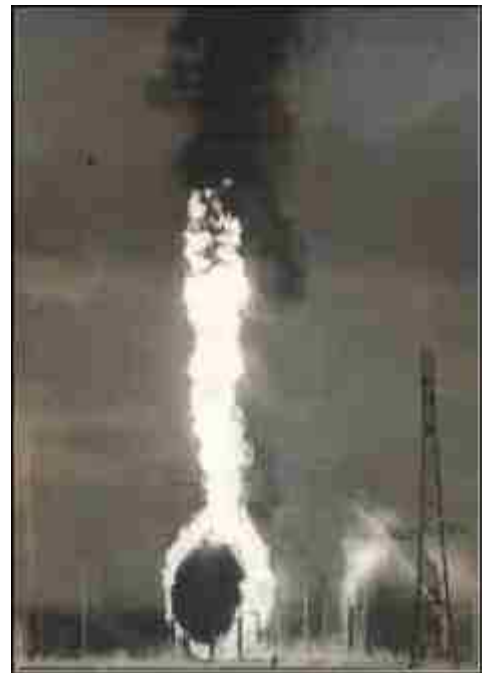
Figure 2 - Sphere T 61443 on fire
Photo : le Progrès

- 7.45 am: The safety valve on sphere 443 opens due to the internal pressure of the LPG: upon release, the gas immediately vaporises and ignites, resulting in a 10 m-high torch. At that moment, the firemen stop spraying the sphere and essentially concentrate on cooling down the neighbouring spheres. The valve's opening is regarded as positive as it will allow the situation to be controlled within 2 or 3 hours, once the gas is consumed. At 8.05 am, one of the rescue teams chooses to secure the nozzles and withdraw the firemen.

- Around 8.45 am: Sphere 443 explodes. A fireball forms in just a few seconds and reaches nearly 250 m in diameter, reaching nearly 400 m in height.
- *At 8.55 am:* The emergency shutdown of the units is ordered. Zone B is evacuated: All of the personnel who had survived the explosion fall back.

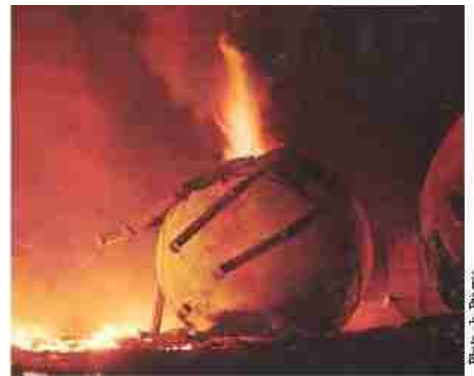
Figure 4 – Illustration of butane sphere 462 on fire

The sphere opened up in the zone where the metal was in contact with the gas phase and the sheeting was ripped back over 7 m. The valve had functioned.

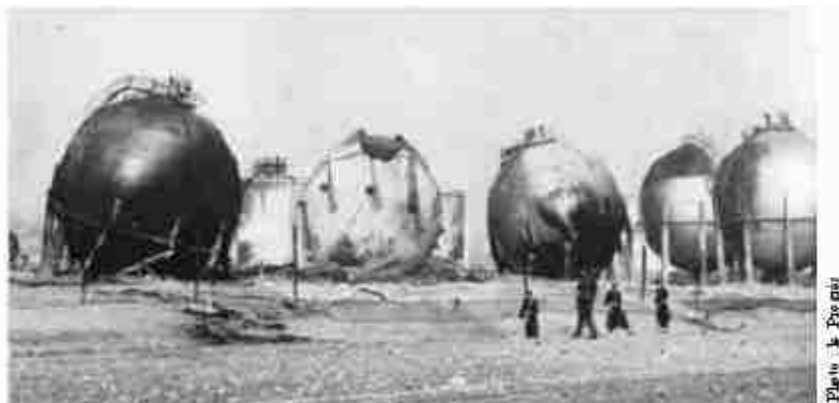
Figure 5 - General condition of the LPG spheres after the accident

The fire destroyed or damaged the LPG and neighbouring liquid hydrocarbon storage facility, including 11 tanks (5 spheres, 2 horizontal tanks and 4 floating roof tanks). Product losses were calculated at 1,012 tons of propane (i.e. approximately 2,000 m³), 2,027 tons of butane (i.e. nearly 4,000 m³) and practically 2,000 m³ of jet fuel, the equivalent of 1,500 tons of petroleum products. The pump station (located between the horizontal LPG tanks and the jet fuel tanks) and 6 fire trucks also were destroyed in the fire.

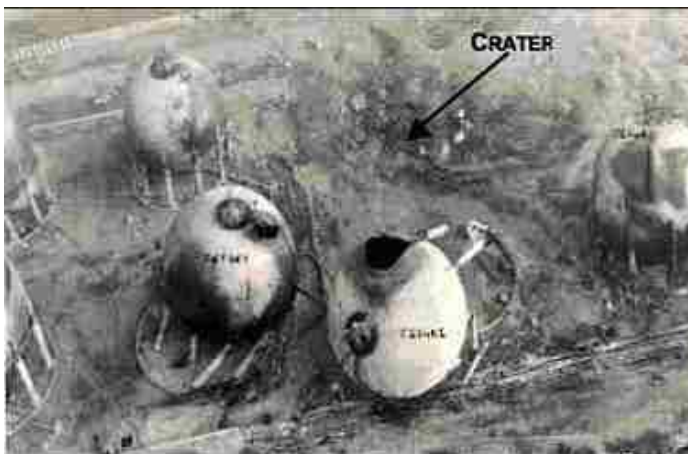
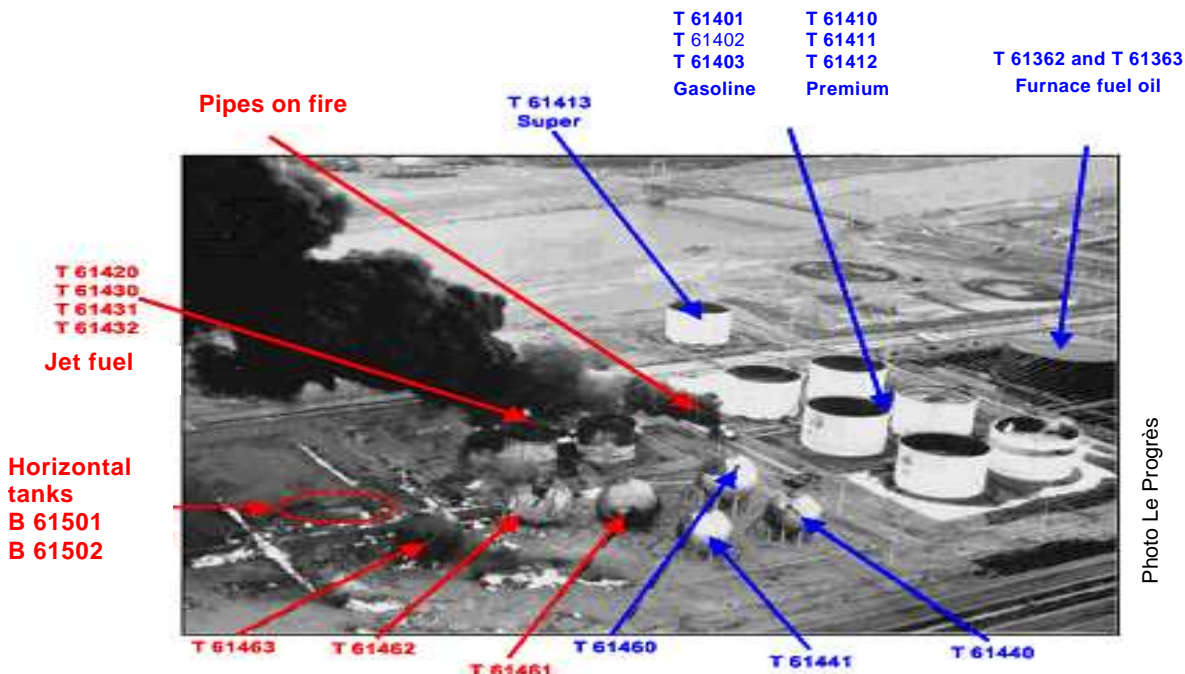
Figure 7 – Summary of property damage

At the site of the explosions, a crater measuring 35 m long, 15 m wide and 2 m deep was left, notably underneath sphere 442.

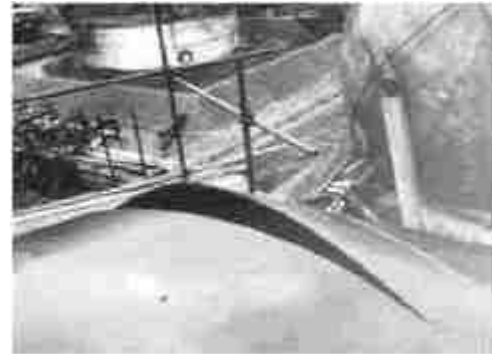
Figure 8
Opening in butane sphere T 61463

This sphere has a 4.50 m-long slit in the metal portion in contact with the gas phase. Based on the fragments recovered, it is difficult to affirm whether or not the valve had operated.

The sphere collapsed following the creeping of the unprotected part of its legs: the sphere was practically full.

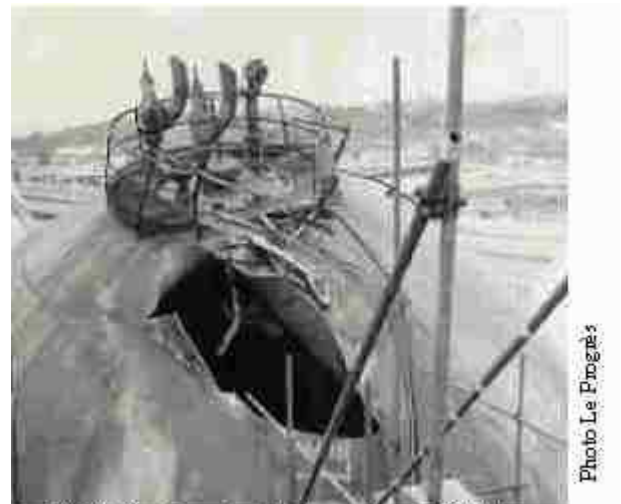
Figure 10 – Opening in butane sphere T 61441

The paint was burned over 1,200 mm on the SW face. The legs were moved and the fire-resistant cement had cracked. The SW face of the sphere was struck by a projectile.

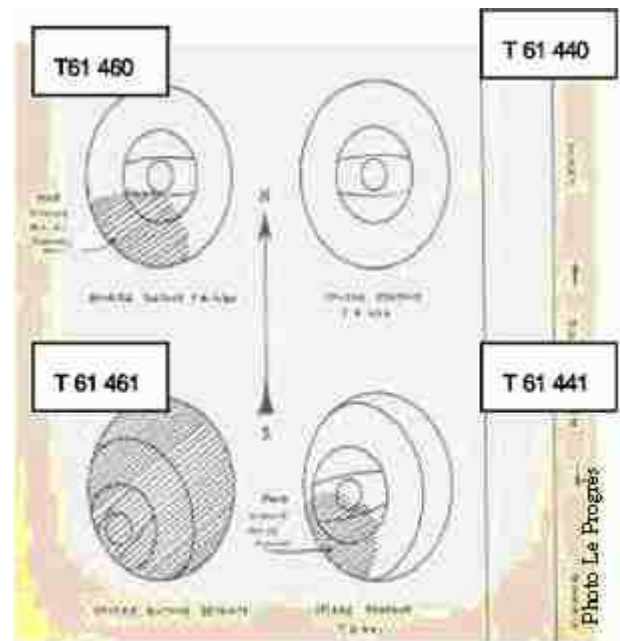
Figure 13 – Zones of spheres damaged by the flames and final position

The upper metal sheets were heat at an angle of 150° (which corresponds to the part in the gas phase). The fire-resistant cement of the support legs cracked, although the legs did not move.

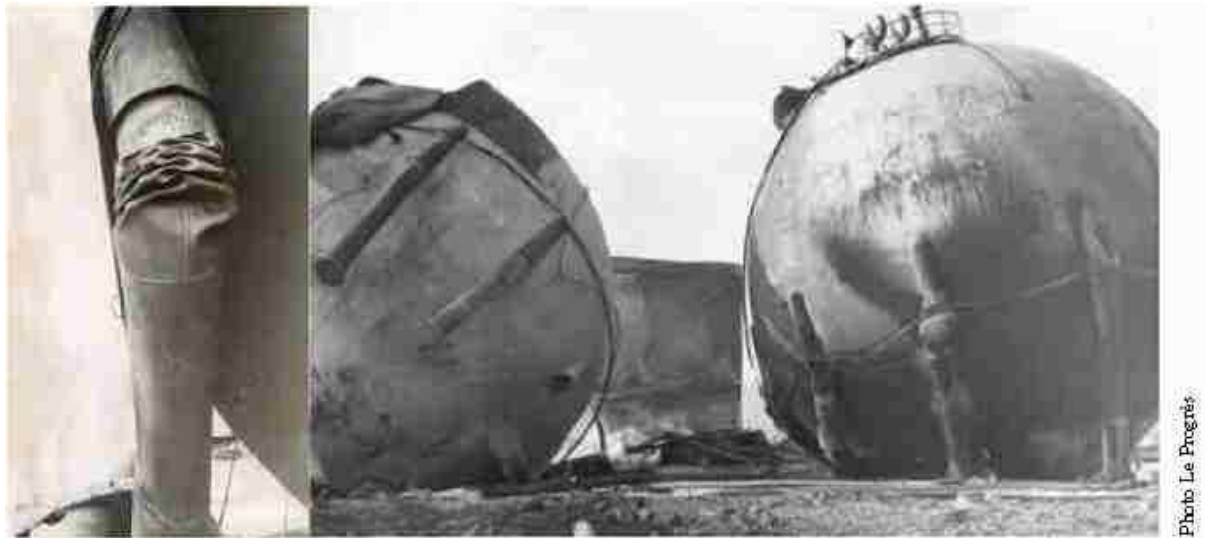
Figure 14 - Illustration of the general condition of the spheres damaged in the explosions.

The damaged spheres show signs that some of them had been struck by elements from the spheres that experienced a BLEVE. By the same token, it appears that the racks of flammable liquid pipes (see photo) were struck by projectiles.

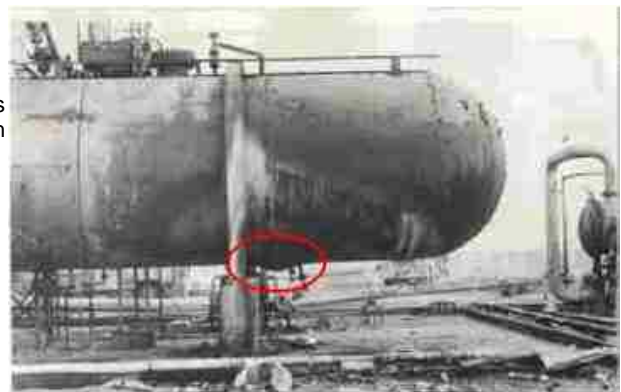
Figure 11 – Bulge underneath jet tank B 61502 (propane)

The "jet tanks" were damaged. In both cases, the metal was heated to very high temperature, then poorly cooled, which caused:

- deformations in the propane tank,
- an opening in the butane tank.

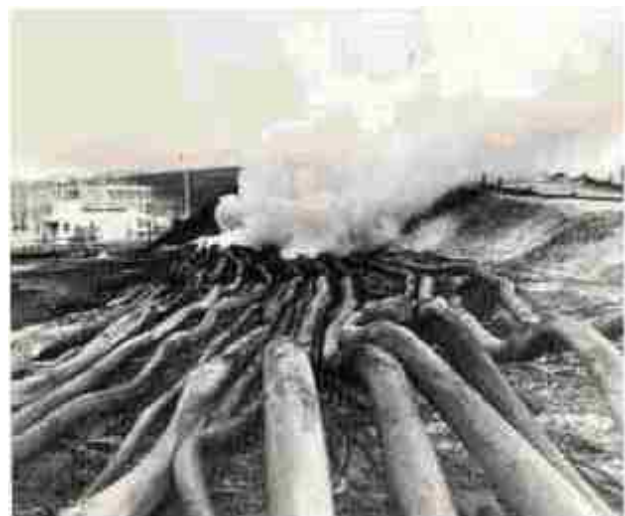
Figure 12 – Pipe damage

This photo shows the condition of the hydrocarbon lines (essentially fuel, FFO,...) located near the motorway over-pass. According to the reports compiled at the time of the accident, the destruction was essentially caused by flying debris from the exploding spheres.

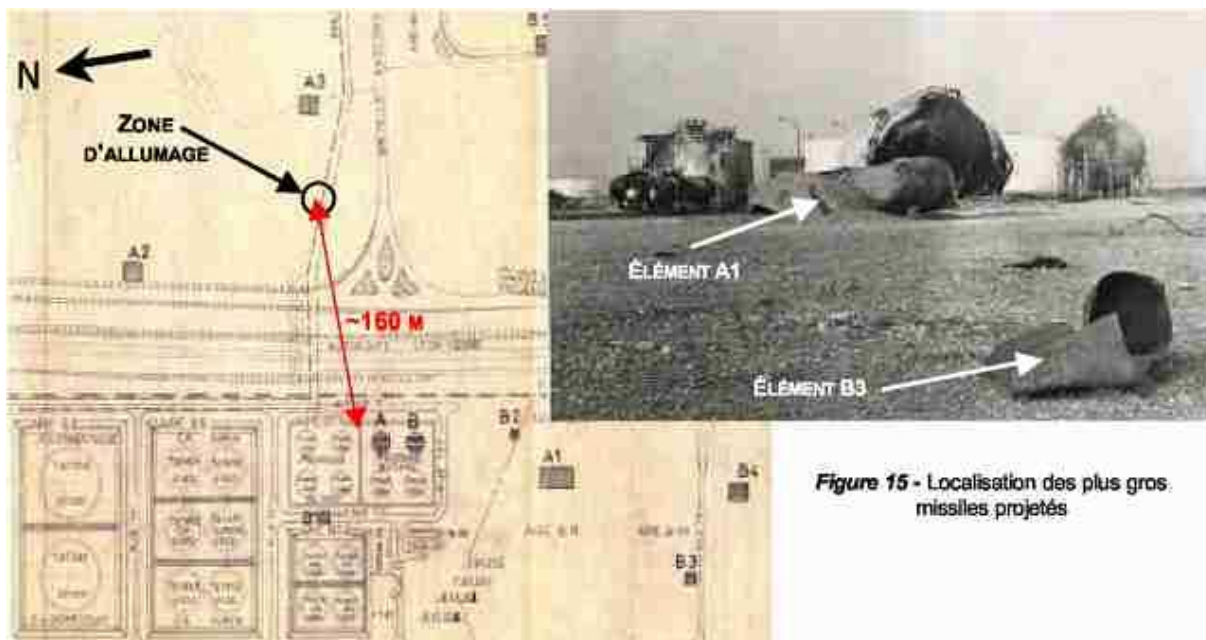
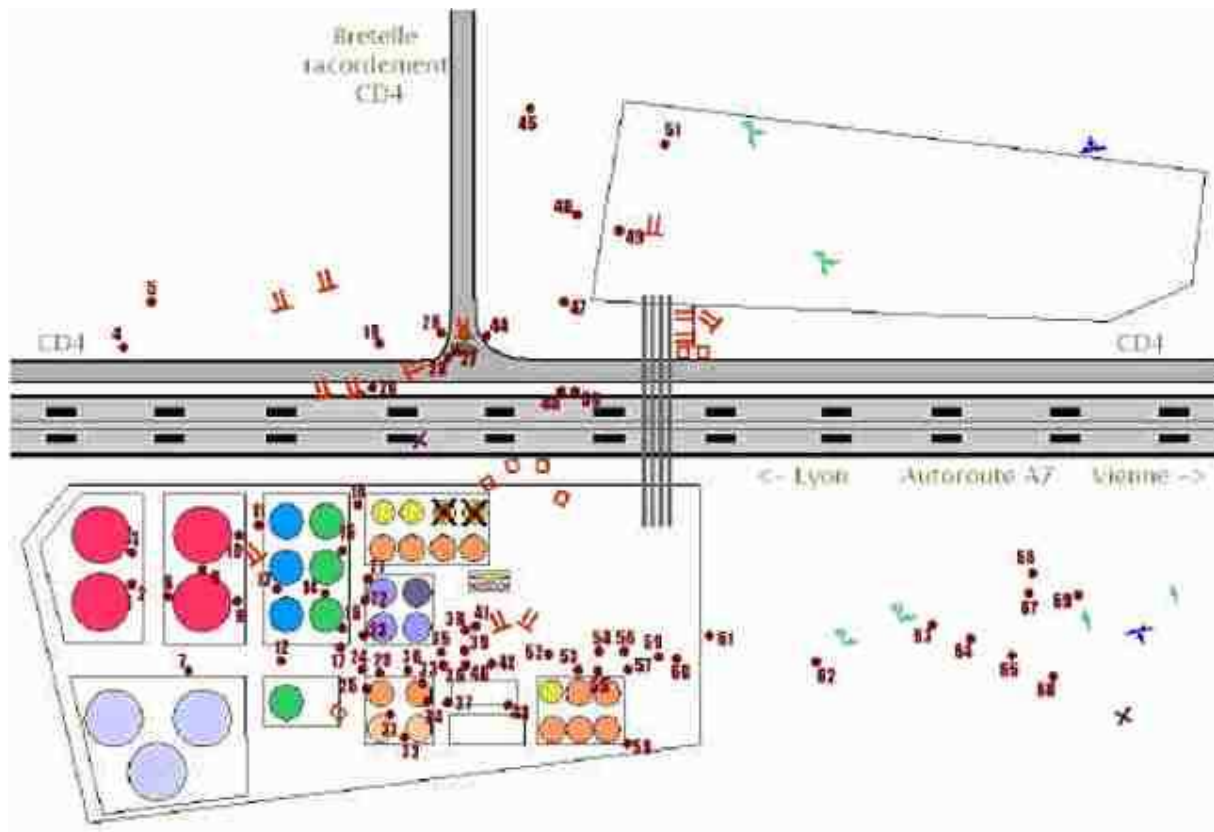
Figure 16 – Diagram showing the location of debris and accessories from the exploded spheres

The propane spheres 443 and 442 exploded violently; fragments of all sizes were found in a radius exceeding 800 m. The largest elements, certain weighing more than 80 tons, were thrown nearly 270 m from their original location (see table 3).

- sphere T 442: one valve open, the other closed, both thrown approximately 800m and found completely exploded.
- sphere T 443: one valve open, the other closed, both thrown approximately 600 m and found assembled.

The diagram below shows the 69 fragments and projectiles recorded and resulting from the explosion of the 2 spheres

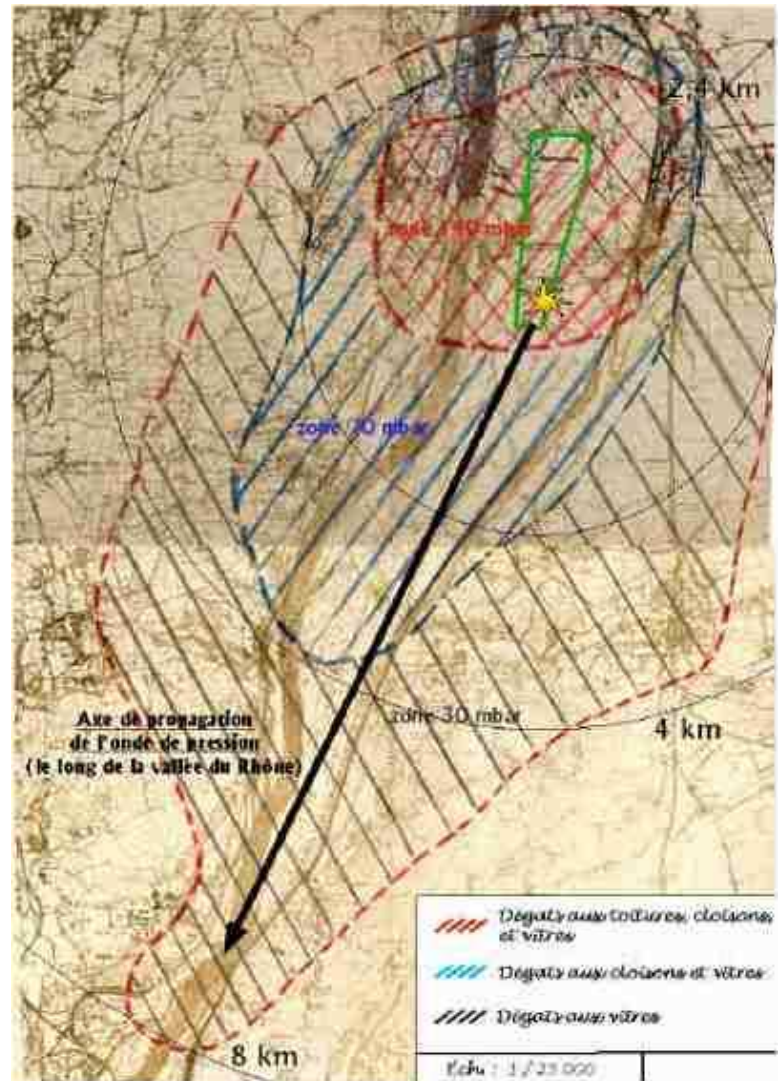
Figure 17 - Overpressure effects / Distance of property damage
Source: DHYCA

Pronounced directional effects toward the south are noted along the Rhône Valley: roofs damaged 2.2 km away, walls moved at distances up to 4.2 km and windows broken further than 8 km away. The blast from the explosion was felt as far away as VIENNE (approximately 16 km upstream from the refinery): doors opened,...

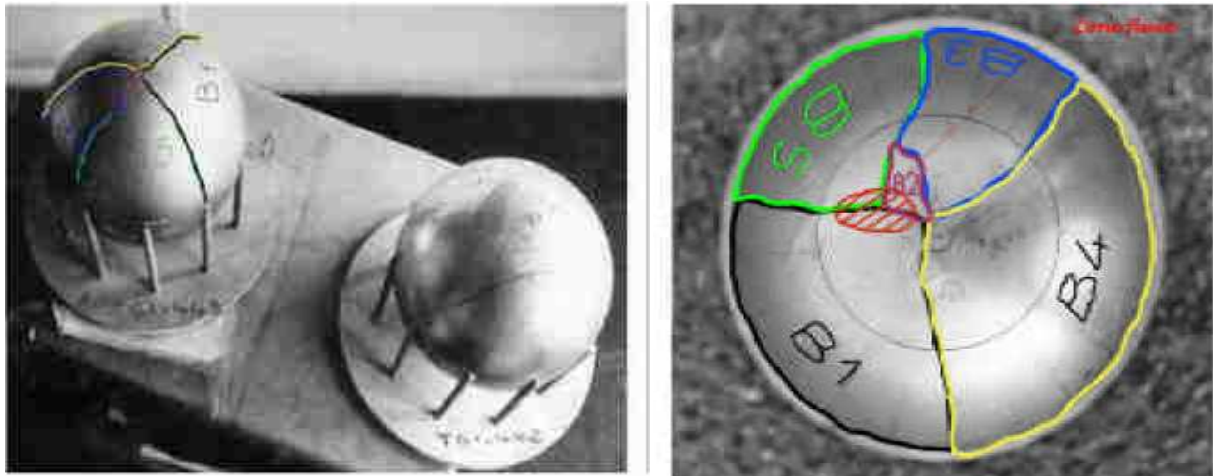
Figure 18 – Model of the main fragments of sphere T 61443

The explosion occurred approximately 2 hours after the leak began and 1½ hour after the cloud irrupted into flame.

The metallographic examination indicated that the upper zone (see figure 18) had yielded: the temperature had reached around 800 °C.

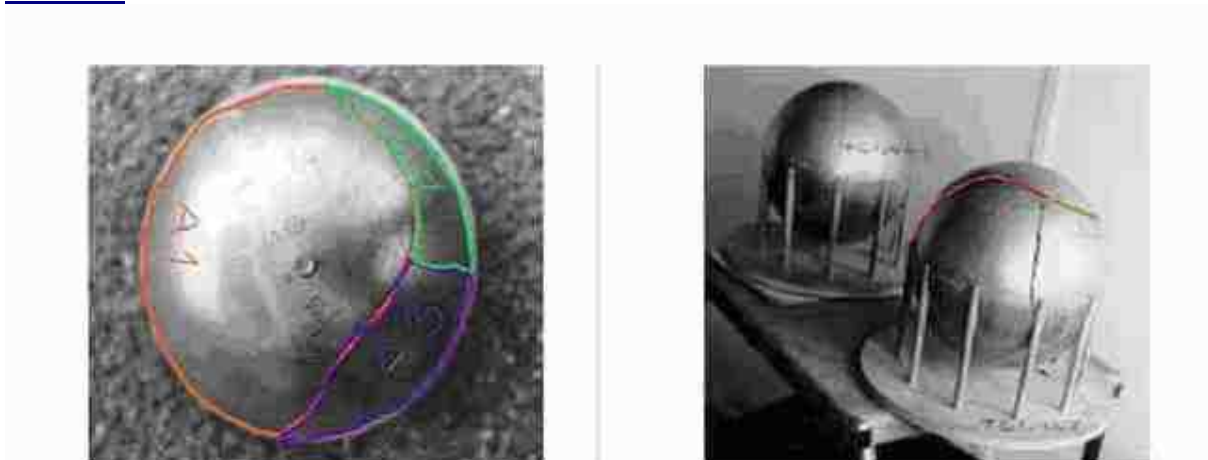
Figure 19 – Model of the main fragments of sphere T 61442

The propane had reached a height of 8.47 m at 5 am, with a diameter of 13.27 m. This sphere was cooled down by its fixed cooling systems starting at 7.20 am.

According to the hypotheses formulated after examination of the impact points and the various fragments recovered, piece B1 from the 1st Bleve (sphere 443) probably damaged the east legs of sphere 442, thus causing it to topple over. The pipes on the lower section of the sphere were broken at that moment.
