Fire in an isomerisation unit and domino effects on a benzene saturation unit, in a refinery
December, 2002

Rome
Italy

Fire
 Refinery
 Paraffin
 Compressor
 Domino effect
 Material failure
 Material losses
 Benzene

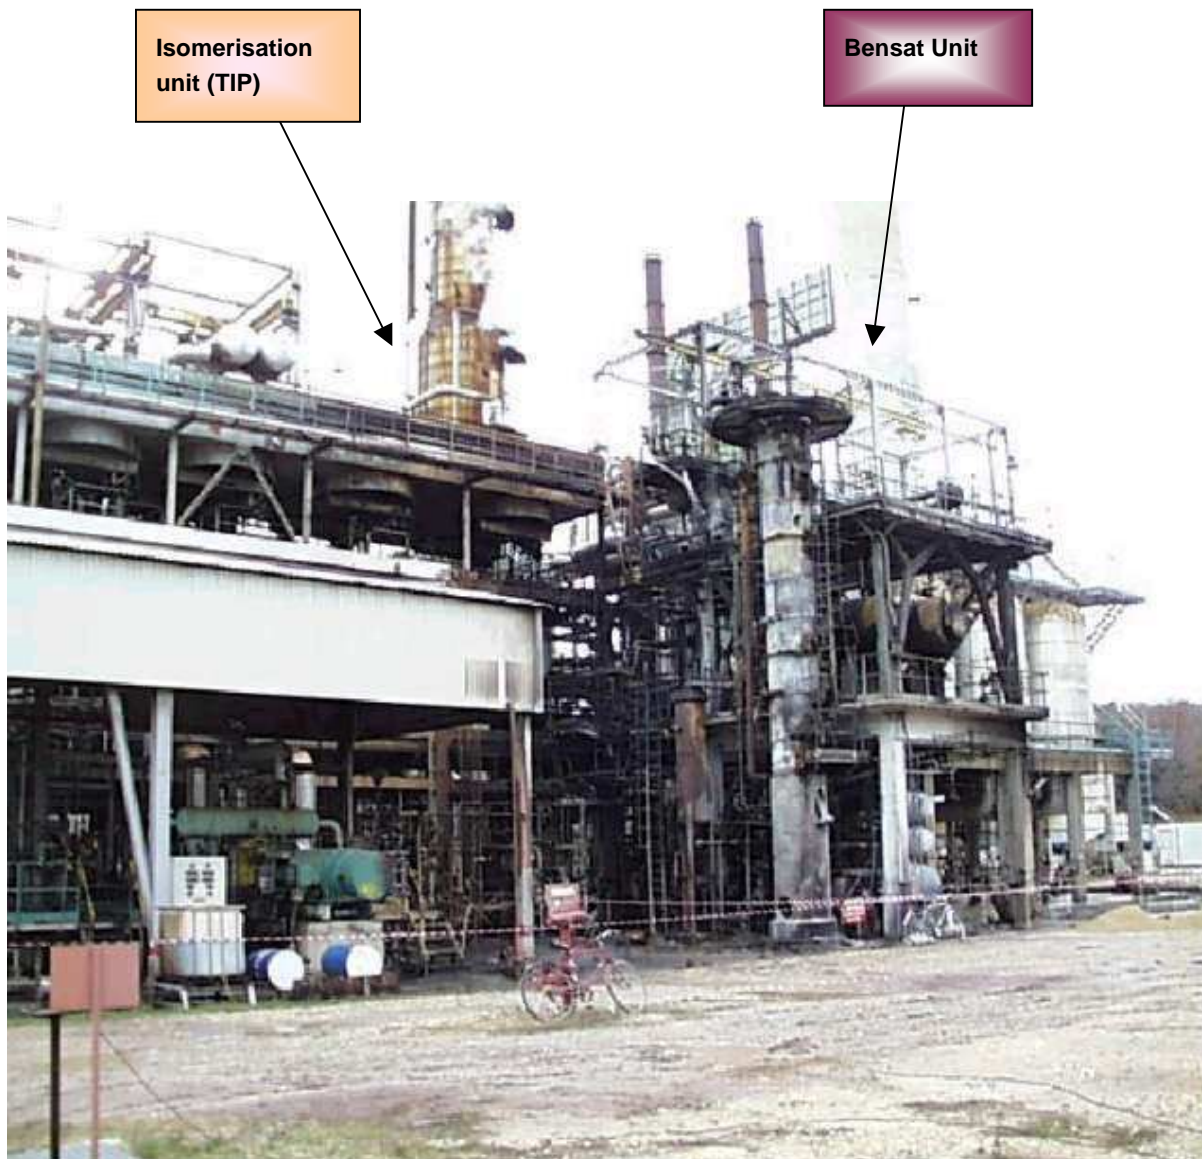
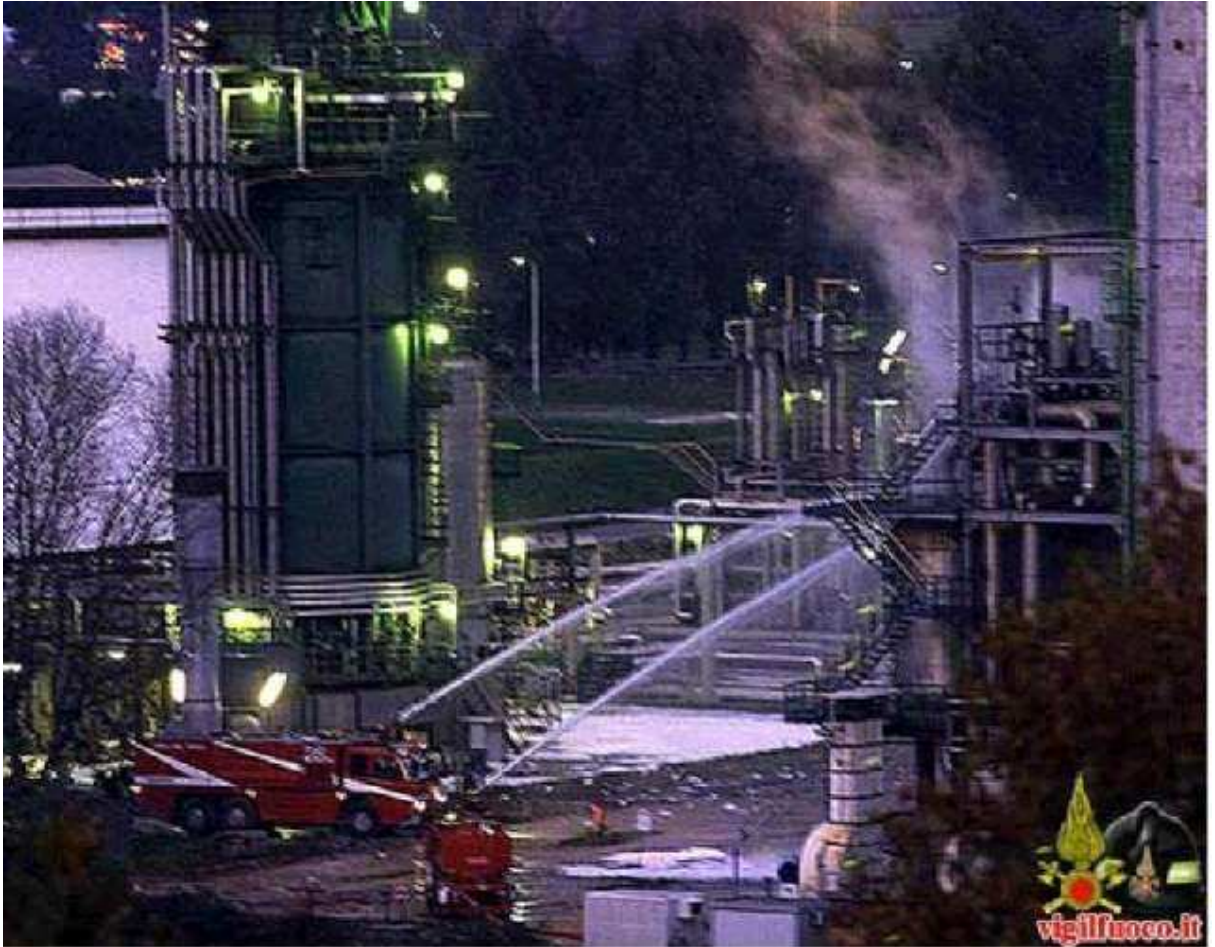
time, a strong burst was heard, followed by a jet-fire starting from the compressors area of the TIP unit (at the bottom of K2901B compressor), impinging the near bensat unit (14 m apart).

A big quantity of highly flammable gas mixture was released and immediately found ignition. Under the effect of the jet-fire, parts of the bensat unit failed causing the release of gasoline and hydrogen, which led to the extension of the fire.

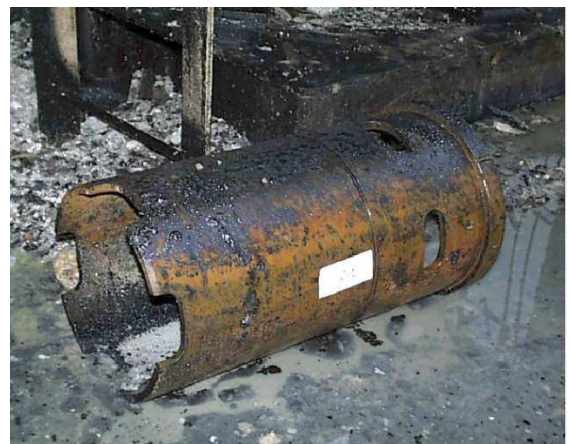
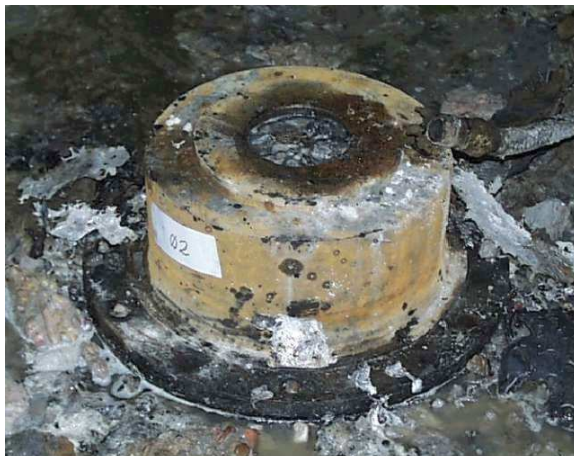
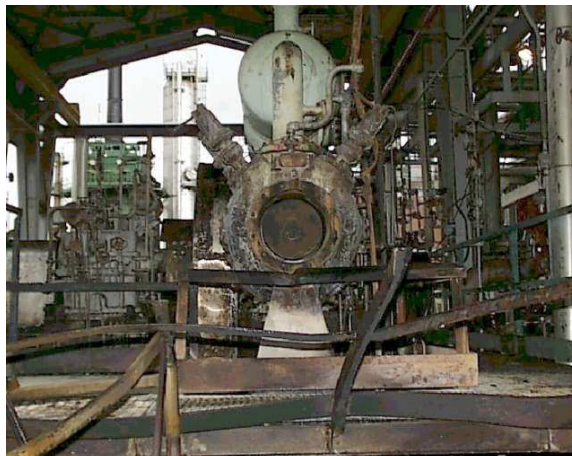
TIP unit

- ✓ About 3 tons of gas mixture rich in hydrogen and about 6 tons of gasoline were released.
- ✓ The cylinder liner and the bottom-head of the compressor were found at distances of respectively 8 and 14 m from the compressor. Some of the structures near the compressors area were damaged by the fire and the direct impact of parts of the compressors.

The first phase of the accident consisted in the mechanical failure of the bottom of one of the cylinders of the compressor K2901B.

Nevertheless, the original causes of the event are not yet well identified. One of the hypothesis is the rupture of the crankshaft-rod mechanism in the compressor, with a consequent hitting action of the piston on the bottom of the cylinder 2. The combined effects of hitting-action with the internal pressure (20 bar) led to the failure of the nuts, which hold the bottom.

- ✗ Substitution of the current reciprocating compressors by a single centrifugal compressor in order to potentiate the TIP unit.
- ✗ Use of interception electro commanded valves in suction lines, to be inserted near the compressor in order to limit strongly possible gas release (currently these valves are hand-commanded).

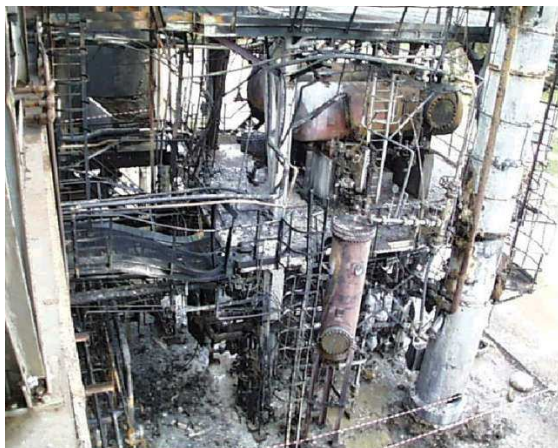
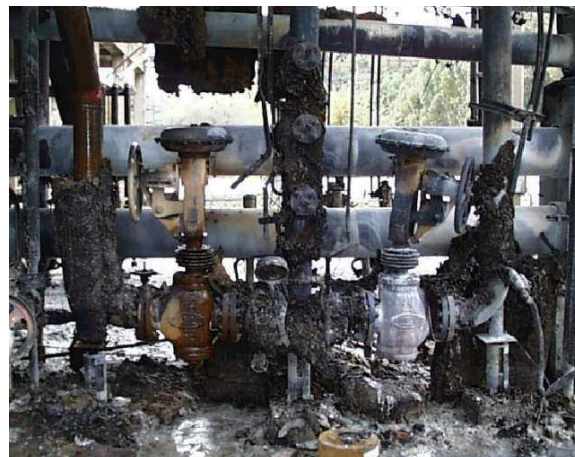
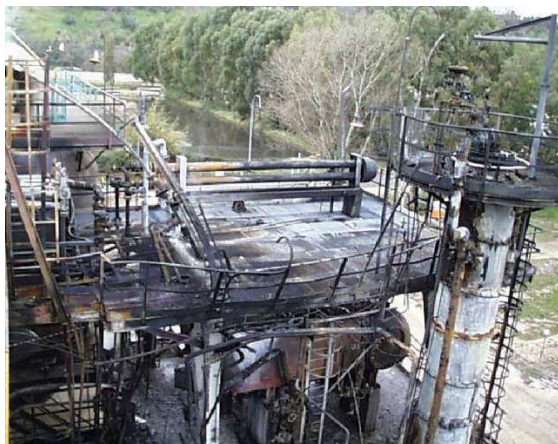
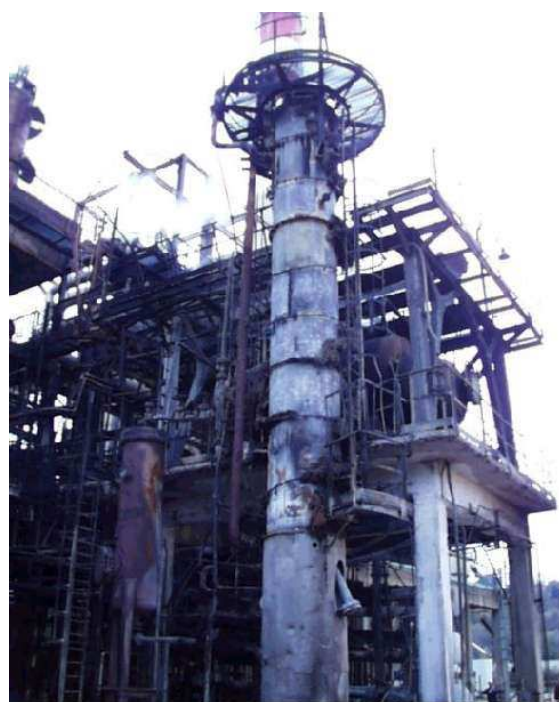
Bensat unit

✓ Most of the structures invested by the jetfire were protected by a fire-proofing layer; they were damaged but didn't have mechanical failure. Pipe connections and process units lost their sealing and released some gasoline and hydrogen that contributed to the extension of the fire and the destruction of the unit.

✓ About 0,3 tons of gas mixture and 6 tons of gasoline were released.
