Rupture and ignition of a gas pipeline

30 July 2004

Ghislenghien

Belgium

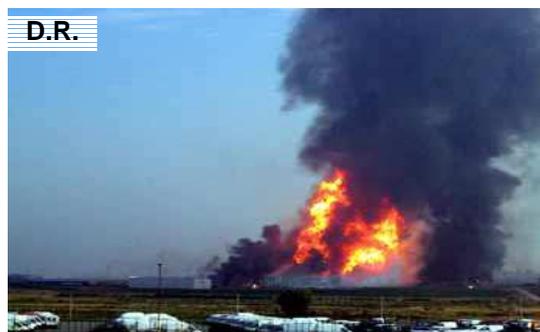
At about 9:00 am, an explosion occurred; two minutes later, technicians were able to isolate the pipe segment between the two sectional valves. The gas cloud ignited, producing a "fireball" that subsequently transformed into a long flare whose height was estimated at 150-200 m. Depending on the estimation source, a temperature of around 3,000°C was reached in the middle of the fireball.

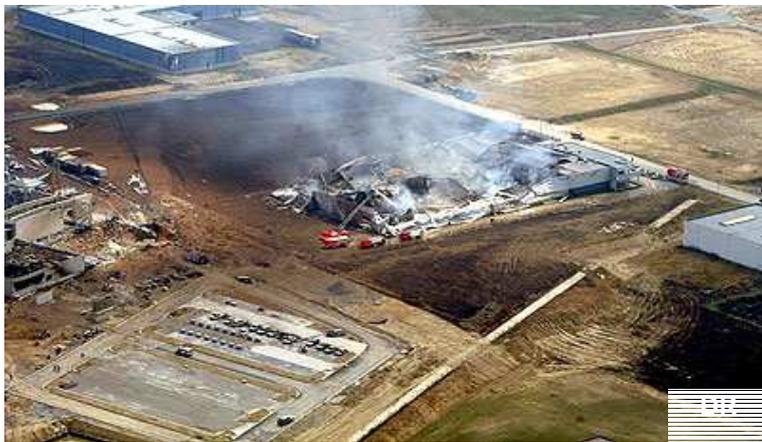
An industrial zone sustained total devastation over a 200-m radius. A 4,000-m² cardboard mill, along with a filling station, a large number of roofs and cars were all destroyed. A portion of a construction site was also damaged and many agricultural fields burned.

View overlooking the industrial zone

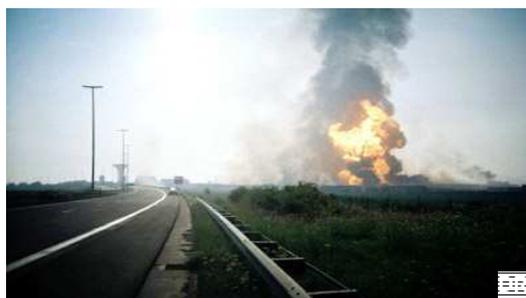
The accident occurred in the vicinity of Belgium's A8 motorway linking Brussels and Tournai; the road had to be closed to traffic in both directions.

View from the motorway
