Explosion in a fireworks storage facility

3 November 2004

Kolding

Denmark

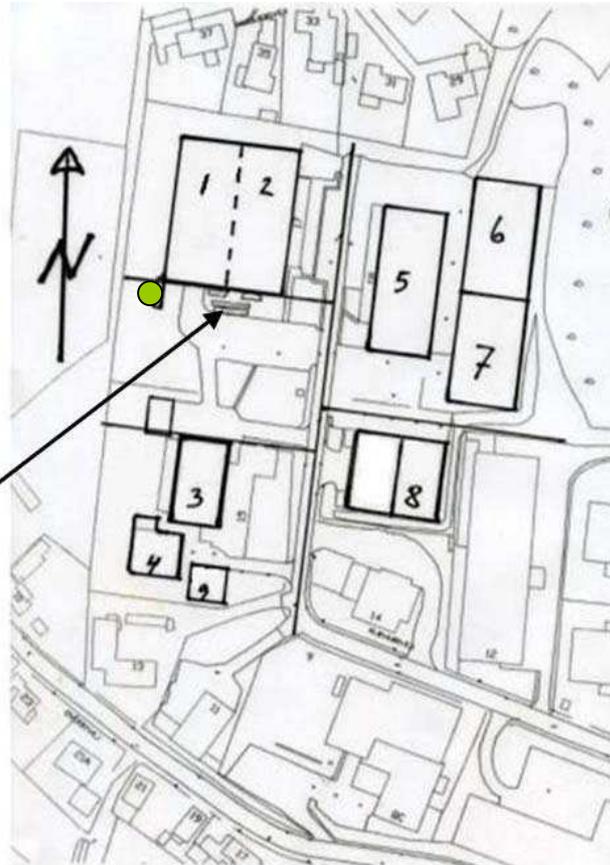
The two 40 feet containers 1 and 2, where the fire started, were 1 m apart and at 20 m from building 1+2.

In the text, container 2 refers to the one nearest to building 1+2.

Two 20 feet containers that were full and closed were located to the north of container 1 and 2.

On the day of the accident, several other 20 and 40 feet containers that are not shown in the drawing were also stored outside in between buildings 5 and 8 and (1+2) and 3.

A gas cylinder storage site (green dot) was also located in the vicinity.

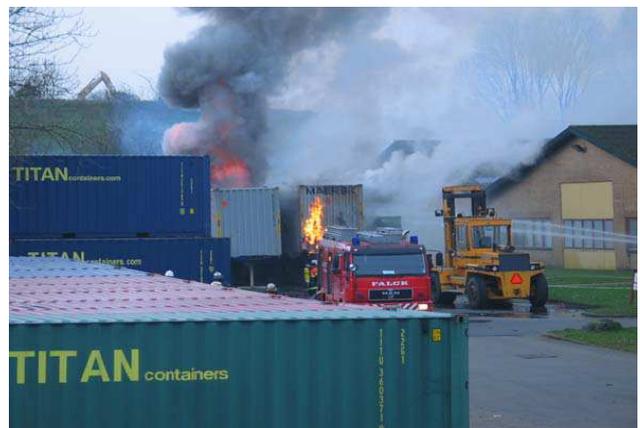
Fire in the 2 containers at 3 p.m. [2]

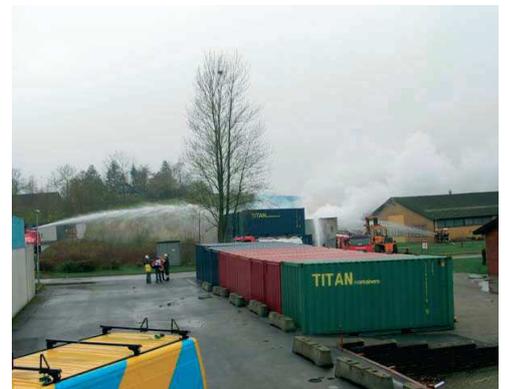
The intervention with the 3 first vehicles. The situation seems to improve.

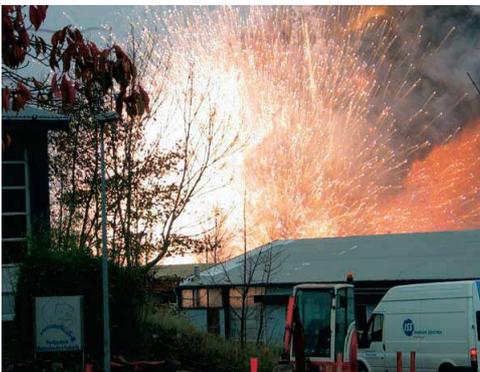
The 3.25 pm explosion

The explosion destroyed the doors and windows of warehouses 1+2 and 4. The ignited fireworks were projected into the buildings. At 3.33 pm, the fireworks exploded in the building 1+2.

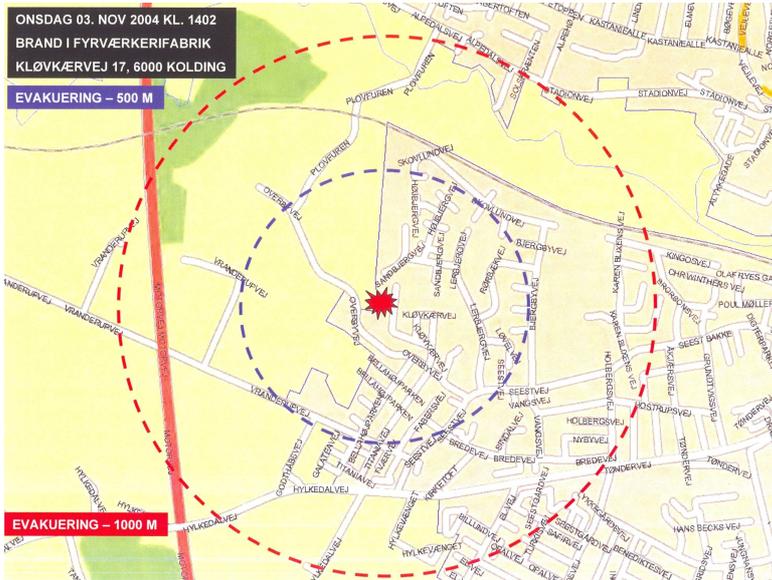
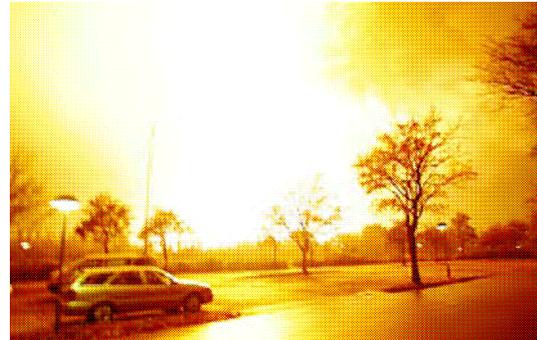
Three major explosions resulting in spectacular fire balls (cf. [8] [9]) of several meters occurred at 5.45 pm (explosions are presumed to have occurred in buildings 6 and 7 containing 150 tonnes of fireworks).

Explosions at 5.45 pm

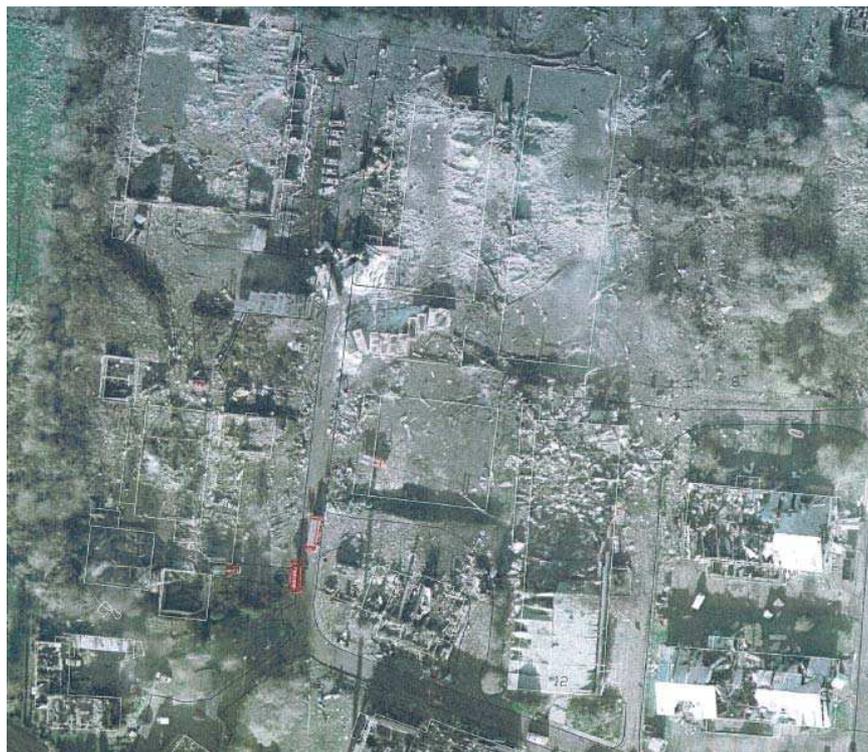
The company, most of the buildings in the industrial zone and a part of the residential buildings in the neighbourhood were destroyed or severely damaged: 450 houses were damaged and some were made unfit for living. Debris of the buildings were found over 1,000 meters away from the disaster.

A 2 m² and 15 cm thick fragment of the concrete wall, weighing a tonne, was found at 150 m from building 6 [3, 4]. The houses to the south of the site were damaged to a lesser extent. They were located on the other side of the 5 to 10 m high hill to the north of the facility and were thus partly protected. The damage caused to the buildings was assessed at 100 million euros [1, 3].

Aerial view of the site after the accident (cf. photo on first page)

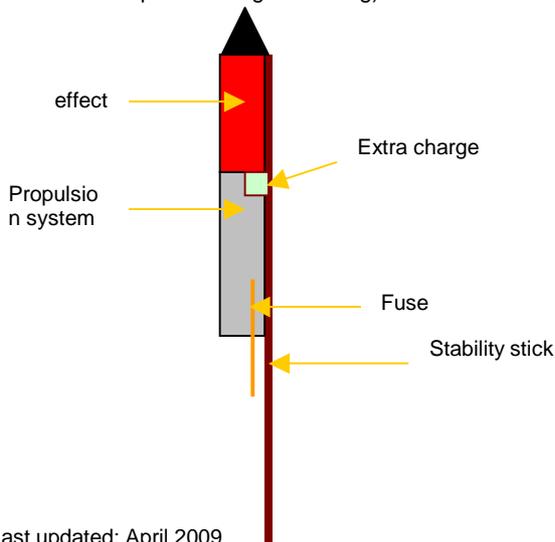
The rocket in question comprises a propulsion system and 3 bombs of 5 cm diameter (effect). An additional pyrotechnic charge between its stabilising stick and propulsion system separates the latter from the support when the rocket is at its peak height.

Danish regulations lay down limitations on the size of fireworks debris when the total weight of the fireworks item tops 200 g. In this case the motor and the support must be separated, which may require the addition of an extra charge.

Initially, an assumption widely spread by the media considered that the extra charge may have been improperly attached and may have been triggered spontaneously by the shock. However, the police found 60 rockets of the same type in Danish shops and proceeded to testing them (chemical analysis, fall test involving a 9 kg load on the support, impact and friction tests. Even though the friction and impact tests conducted by the BAM² in Germany revealed that the flash composition of these rockets was more sensitive than other flash compositions, none of the rockets tested were triggered spontaneously during the tests. The assumption could thus not be validated.
