Burst of a dam

2 December 1959

Malpasset (Var)

France

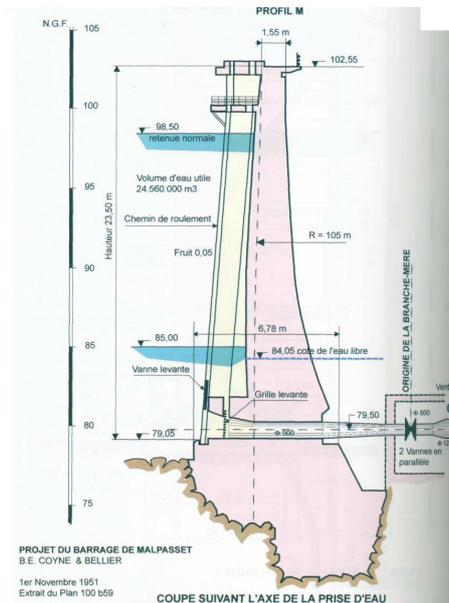
The Malpasset dam is a concrete arch dam with a base width of 6.90 m for a height of 60 m placing it in the thin-walled structures category.

Given the nature of the ground and the topography of the left bank, the dam support was reinforced by an 10 m high abutment as well as a wing wall at right angles with the contour lines.

The structure also includes a spillway (weir) and a draw-off comprising a metal pipe of 1.5 m diameter cutting across the foot of the arch at a height of + 45.5 m and shut by valves (fixed wheel gate upstream that opens automatically when the water level crosses the height of +99.5 m and a butterfly valve downstream).

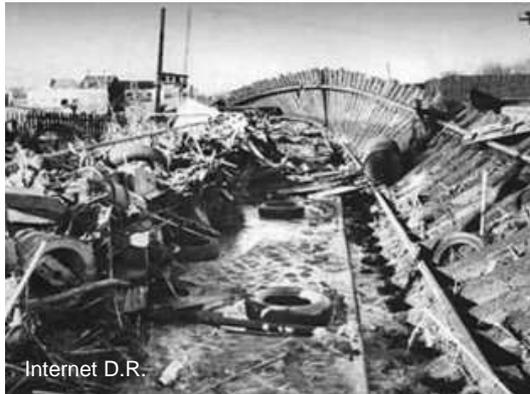
Railway track “twisted like a toy”

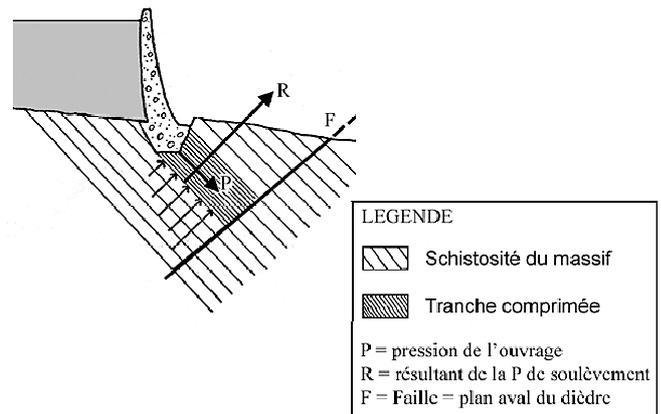
The term “uplift” is used to describe the pressure below the base of the dam resulting from the movement of water in the rocks supporting the structure. Such a pressure is potentially dangerous as it tends to offset the weight of the dam, thus reducing its stability.

At the Malpasset site, a fault (F) located downstream prevented the flow of infiltration water. This water accumulated below the base of the dam.

Moreover, the permeability of rocks decreased with the increase in pressure P as and when the dam was filled³.

The combination of these elements generated a resulting pressure (R) that led the concrete arch and its anchorage on the left bank to detach from their seat.

The water retained by the dam seeped into the cracks and swept away the structure.

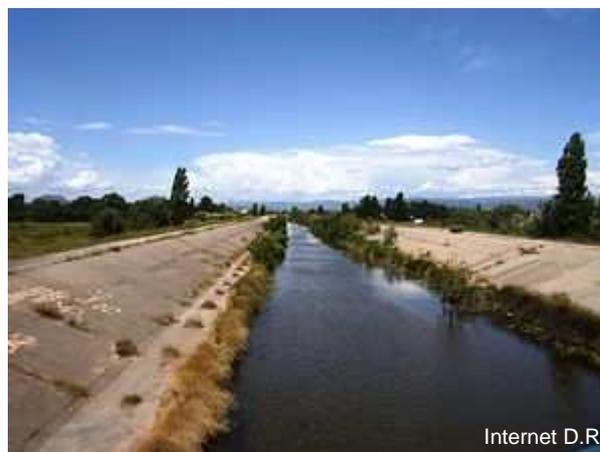
The Reyran river channelled today

The Reyran river was channelled through its course by banks coated with concrete.
