Implosion of a styrene storage tank during truck unloading operations

January 7th, 2005

Tertre - Belgium

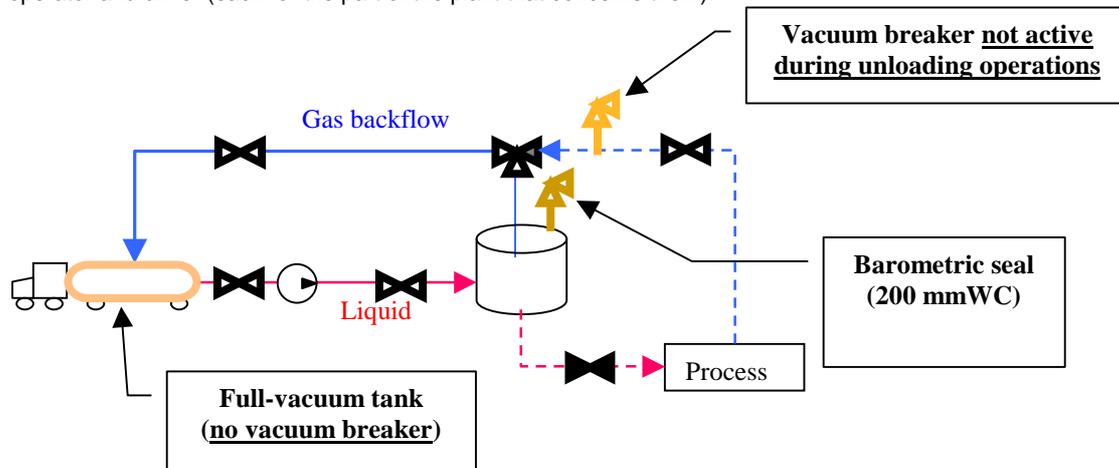
The storage tank involved in the accident is used to store styrene (C_8H_8). It has a total capacity of 44 m³, of which 35 m³ is considered its "usable capacity". This represents 29 tons of product. The storage tank is equipped with a cooling system that conveys a glycol solution through a coil. It is protected against overpressure by a barometric seal calibrated at 200 mmWC. It is equipped with a pressure alarm: high level set at 150 mmWC and very high level set at 220 mmWC which shuts down the unloading pump. It also features vacuum breaker protection in case of significant draw by the process. Owing to the presence of the 3-way valve, this vacuum breaker is inactive when a truck is being unloaded. The storage tank is located in a 80 m³ retaining pit.

A truck comes to unload the styrene two times per week. Using a checklist, the alignment is ensured visually by the operator and driver (each for the part of the plant that concerns them).

The protective equipments installed on the storage tank and tanker efficiently protect the unit against the following two accident scenarios:

- Incorrect alignment of the gas return during the truck unloading operation generating a vacuum in the tanker truck (vacuum breaker or "full-vacuum" tank resisting a partial vacuum) and an increase in pressure of the storage tank (valve)
- Significant intake by production causing a vacuum inside the storage tank (vacuum breaker protection)

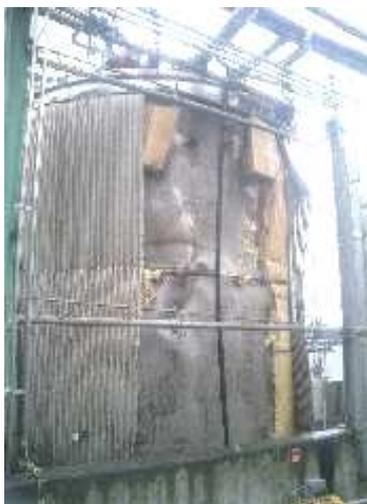
Shortly thereafter, a low level alarm on the tank's refrigeration unit (glycol solution) sounded in the control room. A slight increase in the styrene tank's level was also observed at the same time. Following an inspection on site, a styrene and glycol water leak was reported, as well as significant deformation of the storage tank.

Destruction of the storage tank (and the internal coil),

The accident is due to the incorrect alignment of the gas return line: the butterfly valve on the truck remained nearly completely closed throughout the entire unloading operation (forgotten by the driver).

The tanker began depressurising and, as it was "full vacuum" type, a partial vacuum was created. Upon completion of the unloading operation, the partial vacuum was estimated to be 0.6 bar. This would not have happened if the tank had been protected by a vacuum breaker, as stipulated in the operator's specifications.

At the same time, the storage tank developed a slight overpressure. The high level alarm was not managed correctly in the control room when it had sounded. As far as the very high level is concerned (causing the unloading pump to stop), it was never reached due to bubbles that were trapped in the barometric seal, which limits pressure increase inside the tank.

At the end of the unloading operation, when the driver opened the butterfly valve completely, the pressures in both the tanker truck and the storage tank were balanced out. The intake of air that followed was enough to cause the implosion and subsequent destruction of the storage tank.

The operator replaced the storage tank and undertook the action indicated in the following paragraph.

- Installation of a system to prevent the depressurisation of the storage tanks at all time (even during truck unloading operations).
- Slaving of the unloading pump to the correct connection of the lines (pressure measurement).
- Ensure proper communication between the driver and the operator (the driver must not initiate actions without informing the operator). Furthermore, the two individuals must be able to communicate in a common language. In this case, one spoke French and the other Dutch.
- Ensure the correct configuration (set point) and management of the alarms (classification by priority).
- This accident scenario must be considered in the safety studies (HAZOP analysis) and applied to other the unloading stations, where applicable.
