Toxic release in a frozen food warehouse

23 April, 2005

Nemours – [Seine-et-Marne]

Toxic leak
Food industry
Refrigeration /
Ammonia tank
Organisation
Training
Work
Emptying

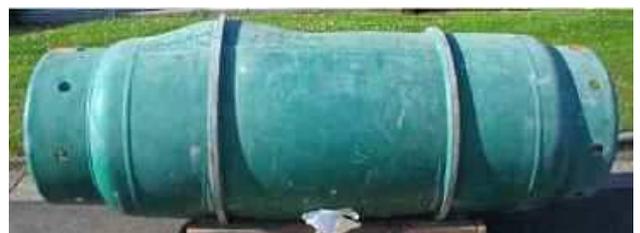
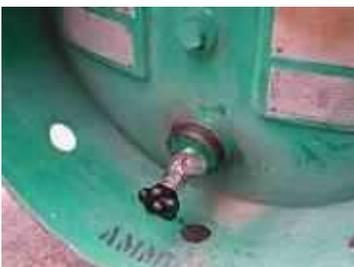
The equipment responsible for the accident was a pressure tank, identified as No. 0935. Its rated capacity is 450 kg of NH₃. Its maximum service pressure is 32.5 bar and its operating temperature between -20 °C and +50 °C.

The tank was equipped only with filling and drainage valves and was not equipped with any pressure accessory such as a "pressure gauge" or "safety valve" (see photo).

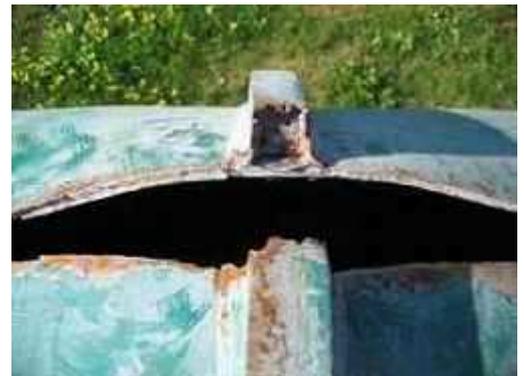
One of the tanks burst Saturday, April 23, 2005 at 11.50 am, releasing 450 kg of NH_3 . None of the tanks had been handled during their storage period.

The rupture of the pressurised tank was the result of abnormally high pressure in the tank as a result of overfilling.

Considering the significant variation in temperature during the storage period of the NH₃ drained from the refrigeration installation, the dilation of the liquid contained in the tank increased the pressure and ruptured the tank.

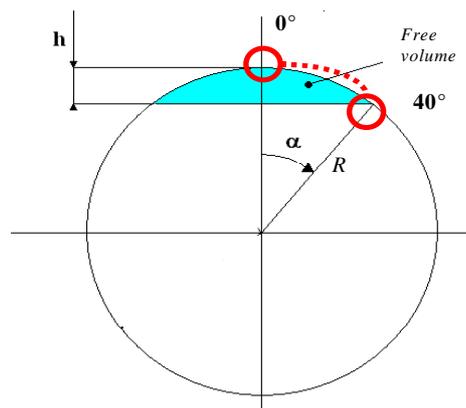
The coefficient of 85% is obtained by aligning one of the 2 painted marks with 40° angle on the side of the tank. The operator can thus position the eduction pipe (built into the tank) allowing the NH₃ to discharge before the entire available volume is filled up. The tank's positioning is thus extremely important as shown in the following diagram:

It was noted that, due to the design, the end of this discharge tube is a variable distance from the cylinder wall: It cannot thus fulfil its role with precision.

Next, one must admit that the volumetric method used to transfer product cannot adequately guarantee filling of tanks more than 430 kg. This quantity is very close to the tank's maximum quantity, particularly during filling operations at very low temperatures (-18 °C).

Furthermore, the procedure provided did not correspond to the tank model used, and thus to the marks indicated on the body of the tank.

Next, within the scope of regional action, the prefect initiated a complementary order outlining organisational and technical provisions intended to reduce the probability of an accident. In compliance with the conclusions of the *Pôle National d'Expertise des Appareils à Pression*, the quantity of NH₃ introduced into the tank must be weighed when the operation is not performed in a confined environment.
