Spillage from a semi-buried jet fuel tank

30 December, 2005

Sainte-Marie – [Reunion Island]

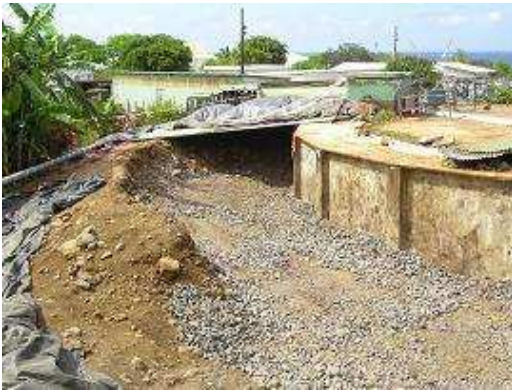
▲ Backfill around tank SEA2 (photo DR)

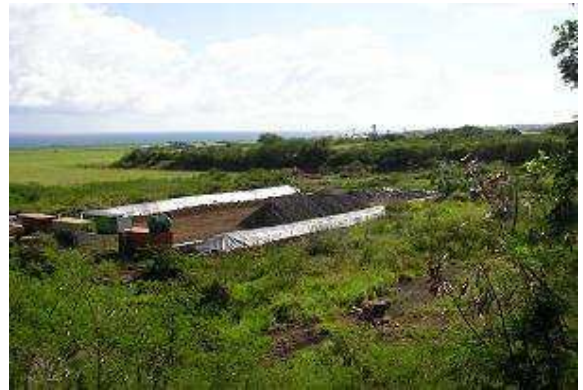
▲ Treatment of polluted soil (photo DR)

In October 2006, the polluted soil storage bins were removed from the depot B parking lot to a site specially equipped to process the soil. The removal of the earth continued to the polluted zone. Treatment of the polluted soil using bio-venting was started in December 2006. Approximately 1,000 m³ of soil has been removed since the day of the accident.
