Sudden opening of a crude oil tank bottom

12 January 2007

Ambès (Gironde)

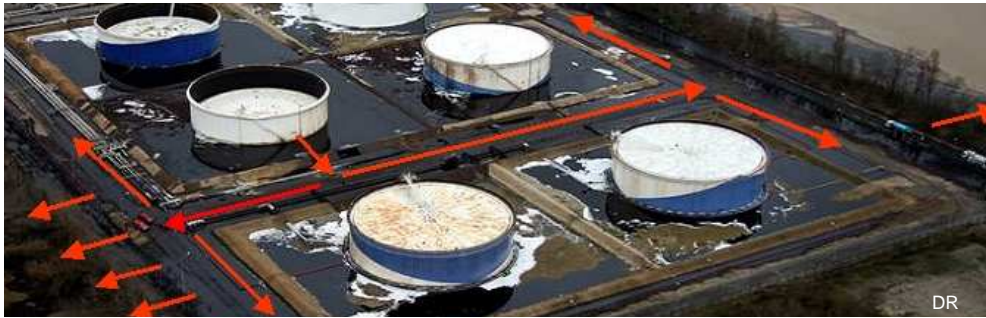
On January 12, 2007 at 8:00 am, a portion of the tank bottom broke and 12,000 m³ of crude oil spilled in a matter of a few seconds.

The earthen dykes were able to mechanically withstand the wave effect. However, 2,000 m³ of crude oil overflowed and spread on the ground and roads both in the immediate area around the depot and outside the site.

The products that spilled into the gutters and retention basin were channelled towards the site's settling pond and then transferred into empty storage tanks. Approximately 6,000 m³ of product were pumped in this manner.

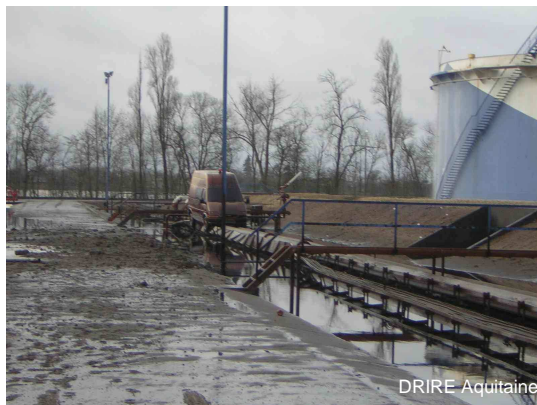
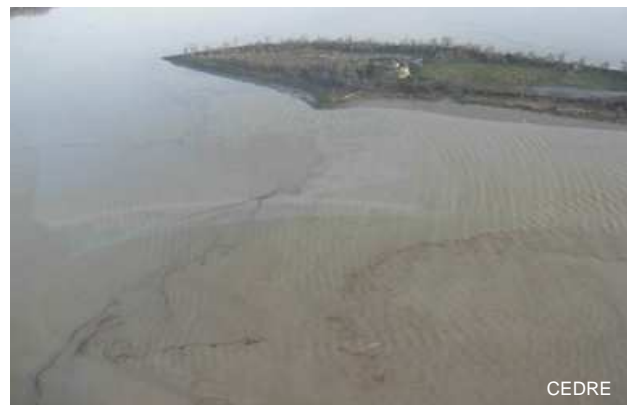
Most of the $2,000 \text{ m}^3$ of oil spilled outside the basins was confined within site boundaries. A substantial percentage of this volume quickly reached the stormwater ditches and then by gravity flowed into the settling pond, thus triggering the immediate shutdown of pumps used for discharging pond water into the external environment, although 100 m^3 did get released before pump shutdown:

- 50 m^3 flowed into "jalles" (pits and swampy channels) located to the east of the site, where the oil polluted 2 km of ditches and infiltrated deep enough to reach the water table.
- To the west, another 50 m^3 reached the Garonne River at the beginning of the flood tide period. For the most part, the oil slick remains enclosed along the river's right bank, yet it was rising at the time because of the flood-tide condition. Iridescence could be observed all the way to the *Pont d'Aquitaine* Bridge 12 km upstream. When the tide changed, the oil slick shifted downstream and reached the site of the "*bec d'Ambès*" (confluence of the Garonne and Dordogne Rivers).

To the south, the oil also spread over the ground and small roads, contaminating down to deeper layers, then crossed departmental highway no. 10, at which point it was largely contained by a parapet running parallel with the Garonne. A small quantity nonetheless seeped through and slightly contaminated the upper part of the riverbank at this location.

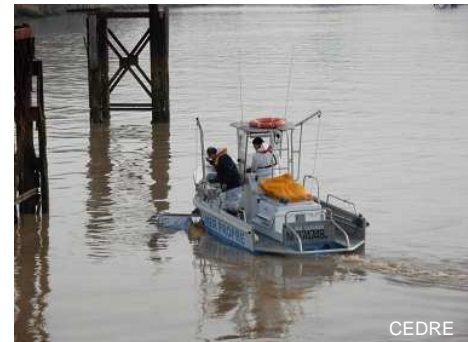
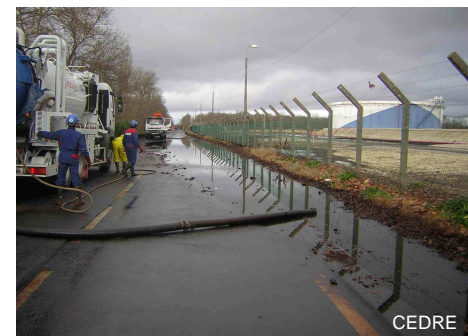
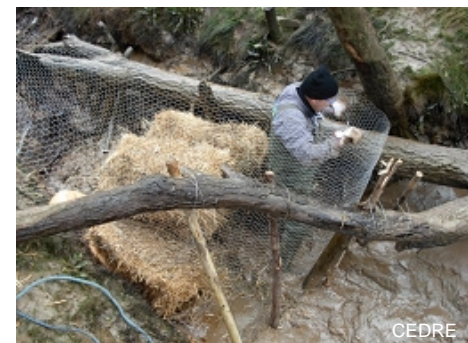
The tracking and maintenance of absorbents (which serve to remove pollutant quantities rinsed by the river from its banks) at the level of the site, along with the collection of residual floating matter by the pollution control boat and first-stage containment efforts on the banks, continued until January 25.

Cleanup operations were suspended on the 25th due to snowfall and then came the weekend. Efforts resumed on January 29 and were definitively stopped on January 31 as regards physical collection efforts and on February 7 for the monitoring and maintenance of absorbents by the pollution control boat.
