## Tank failure in a bitumen storage unit of a refinery

8 September, 2004

Italy

Refinery  
Storage unit  
Tank  
Bitumen / hot-oil  
Failure  
Overpressure  
Victims

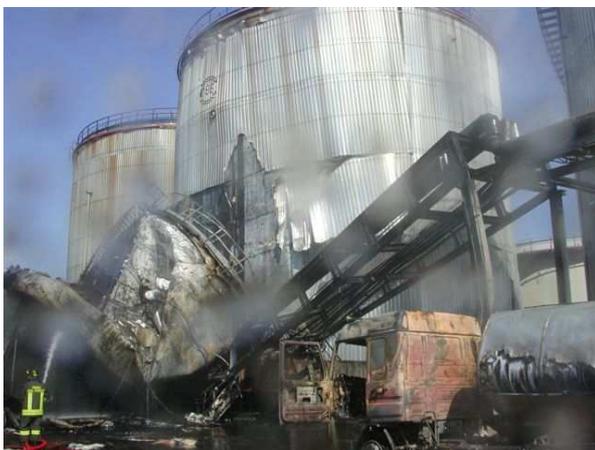
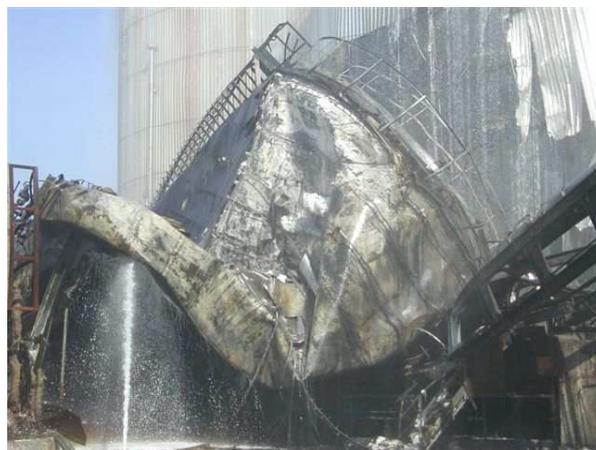
The missile-tank exploded fell down on a 2<sup>nd</sup> bitumen tank (TK166) of 8000l of capacity. The missile roof entered in the TK166 shell, then squeezed itself into the TK166 basin (Fig. 2,3).

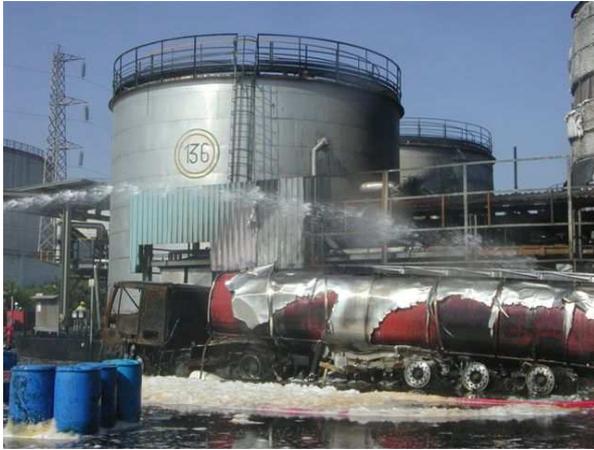
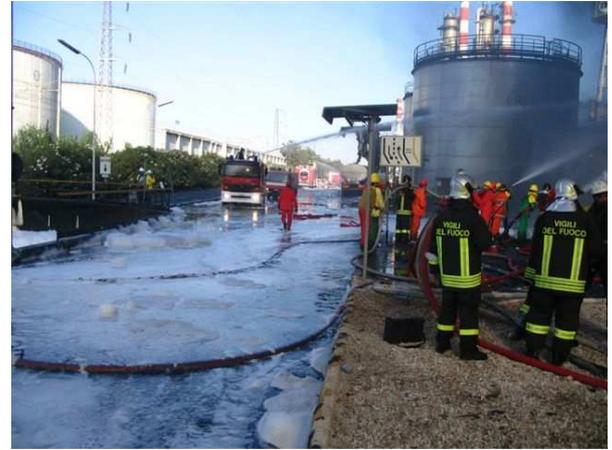
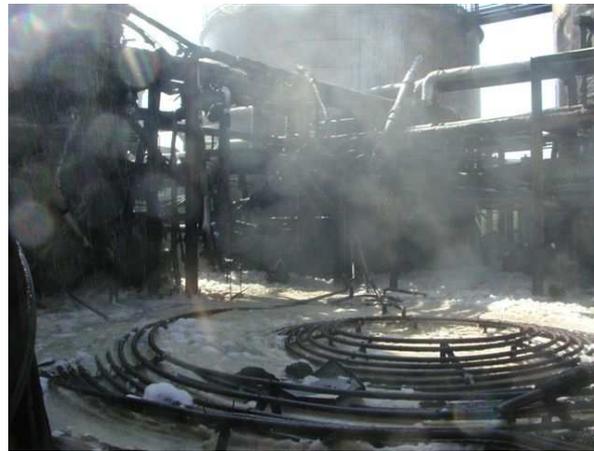
Fire was handled through water and foam, while tanks and browsers involved were been cooled (Fig. 4, 5, 6).
