Spill of heavy fuel oil in an oil terminal

21 June, 2003

Oil harbour of Göteborg - Sweden

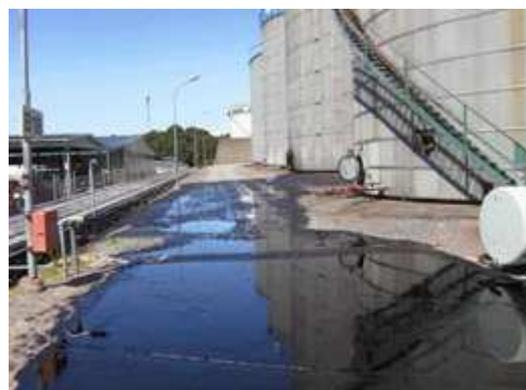
Oil spill outside tank No 375 was spread on the surrounding ground. Under the pipe rack (in the left) there was a rain water drainage sewer.

- ✓ The oil terminal is an old installation and therefore there were no bunds around the tank area where the accident occurred. The spilled oil was spread over a wide area on the surrounding ground. In a low point under a pipe rack close to the storage tank there was a rain water drainage sewer. A huge amount of heavy fuel oil reached the harbour rain water drainage system.

- ✓ The sewer under the pipe rack in the oil terminal has been connected to the harbour oil contaminated drainage water system and is no longer connected to the rain water drainage system.
- ✓ Oil alarms have been installed in the rain water drainage basins. In each basin there is now one oil alarm located at the surface and one oil alarm located in the bottom of the basin.
- ✓ Installation of oil alarm in the rain water drainage system at each oil terminal has been started.
- ✓ Installation of shut off valve of the rain water system at each oil terminal has been started.

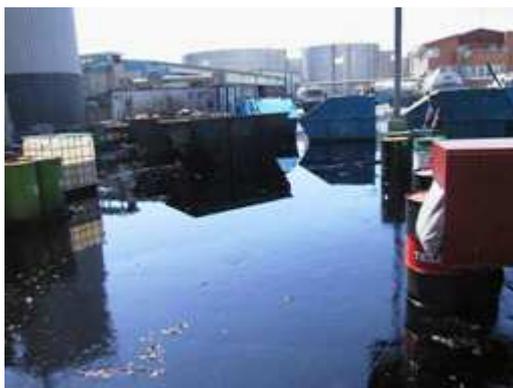
*The ground at a neighbour company was filled with oil.
Photo: the insurance company.*

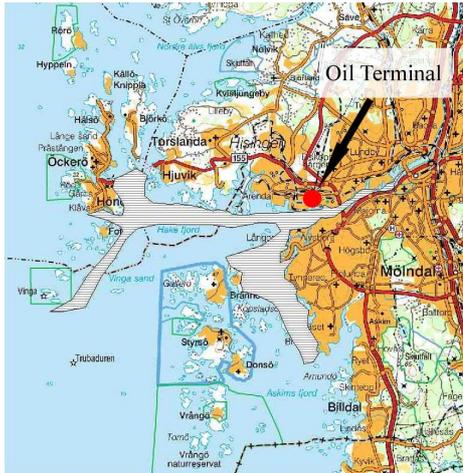
The area outlined on the map shows how the oil was spread in the coast archipelago outside Göteborg. The oil spread in two main directions, south and west from the harbour of Göteborg.

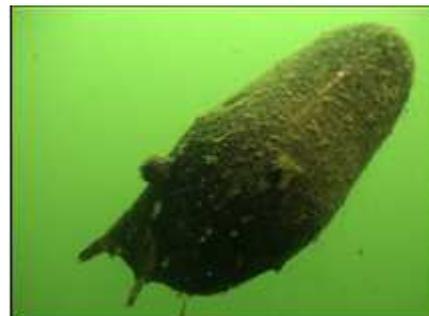
- ✓ The heavy fuel oil was probably mixed with lighter high aromatic oil and therefore the oil did not behave as expected. This heavy fuel oil formed clusters in the water and were spread over a wide area in the coast archipelago. The clusters dispersed and oil were detected on the sea water surface and on several beaches and harbours outside of Göteborg.

*The oil formed clusters that did not float on the water.
The diameter of the clusters was 3 to 10 centimetres.
Photo: Swedish Coast Guard.*

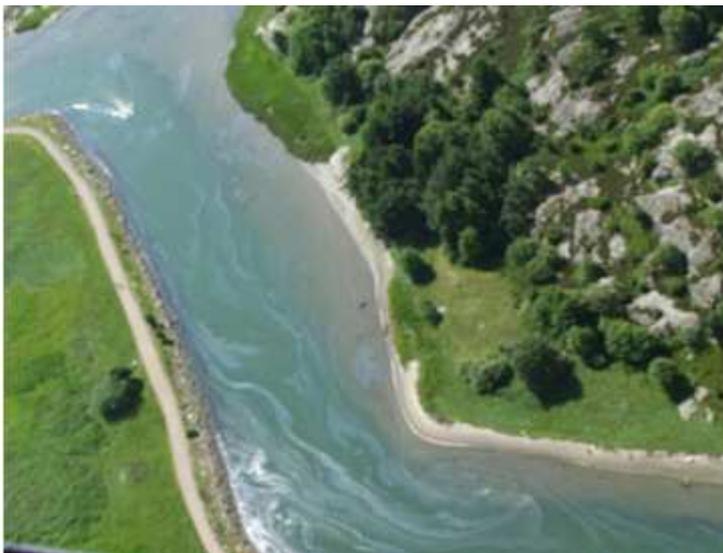
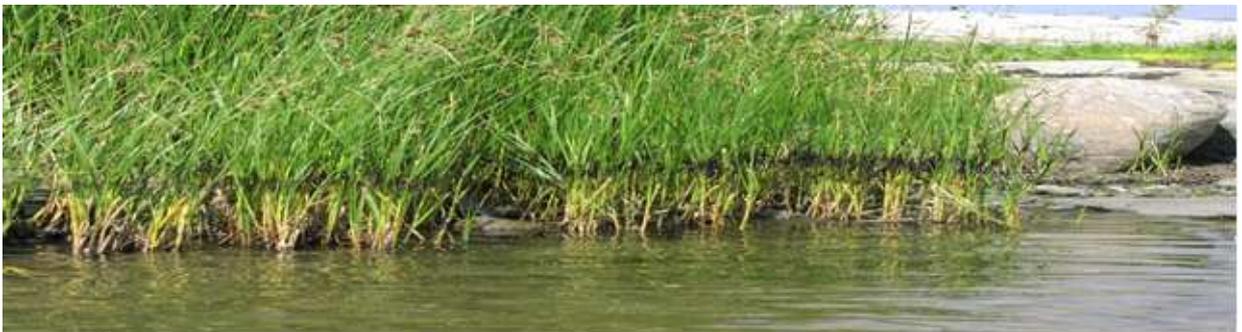
Environmental consequences of the spill of heavy fuel oil in the oil harbour.
