Fuel oil spill in an estuary during a transfer operation

16 March 2008

Donges (Loire Atlantique) France

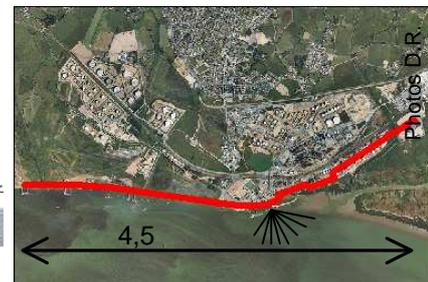
The leak occurred on a pipe approximately 4.5 km long connecting a cargo fuel oil storage tank to a ship loading station.

At the leak point, the rack supporting the defective pipe runs parallel to the gas storage zone at the periphery of the Loire River banks over a length of some 300 m.

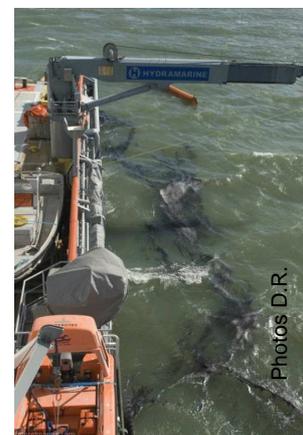
Shortly thereafter, a pellets collecting ship was deployed at the mouth of the river as well as two trawlers equipped with special nets for collecting hydrocarbon pellets in the estuary. Booms were also set up in order to recover supernatant hydrocarbon.

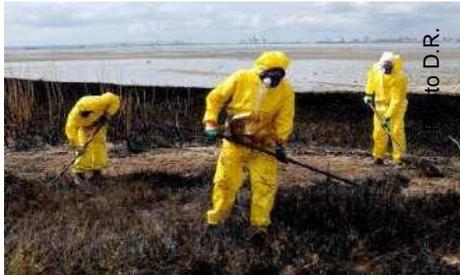
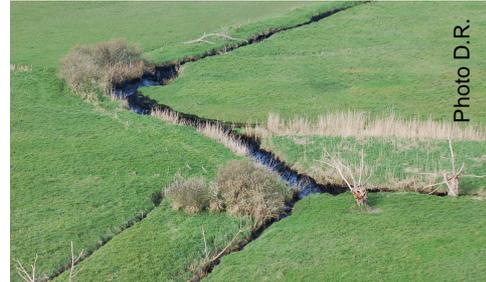
Exposed to the effect of tides and currents, the fuel oil dispersed onto the northern and southern shores of the Loire estuary. Hydrocarbon pellets were recovered on beaches in the neighbouring Vendée Department and as far south as the Isle of Rhé. Pollution cleanup efforts, in some cases requiring mobilisation of up to 750 personnel all at the same time, lasted three and a half months to clean not only some 60 km of fouled riverbanks, but also wetlands further inland (swamps, reed beds, etc.).

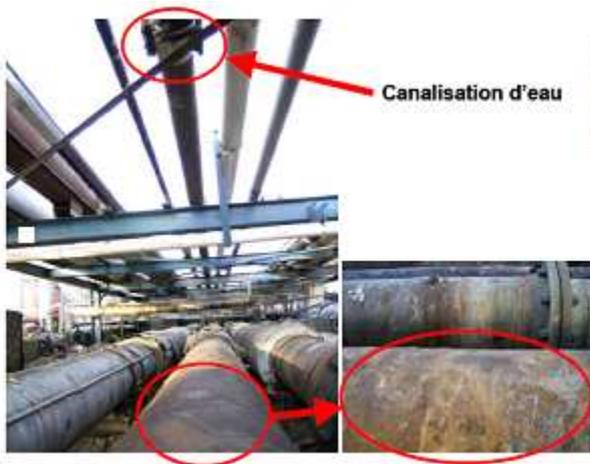
The defective pipe, 12 inches in diameter and lined with thermal insulation, was included in a group of facilities composed of some 20 pipes on two levels. An examination of the defective pipe section revealed the presence of a longitudinal crack approximately 16 cm long by 1 cm wide adjacent to observed local corrosion underneath the thermal insulator lining. Water flowing from a perforated pipe, positioned vertically with respect to the fuel oil pipeline, infiltrated under the leaky thermal insulation, first causing the steel to corrode and then perforating the pipe.

- permanent monitoring from a manned station set up on the path of the pipe network running alongside the Loire;
- definitive shutdown of operations on the defective fuel oil pipe network;
- visual inspections and thickness controls at the level of special network points (braces, tapping points, etc.) after thermal insulation removal on lines over the entire rack length alongside the Loire;
- displacement of the service water pipe route in order to prevent it from aligning with any of the thermally-insulated lines of the rack running alongside the Loire.
