Pollution of the port of Sillamäe by hydrocarbons produced from oil shale

12 September 2008

Sillamäe

Estonia

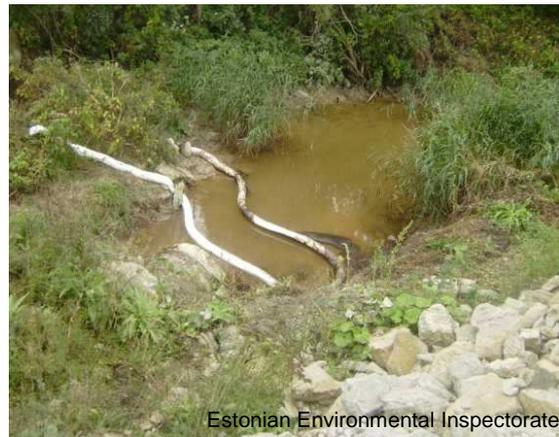
On the 12th of September 2008 Port of Sillamäe reported Environmental Inspectorate on a pollution of sea on its territory. Inspectors found out that the pollution was discharged into the sea from one of the outlets of the heating station. At first there was no information from where the oil had reached the outlet. Due to the wind from the direction of the sea the pollution had not spread to the open sea but stayed near the coastline. The length of the coastline beside the dark pollution that could be noticed in the sea was about 150 m. The localization of oil in the sea was organised by the port and terminal authorities using special boom.

Typical smell of shale oil was in the air. Inspectors took samples from the sea, the outlet and made photos. Moving upstream the open sewage channel, the inlet of polluted water from the drainage system of the oil terminal was found. Sample of polluting material was taken from this place.

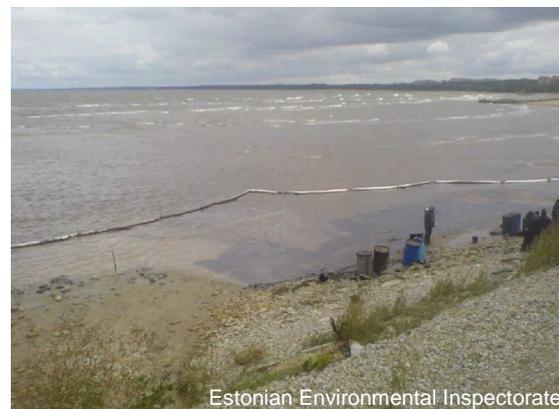
As the Port of Sillamäe found oil in the harbour territory, it informed Environmental Inspectorate and the municipal administration. According to the pollution response plan the port is responsible to take action in combating the pollution. The possible spreading of oil along the coastline was constrained by special boom that is part of the obligatory equipment of the port. The oil was collected with shovels during the next days and stored in 200 litre barrels. The collected material was given to a special hazardous waste treatment facility. The contaminated booms were also given for cleaning to the same company. After separation of the 2400 kg of collected mixture of oil and seawater it was measured that the amount of polluting substances was 240 kg. Three samples, taken from the polluted site gave the content of 1-based phenols as 0,0558 mg/kg, 0,0486 mg/kg and 0,0421 mg/kg. So it can be assumed, that the 240 kg of pollution contained about 12 mg of phenols.

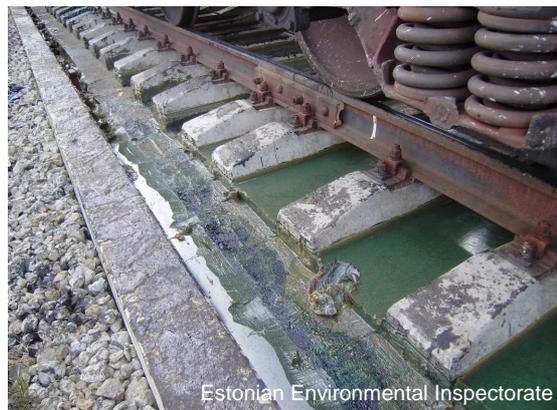
As the inspection on September 12th showed there had been recently a leakage of vacuum gas oil during the loading from the railway tank wagons. The railway is built on a reinforced concrete pool that is filled with crushed stone and the rainwater is discharged through a drainage system equipped with oil separators. The pumped rainwater is discharged into the sewage system of the nearby heating station and should reach the Baltic Sea. The system has valves and a well, which collects the oil products that have leaked. These should be pumped out from the well.

Actually for a long period the leaked oil products had not been pumped out from the pool under the railway. Thus, not only the recently leaked vacuum gas oil, but also significant amount of previously loaded shale oil reached the ditch running towards the sea.

The depot owner company has planned to equip the drainage water collection and discharge system with an alarm signalisation. The permitting authority can decide on revoking the environmental permit if the company having the permit is not aware of the situation of its clients.
