Liquid chlorine leak in an industrial gas plant

27th May, 2009

**Martigues (Bouches-du-Rhône)
France**

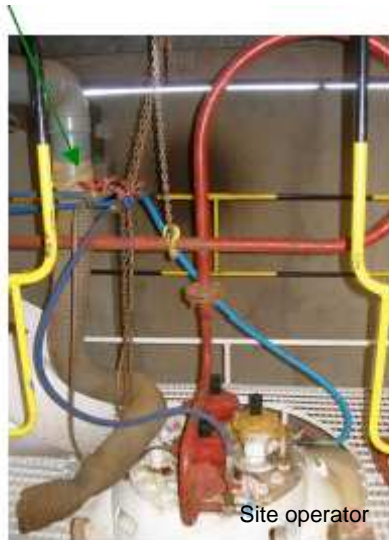
The triggering event had occurred the previous day at 2 pm; two experienced technicians had connected a chlorine tanker car in accordance with the "Tanker car acceptance and connection" procedure, involving: removal of flanges from the fixed installation as well as the car; positioning of the moving head on the car's liquid valve (in red); connection of the high-pressure compressed air "inflation" intake (i.e. pressurised drainage system) onto the car's gas valve (yellow); and lastly repositioning and tightening of the flanges.

Car - moving head valve connection

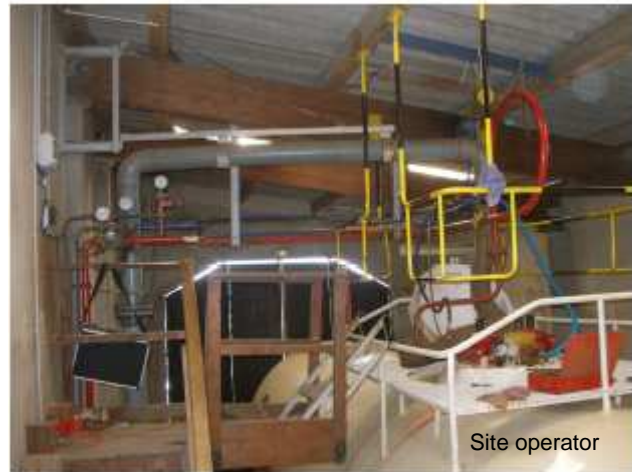
Chlorine tanker car transfer station (chamber no. 2)

Between 3 and 4 pm, the technicians installed an air intake on the tanker car's valves, then opened manual valves on the low-pressure air circuit. During verification of the seal on the moving head-car connection by means of an alkali test, they detected a chlorine leak. In the event of leak detection, the emergency shutdown system was supposed to be activated; one of the technicians however, instead of starting up this system, acted out of reflex and adjusted the closest air control valve (see arrow in photograph) to shut the tanker car's liquid valve (in red). The automatic chlorine detection chain placed all installations in secure mode; the two technicians, wearing self-breathing apparatuses, clamped the flange and stopped the leak. The pipe containing liquid chlorine was subsequently drained and degassed towards the bleach tanks, before being filled with inert air by opening the car's high-pressure inflation system. The compressors were turned off and the technicians scheduled a flange joint change for the following morning.

On the day prior to the incident, the technician instinctively closed the nearest air control valve when noticing a chlorine leak at the level of the moving head-tanker car connection, so as to close the chlorine car's valve, instead of activating the emergency shutdown system. In reality, this air control valve contained no outlet and the entrapped air pinned the control rod in an intermediate position, meaning that the tanker car's valve remained partially open.

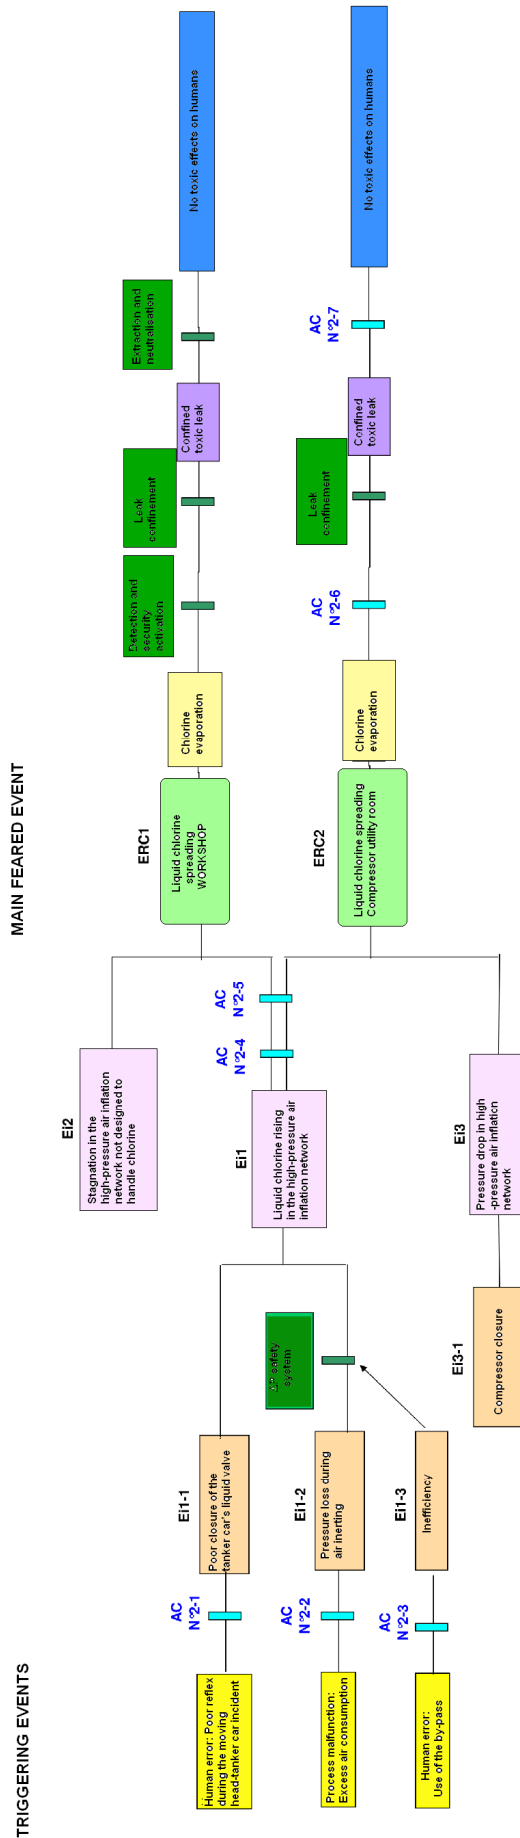
Causal tree analysis for the chlorine leak incident on 27th May, 2009

This incident thus resulted in a rise of liquid chlorine within the high-pressure inflation circuit due to a combination of the 3 following factors:

- poor closure of the car's liquid valve subsequent to the initial incident on the car's moving head (closure of the wrong valve when the technician acted out of reflex);
- pressure drop during the air inerting step (air circuit designed too small given the exceptional operating conditions);
- inoperability of the differential pressure ΔP safety system (by-pass of the safety ΔP by technicians instead of responding to the malfunction).

AC	Description of the corresponding corrective action (causal tree analysis)
N°2-1	Installation of new 3-way manual valves on the low-pressure air circuit controlled upstream of the instrument console
N°2-2	Modification of high-pressure air networks with the creation of 2 independent circuits, each with a dedicated air supply tank. [high-pressure inflation network] / [high-pressure process network + control low-pressure network]
N°2-3	Secure mode for "technical" manual valves by means of padlocking
N°2-4	Installation of 2 "liquid trap" buffer tanks on each of the 2 high-pressure air networks
N°2-5	Installation of a chlorine detection devices on both of the high-pressure compressed air networks, with servo-controlled closure of guided valves
N°2-6	Installation of a chlorine detection device in the compressor utility room
N°2-7	Placement of an air extraction duct in the compressor utility room connected to the neutralisation tower

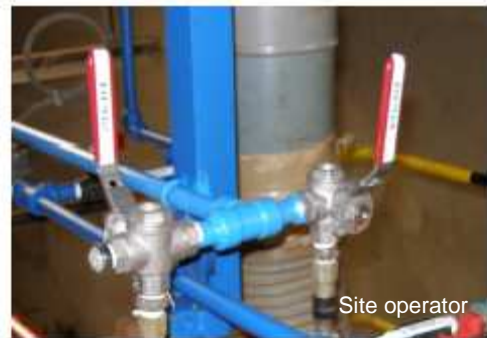
Installation of 3-way valves

- installation of new 3-way manual valves on the low-pressure air circuit controlled upstream of the instrument console for the purpose of bleeding the tanker car valve air supply and thereby avoiding the operational error due to air valve closure that resulted from an inappropriate reflex action;

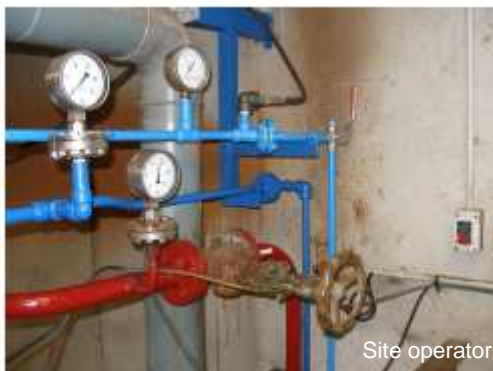
Independent air circuits with distinct identification

- (reversible) locking of the ΔP safety by-pass, given that this by-pass was only necessary for installation maintenance (padlocked manual valves);
- separation of the high-pressure air circuits (i.e. process and inflation) by introducing a compressor for each circuit in order to both avoid disturbances between the two and increase air supply capacities, which were inadequate at the time of the incident. Installation on both circuits of 2 "liquid trap" buffer tanks.

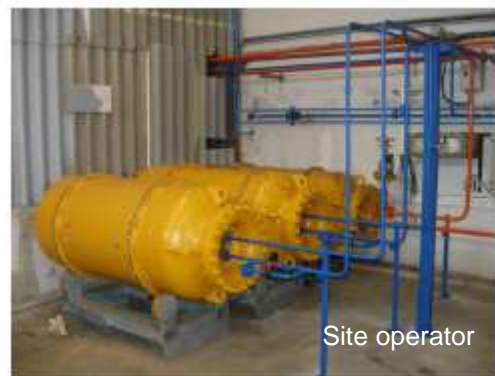
Installation of "liquid traps" in both high-pressure circuits
