Fertiliser decomposition in a dryer

8 February 2010

Ribécourt-Dreslincourt (Oise) France

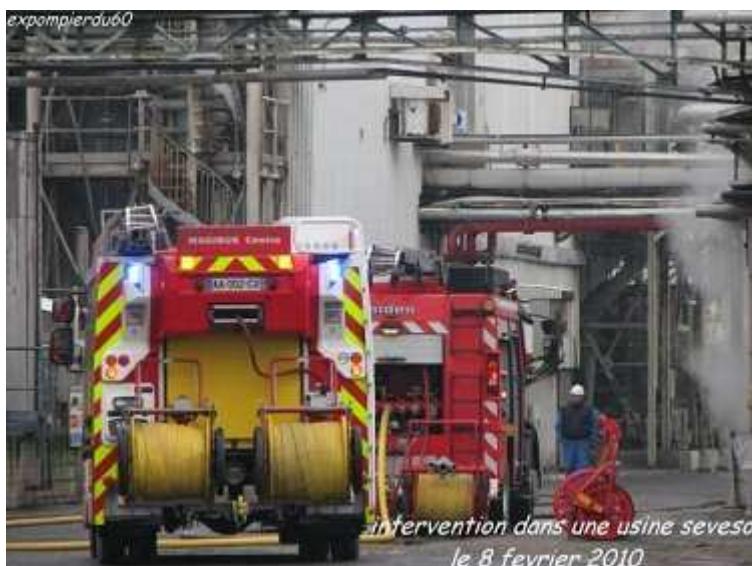
Around 10:30 am, an employee noticed yellow smoke being emitted from the main chimney of the NPK fertiliser plant. This smoke was caused by a decomposition of the NPK 11-11-32 fertiliser contained in the dryer. To limit the accidental discharge, the technician running the control room shut off the exhaust fan ; the gas resulting from decomposition of this product was thus released into the plant.

The internal emergency plan was activated and the local fire crew arrived on the scene at 11:10 am. Once the dryer had been restarted and flooded, fertiliser decomposition could be stopped, with the responsible material removed from the dryer and stored for a full day before reuse by the operator.

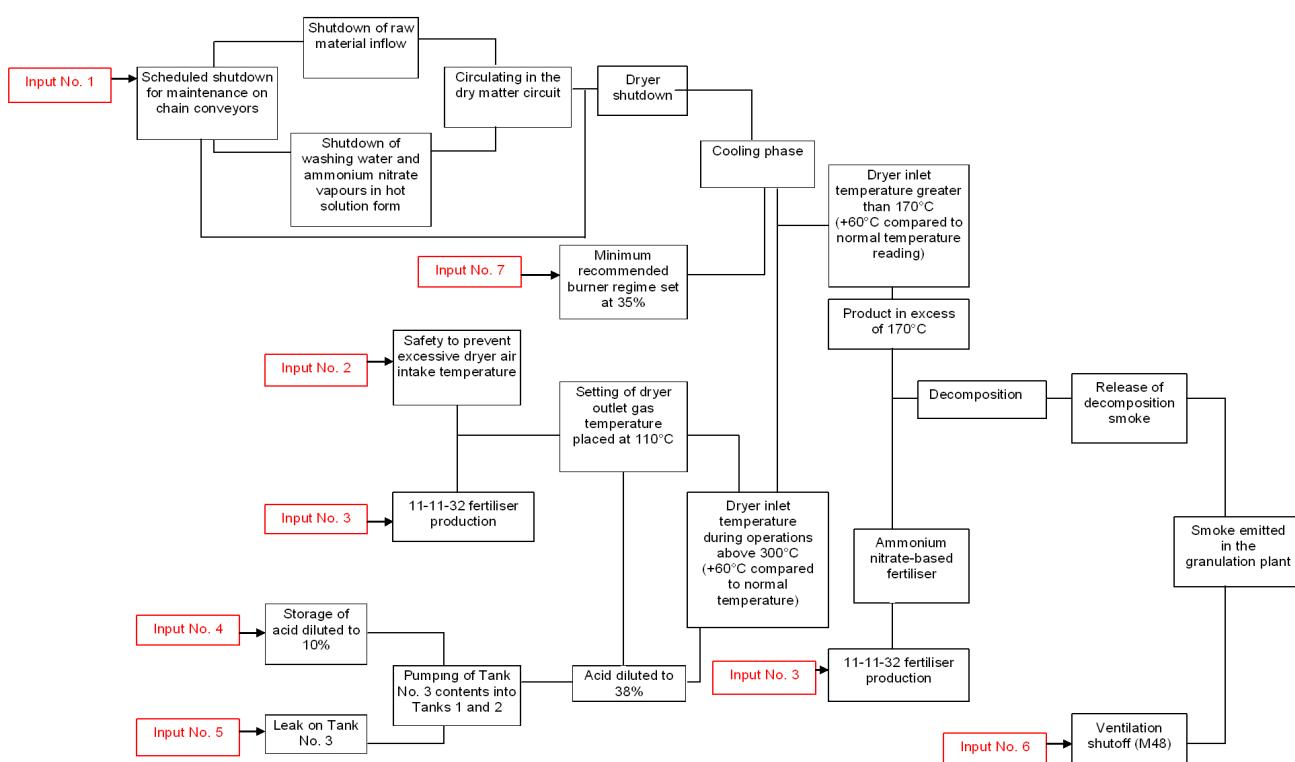
Causal tree of the accident

On Thursday, 28 January 2010 around 7 pm, a leak in Tank No. 3 containing diluted phosphoric acid (10% to 30% P₂O₅) forced technicians to transfer tank contents in concentrated acid form (53% / 54% P₂O₅) into Tanks 1 and 2, thereby causing a considerable dilution to occur: Tank 1 at 42% P₂O₅, Tank 2 at 38% P₂O₅. Tank No. 3 was corroded, and its shell was leaking at a level 1.5 m from the bottom.

The use of a lower concentration phosphoric acid (38%) than that typically used (53%) caused a thermal disequilibrium of the dryer installation. The slurry of ammonium phosphate powder on aggregates therefore contained more water to be evaporated, resulting in a lower dryer outlet gas temperature. Since this temperature had been set at 110°C, the drying inlet air temperature was automatically raised in order to compensate for this disequilibrium. A temperature close to 300°C was recorded at the dryer inlet instead of the more customary 240°C.

This technically-motivated shutdown procedure transitioned the plant into a dry granulation operating mode with periodic interruptions of the rotating tubes, to ensure the product stayed dry in the granulation loop and avoid clogging by product riprap on the tube walls. Nonetheless, the temperature reached at the dryer inlet, after the cooling phase (according to a procedure that was strictly followed), was 170°C in stead of 110°C due to the high initial temperature (300°C). Start-up temperature for the dry fertiliser decomposition process (above 170°C) was reached inside the dryer inlet tube, thus leading to fertiliser decomposition and the release of yellow smoke. No alarm was sounded since the alarm threshold (370°C) for the hot air intake temperature probes had not yet been exceeded.

- modification of the manufacturing standards to incorporate an alarm threshold on the hot air intake temperature adapted to each manufacturing process ;
- an alarm threshold for the ammonium nitrate-based fertilisers increased to 260°C ;
- revision of the maintenance shutdown procedure for the purpose of specifying temperature controls and thresholds on the various steps required for the installation shutdown routine ;
- creation of a response guide as part of the internal emergency plan, in order to avoid having a technician shut off ventilation in the event of a toxic gas release.
