# Rupture of an oxygen pipeline

13 June 2010

**Richemont (Moselle)**

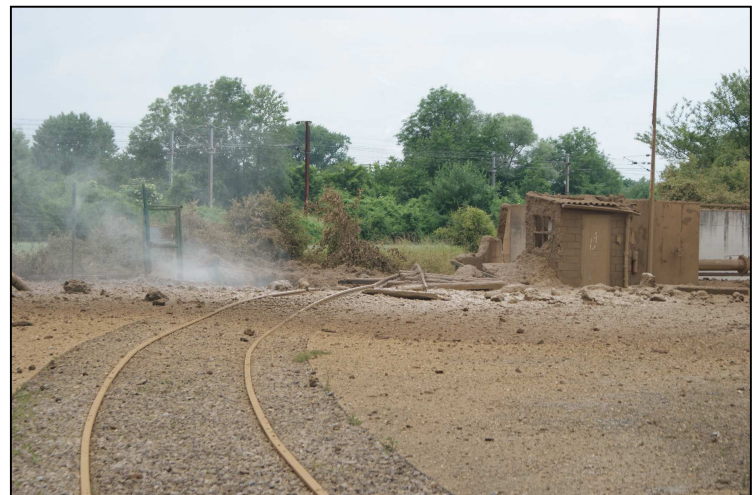
On 13 June 2010, the pipeline burst around 1:30 pm on the plant's premises at the boundary with public property, where the pipe passes in a concrete pipe underneath the railway that serviced the plant.

The site's internal emergency plan was activated within an hour after the break ; fire-fighting crews and the local gendarmerie were dispatched to the scene. The pipeline was safely isolated by shutting off a valve; by 2:30 pm, an O<sub>2</sub> concentration of 26% was recorded 5 m from the isolated pipeline section. The operator duly informed the facility's clients and issued a press release at 6 pm.

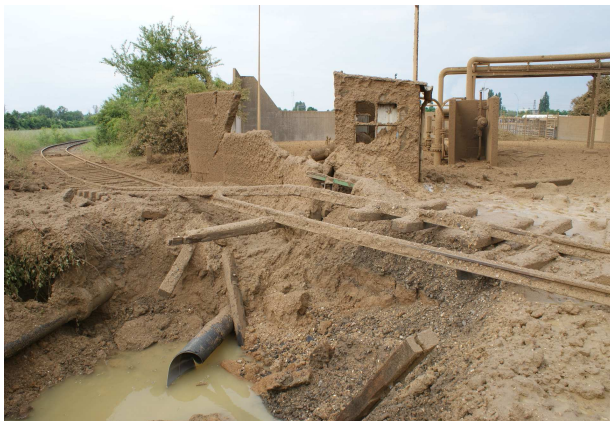
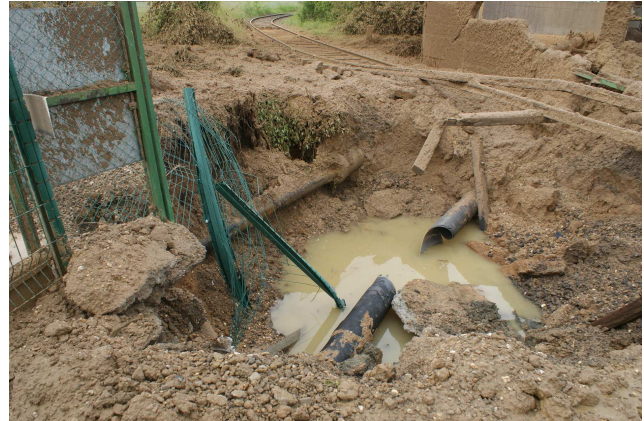
DREAL - Lorraine

- The oxygen pipeline, "rolled out" in a strip over 1 m, was immersed in water.
- A crater was formed (diameter: 7 m, depth: 3 m). The TNT equivalent was evaluated by the operator at 0.14 kg.
- Pieces of the railway, along with sludge and fragments of pavement and concrete, were projected some 50 m (1-kg debris found 60 m away and 15-kg pieces blasted 30 m).
- A concrete wall located a few metres from the pipeline was partially destroyed.
- The fence was twisted and damaged.
- No fire outbreak was detected on the tube structure, although the onset of combustion was observed on a 220/24 V transformer installed in an electrical utility room 3 or 4 m from the break.

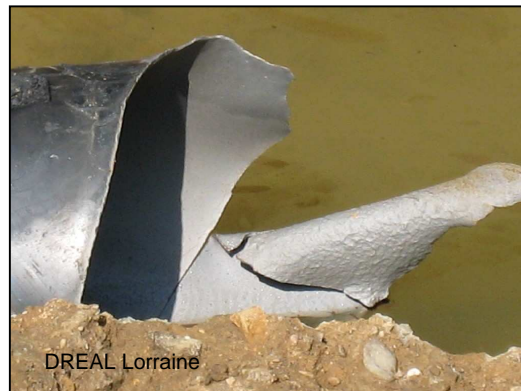
Corrosion seems to be the most likely source of this pipeline break. The metallurgical appraisal found the presence of generalised corrosion over a section where a casing crossed the alignment at the point of the accident, making it plausible to conclude that several factors acting in unison were the underlying cause :

- presence of an electrolyte (water), which moreover had a high chloride content
- delamination of the pipeline's anticorrosion lining
- defective cathodic protection
- an over-oxygenated atmosphere.

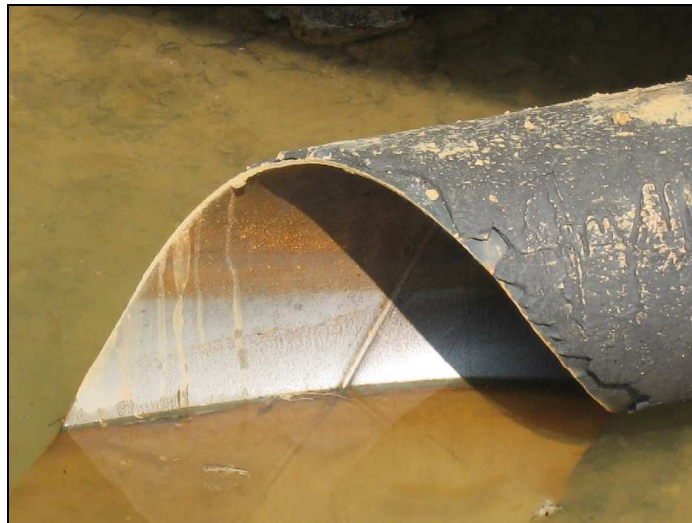
DREAL Lorraine

The final metallurgical expert's report cited a combination of several factors : defective seal on the shaft, shifting water table level in the shaft creating medium discontinuities for the electrolyte as well as diminished cathodic protection, local deterioration of the lining with delamination of the coal tar pitch. The water reaching the coal tar pitch/steel interface, plus the onset of corrosion penetrating the pipeline and a micro leak of  $O_2$ , all helped accelerate this phenomenon.

Above the new segment of pipeline, concrete slabs were installed to distribute the load. The specifications issued in the geotechnical expert appraisal commissioned by DREAL were respected when burying the line.

The monitoring and maintenance plan was updated in order to take this feedback into account.
