Bursting of a high-pressure steam pipe

28 June 2010

Le Grand-Quevilly (Seine-Maritime) France

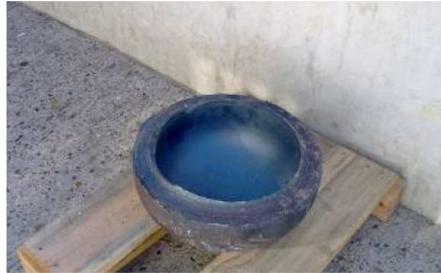
No hazardous substance listed under the Seveso Directive was released, since the leaked substance was overheated pressurised steam. This steam leak caused the asbestos cement cladding to be ripped off the breeze block wall of the machine room located opposite the blast zone. A 40-kg dished bottom was found onsite at a distance of 230 m from the damaged unit (Fig. 4).

Figure 4 : Photograph of the dished bottom projected on the day of the accident (source: GPN)

A break was detected along the bottom weld seam on the tube, over the bonding zone thermally altered by the weld, on the bottom side. The weld has remained fastened to the tube. The operator observes that the only visible flaw was a slightly oxidized surface condition at the level of the break on the dished bottom.

Furthermore, damage had started to slowly progress on the outer skin of the dished bottom and was gradually entering into the thickness of the zone thermally altered by the weld (slow creep), without any apparent deformation. The metallographic inspection of rupture on the bottom side revealed the presence of oxidized microcracks running parallel to the weld bond zone. The technical appraisal also underscored the fact that the heat treatment performed after welding might have accelerated damage, since the temperature selected had been adapted to a P22-grade steel and not to an ordinary carbon steel.

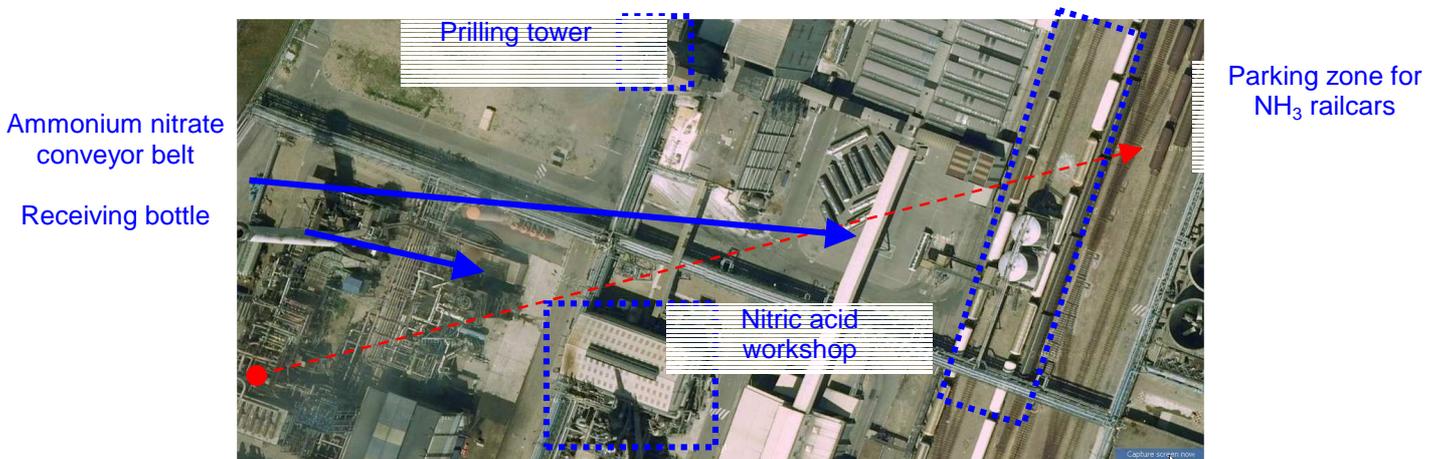
The projection of this piece of equipment led to no injuries, yet still caused damages inside the unit: a grated walkway was torn down, and a safety ladder sustained damage. The dished bottom was ejected above the ammonia receiving bottle (placed at the end of the synthesis process) and above an ammonium nitrate conveyor belt to come crashing down between two railway lines. Though these lines happened to be empty on the day of the accident, they were often used to park railcars loaded with ammonia awaiting construction of a full ramp (Fig. 5).

Figure 5 : Trajectory travelled by the dished bottom shown in red (source: Google and DREAL HAUTE NORMANDIE)

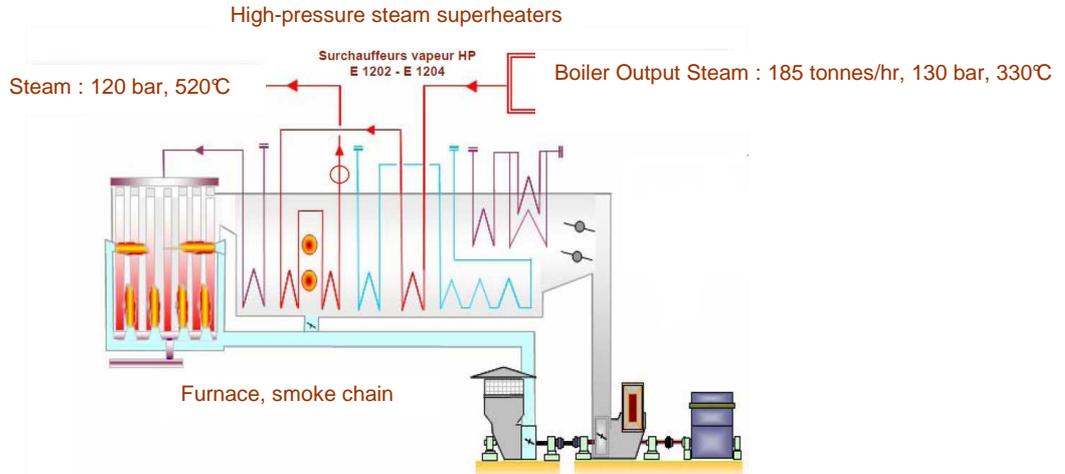
The dished bottom was convex and welded with a tulip-like shape on a weld-free drawn tube made of P22 type steel (cross-section with 2 dished bottoms). This tube served as a collector for a 14-inch pipeline (DN 350, thickness: 44 mm), conveying the 520°C water vapour at high pressure (120 bar) between a superheater and turbines. The superheater is a heat exchanger that enables recovering excess heat from the unit's reforming furnace in order to increase temperature of the steam produced by the boilers (Fig. 6). The piping was insulated and removed from all machines generating vibrations; it was placed high above ground on the smoke chain chamber roof, at the level of the unit's steam reforming installations (Fig. 7).

Figure 6 : The unit's overheated steam production circuit (source: GPN)

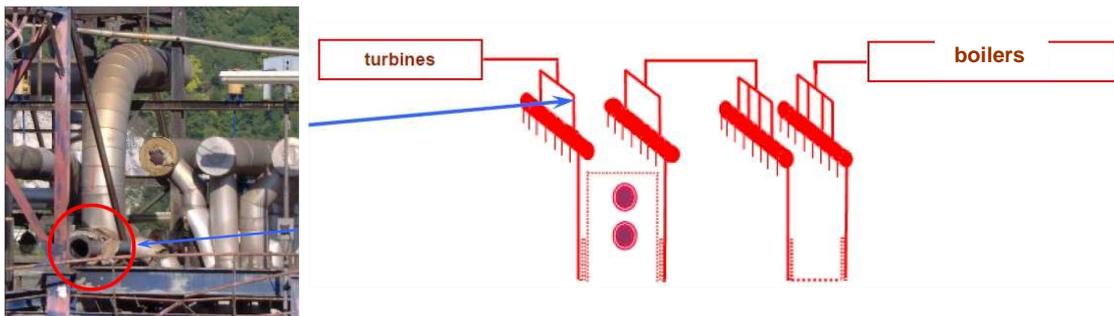
Figure 7 : Localisation of the damaged pipe (source: GPN)
