Gas explosion in the cat cracking and gas plant units of a refinery

9 November 1992

La Mède [Bouches du Rhône]
France

- Explosion
- UVCE
- Gas
- Catalytic Cracker
- Gas-plant
- Piping
- Rupture / Corrosion
- Victims
- Material damage

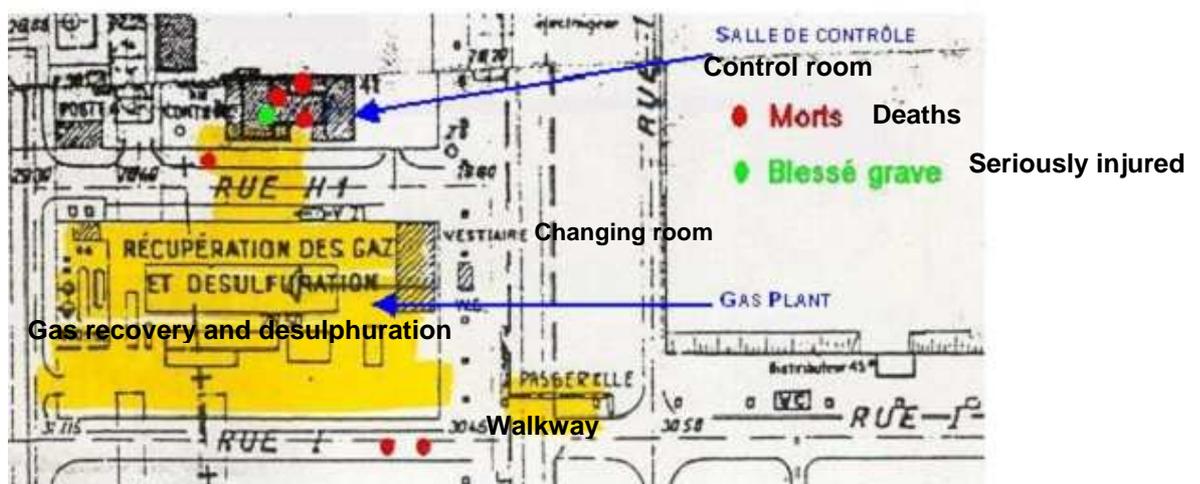
The final human casualty included 6 deaths and one case of serious injury among the refinery staff. 37 other persons including two firemen sustained minor injuries. Most of the victims were in the control room that was destroyed during the explosions (see. figure 3).

Figure 3 - Disposition des victimes
Location of victims

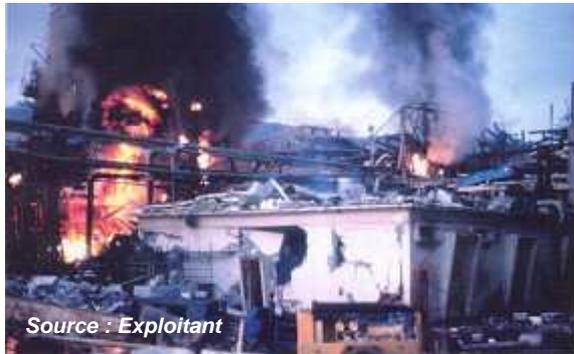
Figure 4 – View of the control room at 9.00 am

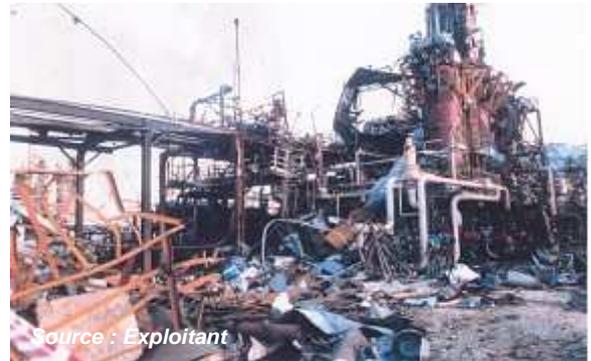
Figure 5 – View of the cryogenic unit

The most severe damages related to the fire were directly on the gas-plant and cryogenic units, the adjoining piping and a heavy gas oil tank near the B20 tank whose roof was ripped apart due to excess pressure resulting from the explosion. The C24 tank, whose main function is to receive used sodium hydroxide from units for an alkali wash, sustained severe damage in the upper part despite a protective bund wall covering 2/3rd of its height. At the time of the accident the C24 tank contained a mixture of 1,700 m³ of sodium hydroxide and light hydrocarbons. The shell of the A38 tank also sustained some damage following the fire

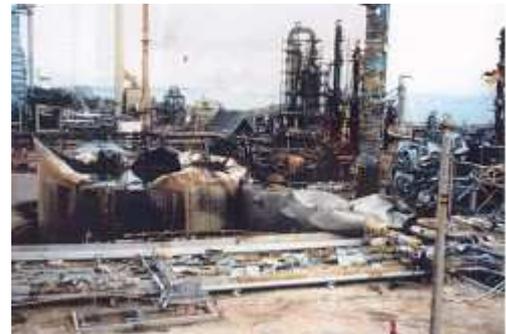
Figure 6 – View of the B20 tank

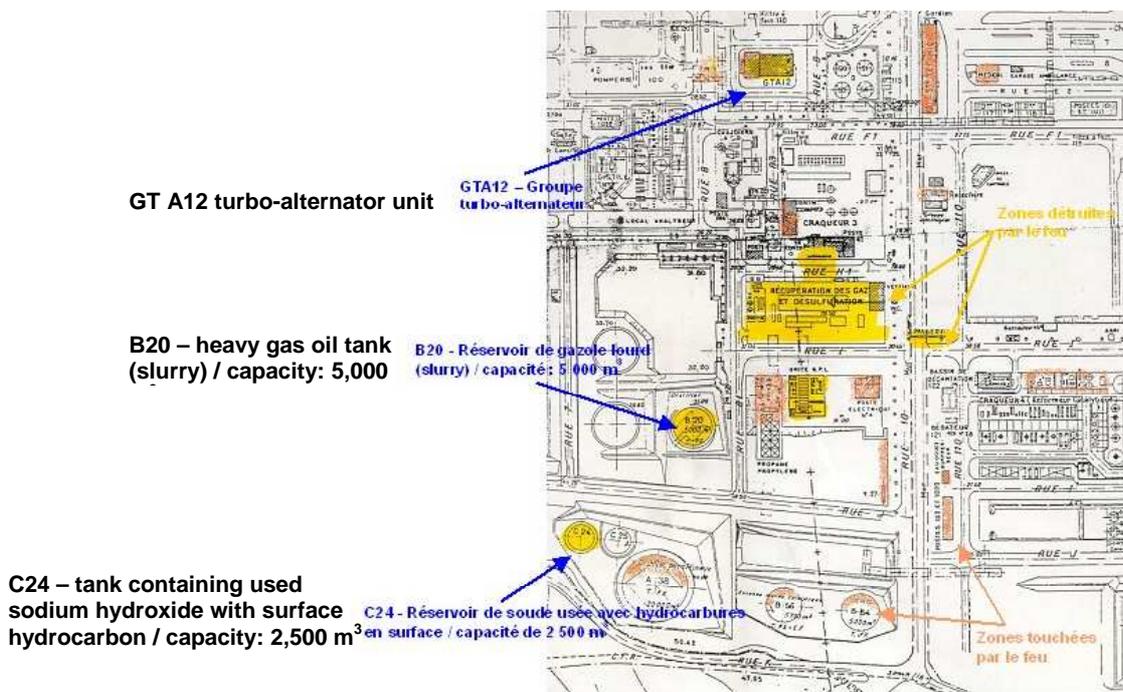
Figure 7 – Diagram of accident zones

The extent of the damage can be classified in 3 zones in the refinery that have been impacted:

- accident zone
- expert zone subject to special checks
- low exposure zone with no damage

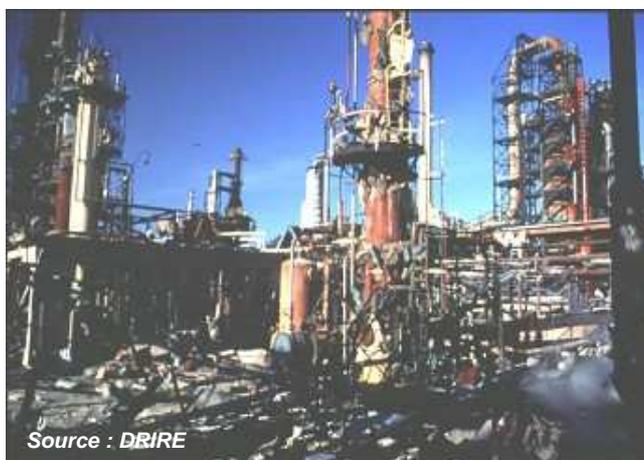
The shock wave resulting from the first explosion in its two successive phases shattered structures (positive over pressure – impulse) and then drew in light structures (depression - negative phase). The explosion was accompanied by a rain of debris of which some were projected as far as 135 m from their initial location (such as the fairing of the cooling tower weighing 340 kg). The resulting cascade effects ripped out and destroyed various piping networks, the metal structure of the GT A12 turbo-alternator unit and caused the resulting fire and set fire to the B20 and C24 tanks.

The explosions secondary to the main one resulted from the indirect cascade effects. In fact, some piping networks weakened by the mechanical and/or thermal effects of the initial explosion gave in and resulted in new explosions.

Figure 8 – Facilities destroyed by the explosion

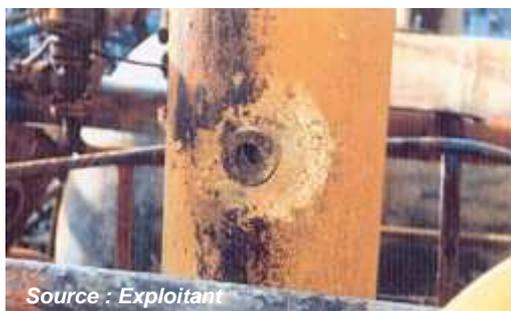
- 2.5 cm diameter (1") spur broken at the boss of the piping network (figure 9).
- An 80 x 20 cm serrated crack in the internal generator of the by-pass of the heat exchanger EA 103, de (figure 10). On the piping network, a longitudinal stretch of corrosion was observed on the internal generator with a significant decrease in thickness (humid hydrogen sulphide medium make the metal more fragile).

Figure 9 - 1" spur

Expert analysis has revealed that a crack on the piping released 12 tonnes of LPG in 10 minutes as opposed to 5 tonnes released through the spur hole of which only one thirds of the quantity vaporises. The spur hole is thus not wide enough to vaporise the quantity of gas required to trigger the accident (quantities greater than 5 tonnes). The crack in the piping seems to be the cause of the accident.

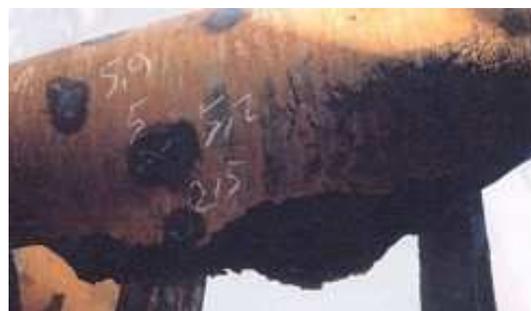
Figure 10 – 8" by-pass

In addition, pipeline inspection schedules at regular intervals were also put in place.

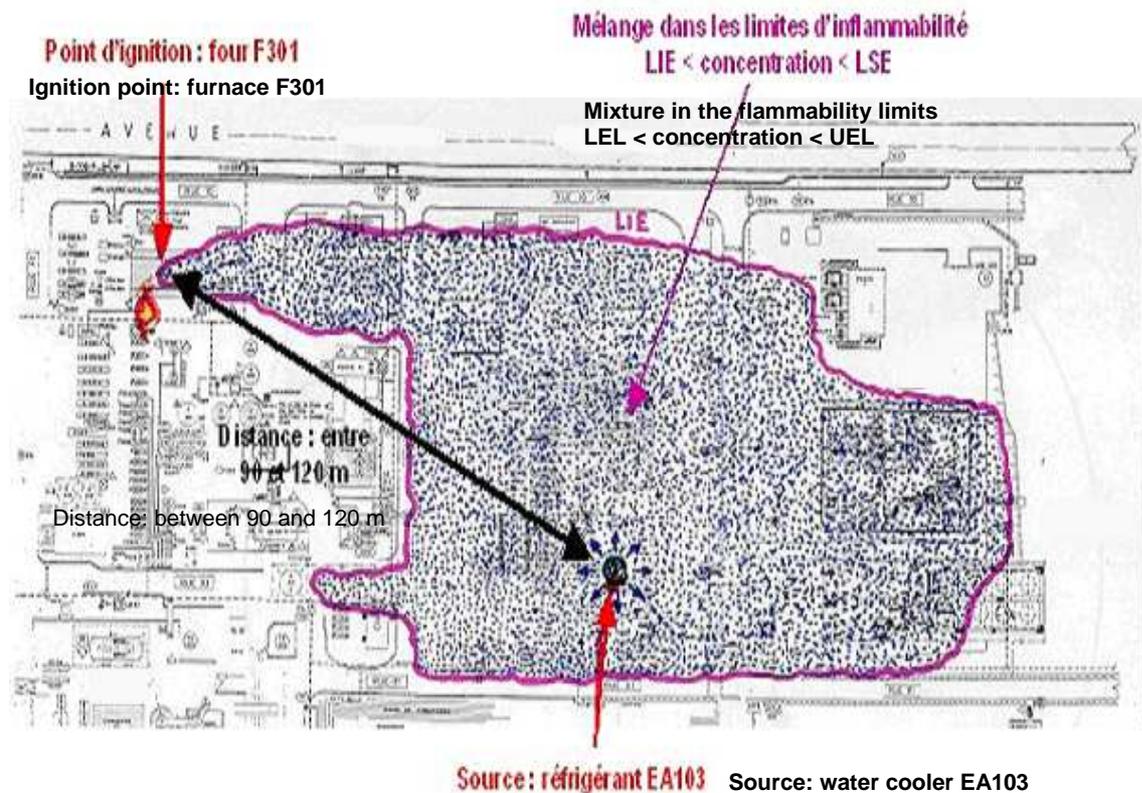
Figure 11 – Gas cloud propagation diagram

The approximately 70,000 m³ gas cloud (gaseous hydrocarbons + combustion air) was spread out over an area of about 14,000 m² and had a variable height of 4 m (cryogenic, propylene fractionating and furnace F301 zones) and 6 m for the gas plant zone.

In a summary, it seems that the gas cloud formed at the leak from the crack in the piping of the tower DA 101 drifted for a few minutes before catching fire at a distance of about 100 m upon contact with the furnace F301. The cloud caught fire at its fringes with lower concentration of hydrocarbon and close to LEL. The fire then spread to zones in the centre of the cloud with higher concentrations of hydrocarbons and finally in a zone with the required stoichiometric concentrations, the explosive UVCE phenomenon was triggered.

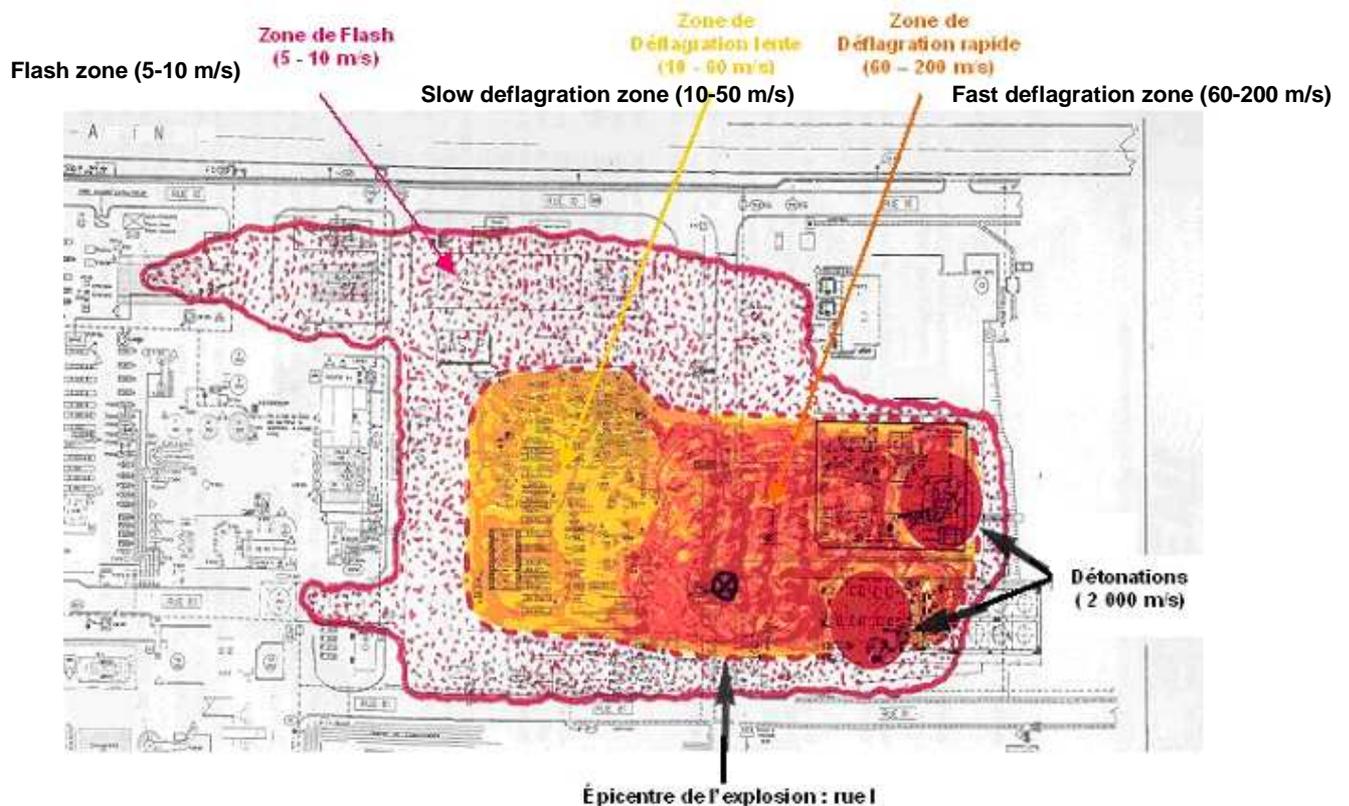
- The initial "flash" travelled at a low speed of around 5 to 12 m/s. Both air blast effect and over pressure was absent as long as the fire front did not encounter an obstacle. The involved surface was around 3,300 m². The flammable volume represented a volume of around 13,500 m³. The first phase can be compared to the functioning of a wick.

- The second phase involved the deflagration phenomenon. The presence of a gas concentration gradient within the cloud, disturbances due to the various obstacles and the partial confinement accelerated the slow deflagration into a fast one (speed estimated at approx. 200 m/s) and hastened the UVCE phenomena. The over pressured generated by the deflagration was weak at around 0.6 bar and the surface in question was approximately 7,200 m². The flammable volume was about 44,000 m³ and contained nearly 3.6 tonnes of gaseous hydrocarbons.

- Lastly, the shock wave from the gas plant compressed the cool gas in the cryogenic unit and amplified by the local phenomena of focusing and reflection, locally triggered one or several detonations (speed > 330 m/s). The weight of the cloud at this stage was relatively low (less than 200 kg of gaseous hydrocarbons). The supersonic spherical waves collided with the propagation of rapid deflagration from the gas plant probably at passage I, the zone designated as the epicentre of the explosion. The over pressure generated is in the order of 2 to 3 bar. The surface in question is estimated at 3,400 m² and the flammable volume represented around 13,500 m³.

Figure 12 - Illustration of the different phases of explosion
