# Hazardous substance release following inadequate HAZOP studies

21 September 2010

Heilbronn  
Germany

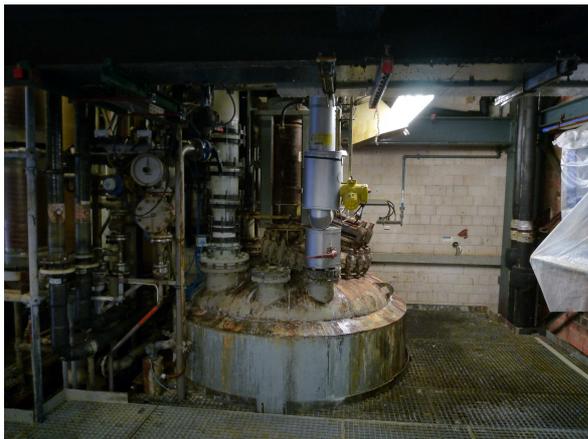
Fig. 1: A view of the reactor after the incident

A failure in the addition of water to a reactor (30 litre added at once instead of in 3 litre aliquots) led to an exothermic runaway reaction. The foaming contents of the reactor broke the glass condenser and led to the release of HCl vapour (ca. 60 kg) to the atmosphere.

Seven people outside of the establishment required medical attention, two of them were kept overnight in hospital. Damage to the equipment was limited to the broken glass condensers and large scale contamination of equipment and the outside of the reactor with the reactor contents.

systems could not respond to prevent any build up of pressure. The peak pressure of the foaming contents was sufficient to break the glass condenser, but was below the nominal pressure of the bursting disk, which was undamaged.

The plant has since been modified to limit the maximum volume of water which can be added at one time and to improve the electronic control system. The HAZOP studies have been reviewed for all exothermic reactions carried out on in this apparatus. In particular attention being paid to consequences of operating failures and a balance between risk control measures and the potential severity of the consequences.
