Explosion and fire on an acrylic acid tank at a chemical plant

29th September 2012

Himeji

Chemical industry
 Acrylic acid
 Thermal runaway
 BLEVE
 Management of change
 Instrumentation
 Internal emergency plan
 Organization

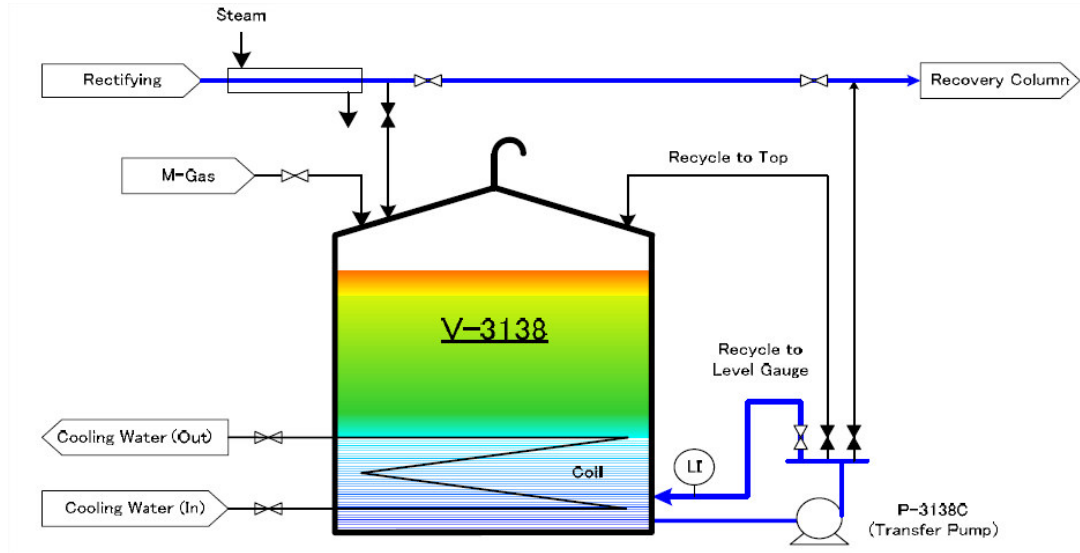
- 3rd phase, thermal runaway reaction (28th until the morning of 29th September): On the 28th between 2:00 and 2:10 pm, tank filling was completed and the recovery column was restarted, yet at this point it was being directly fed from the bottom of the rectification column without routing via the tank. The mix layers above the cooling loop were not being cooled since the upward recirculation loop had still not been activated (Fig. 8). The mix temperature thus kept rising due to the effect of AA dimerisation and climbed to 87°C in the upper layers at 2:10 pm. On the morning of the 29th, exothermic dimerisation continued until the mix had reached proportions of 40% of AA and 60% ADA, increasing its average temperature by roughly another 40 degrees.

The remaining AA then began to homopolymerise. The corresponding chemical reaction, which was even more exothermic than the previous one, raised the stored mix to 160°C by 1:20 pm; at this temperature, the remaining AA evaporated (boiling point: 141°C) and the liquid fraction of the mix exceeded the upper level

measurement limit set for 85 m³. White vapours began escaping by the vents, an event that enabled a technician to detect the runaway reaction and sound the internal alarm. With help from fellow technicians, he set up a sprinkling system at 1:30 pm by drawing from 6 fire hydrants in order to cool the tank and hose down the escaping vapours. Around 1:50 pm, the plant's fire-fighters provided backup and sprinkled the tank using a water cannon supplied by a tanker lorry. This response represented the only available means of extinction (as the addition of inhibitors or water in the tank had become impossible), though it turned out to be ineffective given that the tank was heat insulated. The operator then notified the municipal fire department; arriving on site at 2:05 pm with 3 fire trucks and a brigade of approx. 30 men, the municipal crew resumed the tank sprinkling operation.

Fig. 8: State of the intermediate storage tank during the thermal runaway reaction (Source: operator)

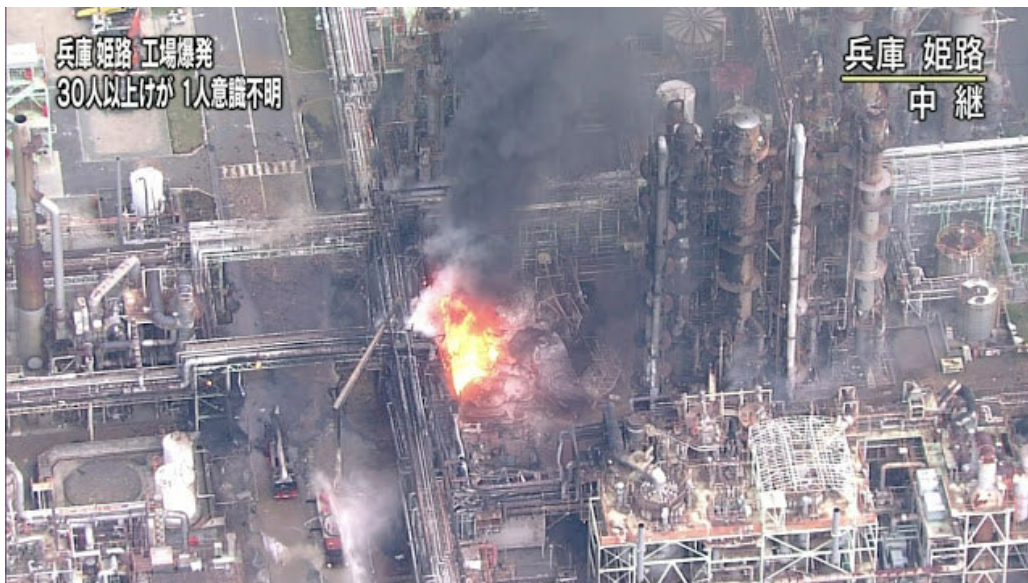
Fig. 9: View of the damaged unit after the BLEVE-type explosion (Source: Japanese television report)

Leaks formed due to cracking, which lowered the internal pressure; however, this sudden pressure drop caused the mix to boil and at 2:35 pm a BLEVE explosion (internal pressure = 6 bar, explosive force = 3 kg TNT equivalent) burst the tank, ejecting its boiling contents within the immediate vicinity. The mix ignited on a hotspot (damaged electrical cable or sparks created by metal debris), initiating a fire around the tank that would not be brought under control until 10:36 pm (Fig. 9).

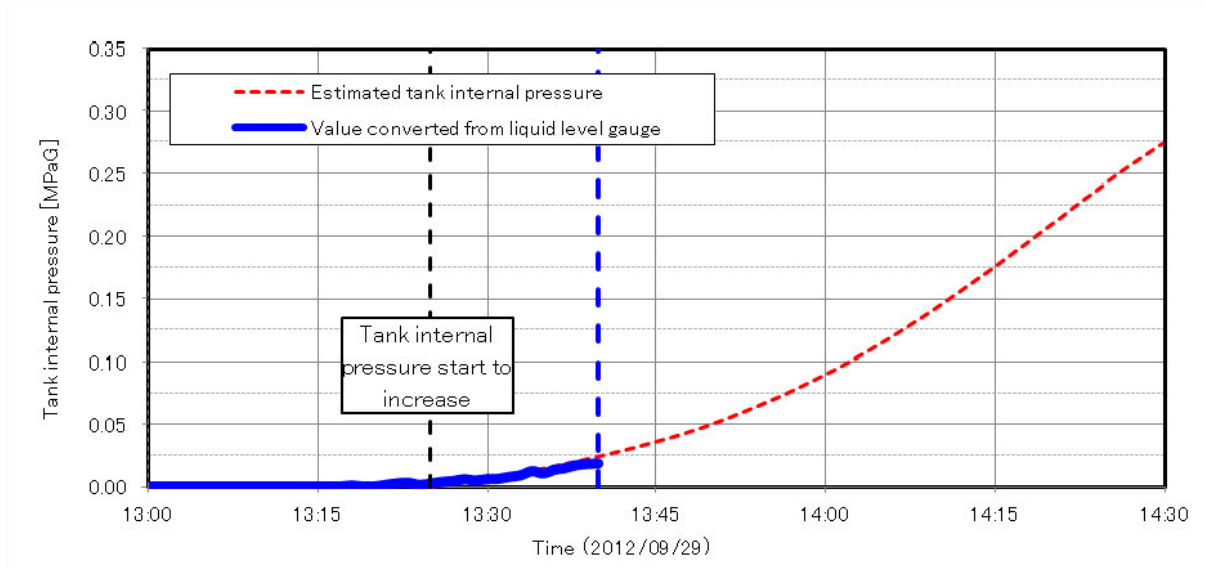
- o 4th phase, the accident (afternoon of 29th September): Pressure inside the tank suddenly began to increase at 2 pm, as the vapour flow rate had greatly surpassed vent discharge capacity (Fig. 10). The tank shell started to crack around 2:20 pm given that the internal pressure reached 2.5 bar and the mix temperature hit 240 °C.

Fig. 10: Evolution of internal tank pressure on 29th September between 1 and 2:30 pm (Source: operator)

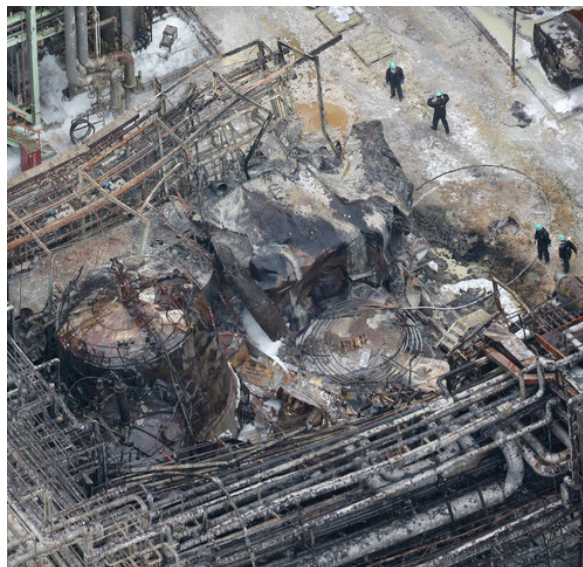
Blasted a distance of over 100 m, more than 80 pieces of debris damaged 6 of the 10 other nearby tanks located within the same retention basin (Figs. 11 and 14). In all, 67 m³ of lost AA and 28 m³ of lost toluene fuelled the fire from inside the basin; the blaze then spread southward to: an electrical transformer station, surrounding cables, and 2 fire trucks in service (Fig. 12). Pumps and pipe racks were also destroyed.

Fig. 11: View of damage after the BLEVE explosion (Source: operator)

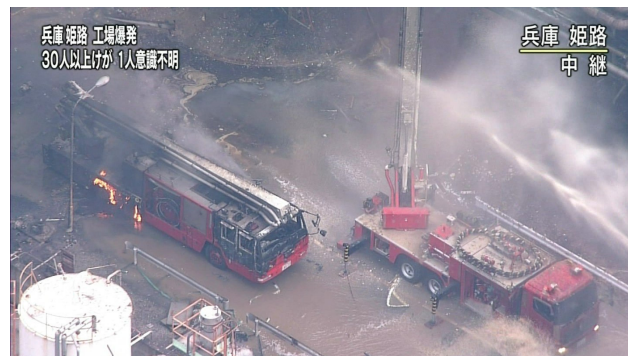
Fig. 12: View of fire trucks ablaze after the BLEVE explosion (Source: Japanese television report)

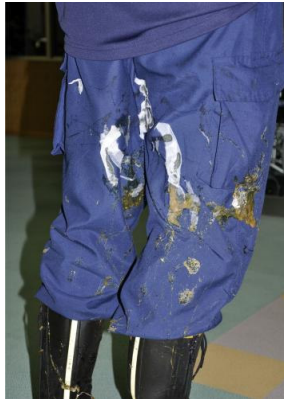
These injuries stemmed either from splashes of mix striking the body (Fig. 13), or from thermal effects produced by the fireball following the BLEVE explosion, or from thermal effects radiated by the ignited basin.

Fig. 13: View of splashes striking an employee involved in fighting the fire (Source: operator)

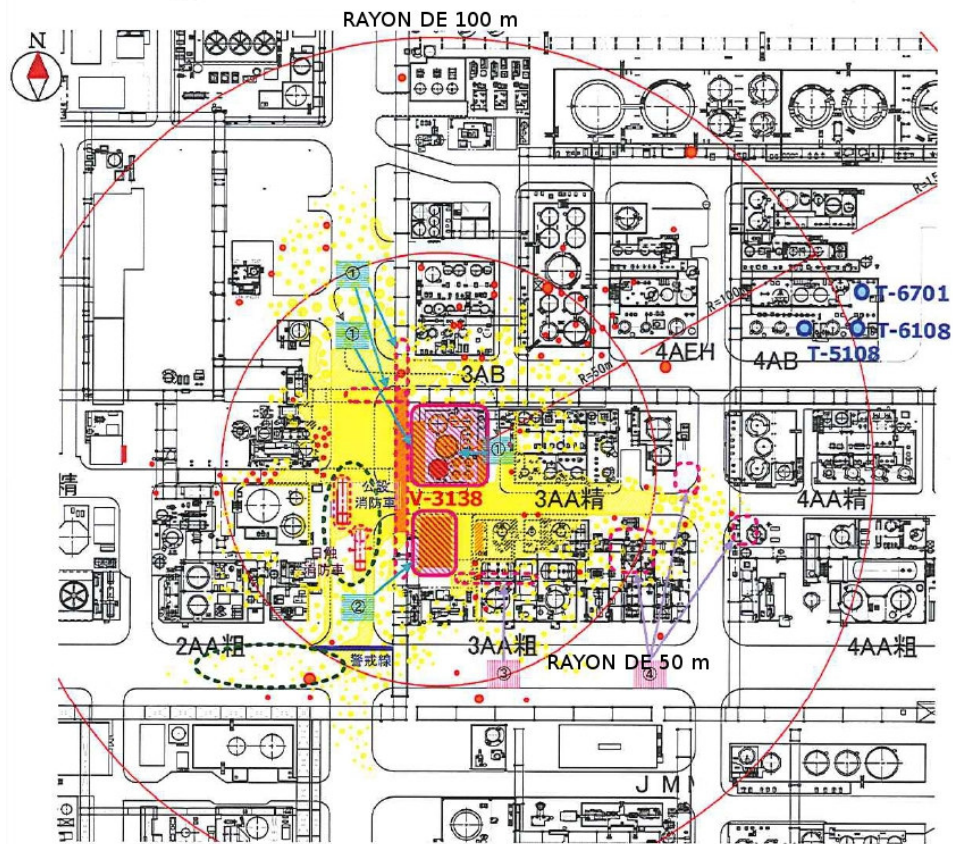
Fig. 14: Thermal effect zones (shown in yellow) and debris projections (red points) (Source: operator)
