## Boilover of a crude oil tank

30 August 1983

Milford Haven [Wales]

Refinery

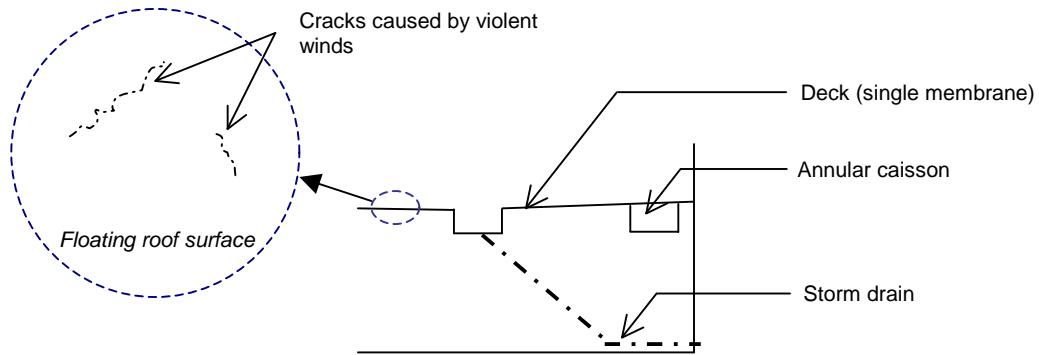
Diagram of a single deck annular pontoon storage tank

<sup>1</sup> The single deck floating roof comprises a central circular membrane called deck that directly sits on the stored liquid and is bordered by an annular caisson divided into compartments impermeable to the liquid. These compartments ensure the floatability of the structure under normal operating conditions, in the event of accumulation of rainwater on the deck or when the deck collapses.
