Petrol Station Accidents France, 1958 - 2007

CONTENT

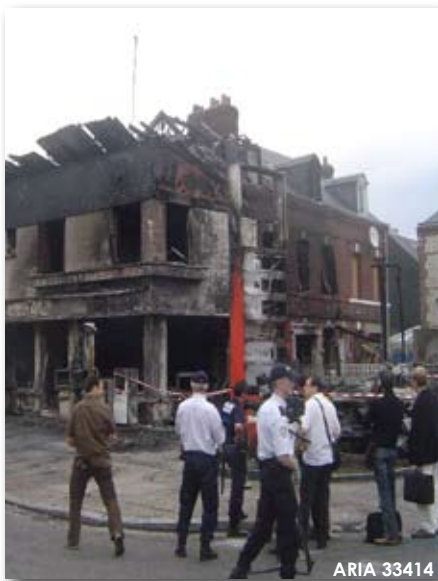
ARIA 33414

The recent accident in Sotteville-Lès-Rouen (ARIA 33414) was a reminder, if any was needed, of the risks inherent to petrol stations located in urban areas. Although service stations are seen as ordinary, experience shows that they are the site of accidents resulting in the loss of human lives (27 people died as a result of 8 accidents), serious injury (50 people suffered injuries in 16 accidents), pollution, and damage to neighbouring constructions. While it is true that petrol station equipment is not exempt from external aggression, customer negligence or malicious acts, implementing the following organisational and technical measures would have reduced the frequency or severity of many of the incidents described above:

- Setting up leak detection systems using both equipment (limiters, jacketed tanks with leak detectors, etc.) and organisational methods (tracking consumption and delivered quantities, supervising tank fill operations, maintenance, etc.).

- Setting up adapted confinement systems in case of release (retention, sealed areas, storm drainage system isolation valves, hydrocarbon detection, etc.).

- Managing tank fill operations through procedures and operator awareness efforts.
- Regular and rigorous inspection and maintenance of facilities and their safety devices.

- Setting up work procedures to reduce personal risks (fire permits, explosivity measurements, fire fighting facilities, etc.).
- Installing adapted equipment, particularly in explosive atmosphere areas.

- Informing and educating staff about existing risks.
- Ensuring on-site security (direct or camera surveillance of sensitive points, systems to limit malicious acts, etc.).

- For a site in an urban area, taking accident risks into account, particularly the intensity and possible effects on people liable to be exposed in the surrounding area (e.g. complying with regulatory minimum distances between facilities, and fencing).

- Conducting investigations with regard to polluted land to limit the risk of ground water pollution and identifying scenarios liable to result in gas accumulation in confined areas (network).
