## ACCIDENTOLOGY INVOLVING HYDROGEN

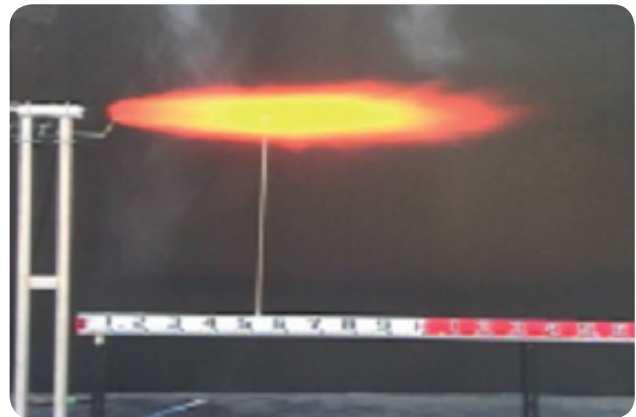
Ignited stream of pressurised hydrogen in the laboratory  
Source : Research Core for Explosion Safety, AIST (D.R.)

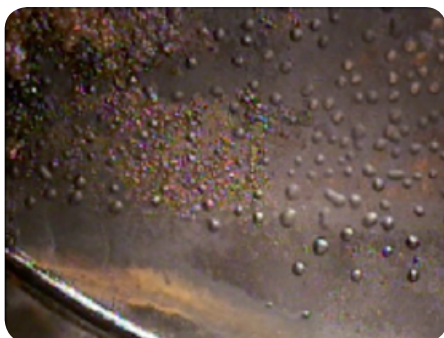
Hydrogen blistering on the wall of a capacity.  
Source : www.maverickinspection.com (D.R.)

- hydrogen blistering : absorption of atomic hydrogen on the surface of low resistance materials resulting in blisters (ARIA 324 and 33330).
- hydrogen embrittlement : absorption of atomic hydrogen on the surface of high resistance materials resulting in low ductility and increased internal stress (ARIA 437 and 14666).
- hydrogen induced cracking and hydrogen stress cracking : blister formation that may effect the integrity of materials especially when stressed (ARIA 2903, 7315 and 22229).

Various **preventive measures** may be planned depending on the type of damage : **choice of materials** (low impurities, specific alloys such as aluminium alloys, one of the rare metals less sensitive to hydrogen attack, etc.), **use of coatings, elimination of stress, improved design and fitting, etc.**

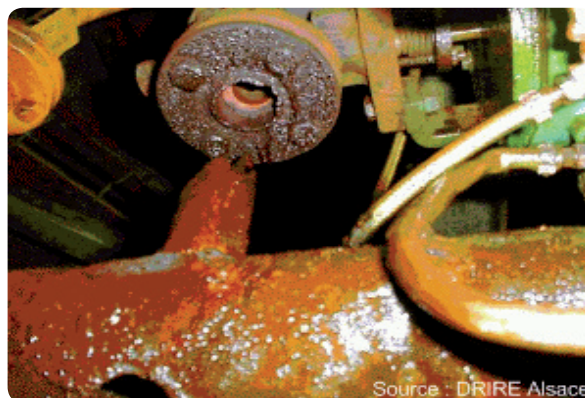
ARIA 26028 - Missing section of a pipeline due to iron/chlorine combustion

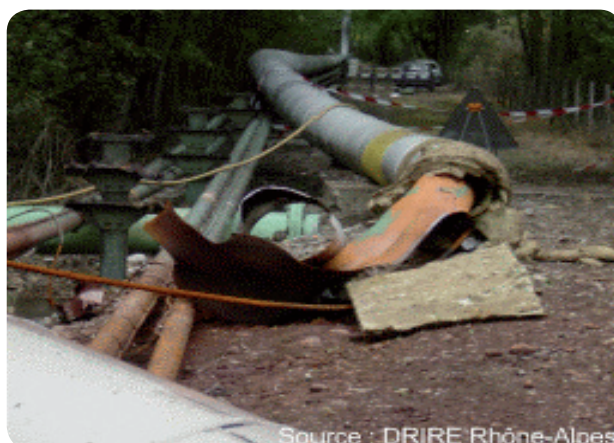
Source : DRIRE Rhône-Alpes  
ARIA 29864 - Hydrogen explosion in a chlorine transport pipe

Analysis of the accident showed that an  $\text{H}_2/\text{Cl}_2$  explosion caused the damage. The formation of  $\text{H}_2$  (20%) can be explained by the combination of several elements: The accidental introduction of humidity into the piping during a previous maintenance operation may have led to hydration of the ferric chloride present in the pipe's environment. According to the operator, the change in the deposit's crystalline phase due to excessive heating of the pipe (80 to 90 °C) promoted corrosion in the steel pipe (by the hypochlorous acid) and the formation of  $\text{H}_2$ . This heating is due to a temperature sensor that lost its electrical power supply 3 days earlier after a cable on the user's site was broken when a slab protecting the structure was poorly handled.

The operator cleaned the inside of the structure (2.5 to 3 t of mineral and organic residues were extracted), and planned to install temperature sensors every 500 m with upper and low safety devices, refurbish and secure the electric (heating) tracing, and perform regular endoscopic inspections. (ARIA 29864)

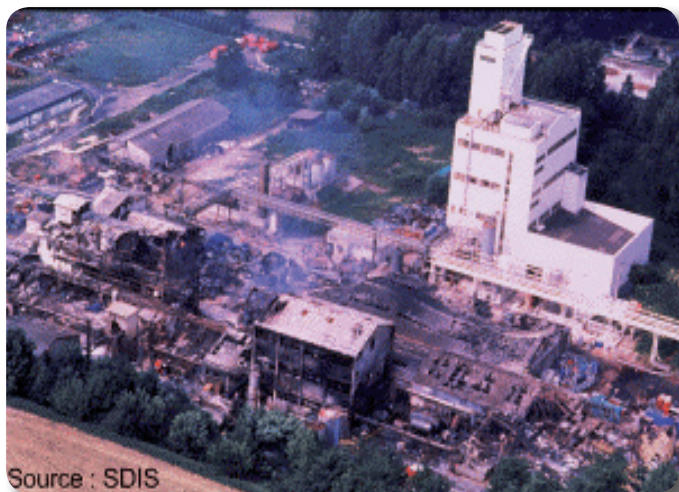
ARIA 161 - Explosion in a chemical plant in Auzouer-en-Touraine
