# DESTRUCTION OF PYROTECHNIC WASTE ACCIDENT ANALYSIS

ARIA 32086 DRIRE Bretagne

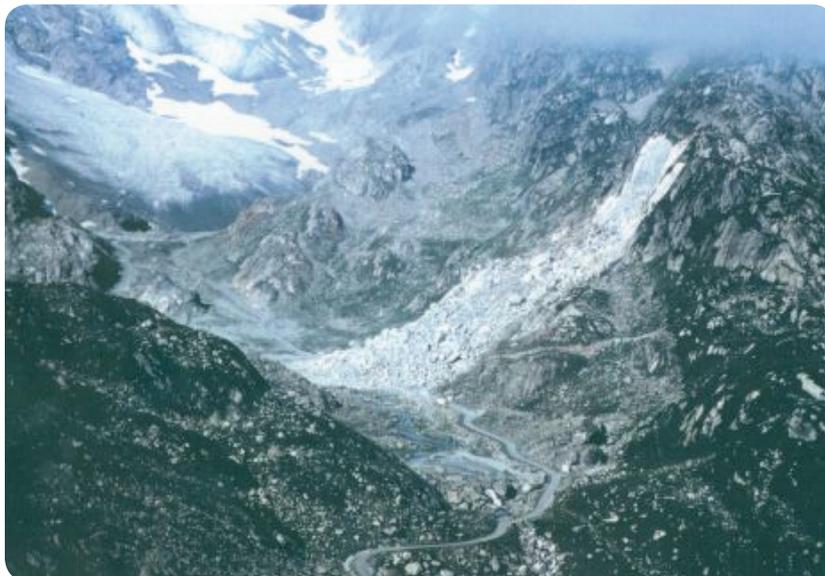
ARIA 37776 (see p 6) Explosion in the Steingletscher underground storage (Switzerland)  
Source : Bienz, Kummer and Partner AG (R.R.)

In Switzerland, in 1992, six people were killed around 4:10 pm by the explosion of nearly 300 tonnes of expired munitions and production wastes inside the underground depot at Steingletscher, located on the slope of the Susten Peak. The explosion, whose TNT equivalent was rated at 200 tonnes and a magnitude 3.7 on the Richter scale, caused the part of the mountainside overlooking the storage zone to slide; huge blocks of rock and pieces of the storage facility were blast over 600 m [...]. (ARIA 37776 [10])

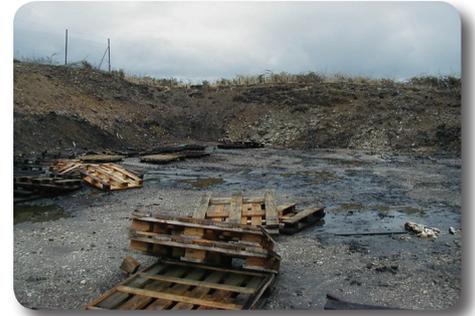
ARIA 32086 - Incendie lors de la préparation d'un brûlage

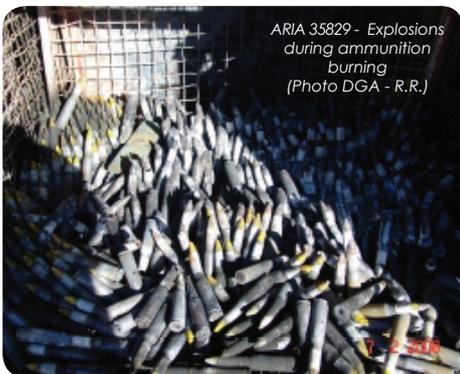
ARIA 35829 - Explosions during ammunition burning (Photo DGA - R.R.)

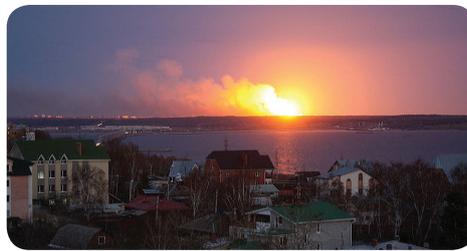
ARIA 37507 - Fire and explosions in an ammunition depot (Russia) Source : MSIAC (R.R.)

According to a federal safety agency, the fire was initiated by the onsite munitions disposal activities. The press indicated that the poor state of local infrastructure as well as noncompliance with safety rules were the causes of many accidents of this type - fires, explosions - every year in Russia. The munitions left unexploded during this accident would, 10 days later, trigger a fatal explosion when loaded onto a railcar for their ultimate destruction. (ARIA 37507)
