## Domino effects

### ③ Ignition of an ethylene leak on a pipeline

ARIA 35672 - 17/03/2008 - GERMANY - KÖLN

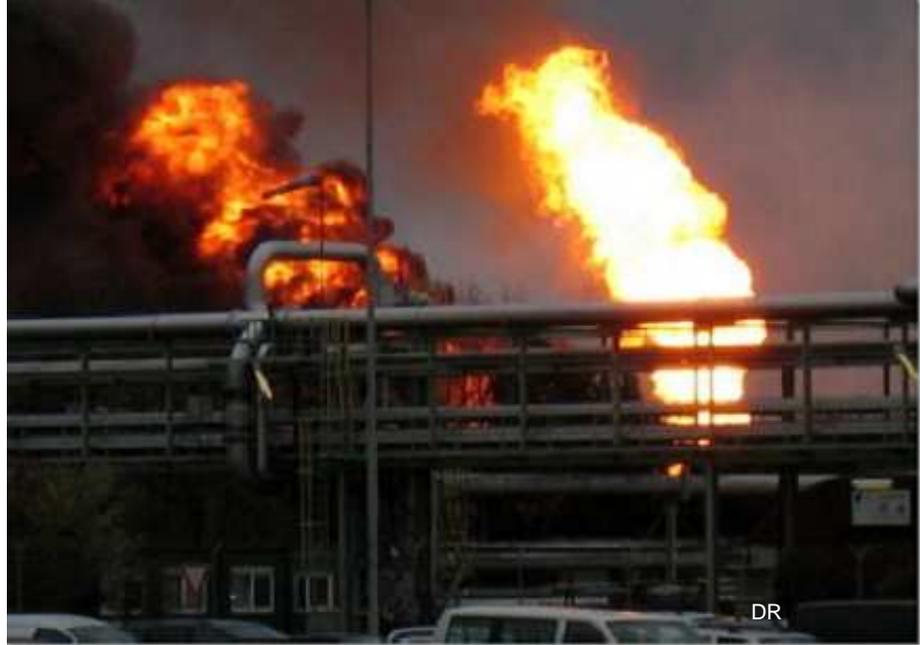
During maintenance operations, there was a leak at the tie-in of an ethylene pipeline connecting several plants in the region and the one connecting a chemical plant manufacturing basic plastics. The valves were closed but the ethylene that stopped leaking from the pipe section ignited. After some time, the heat emitted caused the fire to spread and destroy a by-pass valve leaving 11 km of the pipeline (distance until the next isolating valve) non isolated.

Ethylene contained in this 11 km section of the pipeline was at 80 atmospheres. A massive 30 m high flame was observed. The intense heat flow effected an aluminium tank containing acrylonitrile that was 10 m away. Even though the container was protected by a concrete wall, the acrylonitrile boiled and evaporated. Given the temperature, the container itself was “burning” and risked collapse. The fire-fighting operations became complicated but the blaze was brought under control in the end. However, half of the container was burnt. Material damage was significant but no casualties were reported.

Further to this accident, two expertises put forward several recommendations on improving the safety of pipeline tie-ins, as well as on the minimum distance to be maintained between inflammable gas pipelines and tanks containing inflammable liquids. The local authorities implemented an inspection schedule for transport pipelines of similar configuration implanted near SEVESO sites. The possible application of these recommendations may lead to new inspections, updating of safety reports and adaptations to meet new requirements.

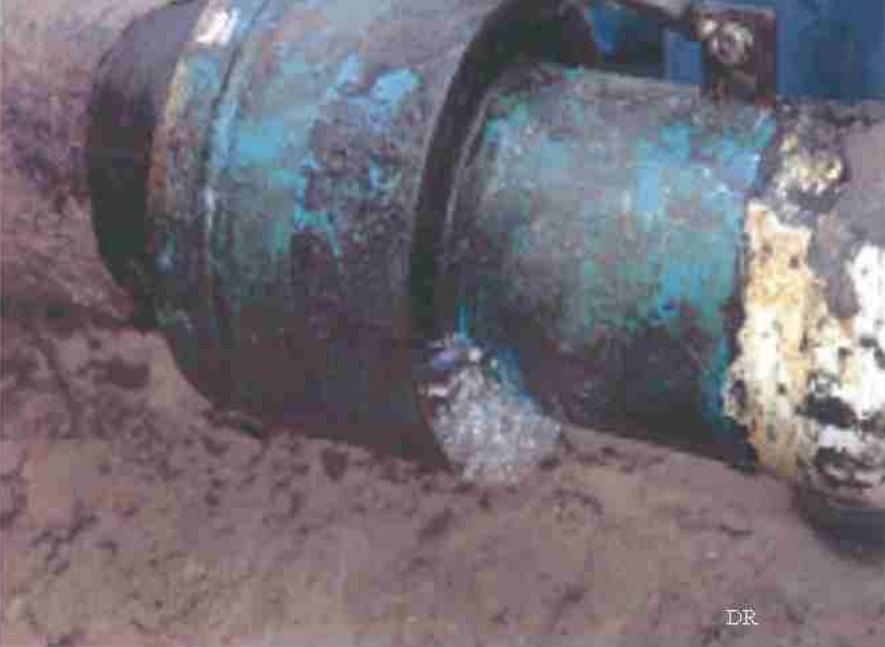
## ④ Ignition of a hydrogen leak on a pipeline

**ARIA 35860 - 12/10/2007 – NETHERLANDS - BINNENMAAS**

A fire broke out in a pipeline passageway bringing together several underground pipes carrying hazardous products such as hydrogen, kerosene, ethylene oxide, etc. The blaze was brought under control in a few minutes given the size of the leakage. The incident had no serious consequences but was nevertheless considered serious due to the presence of the other pipelines in the passageway including some carrying toxic gases.

According to the inspection department in question, hydrogen ( $H_2$ ) in an underground pipeline was ignited by welding operations underway in the vicinity. A differential subsidence of the ground with a local deformation of the pipeline at the cathodic protection device was believed to be the source of the  $H_2$  leak. The sandy nature of the ground was conducive to the subsidence due to the presence of heavy equipment on the surface (drain pump, construction site vehicles, etc.) used during excavation operations carried out for laying a new kerosene pipeline. Even though the transportation of dangerous substances through this passageway is considered to be managed safely, some shortcomings were nevertheless identified. Calculations had to be made to identify the maximum acceptable load above such pipe networks and a more active supervision of pipelines was recommended.
