20 Flooding of an industrial site

ARIA 35426 - 01/11/2008 - 43 - SAINT-GERMAIN-LAPRADE

21.20 – Manufacture of pharmaceutical preparations

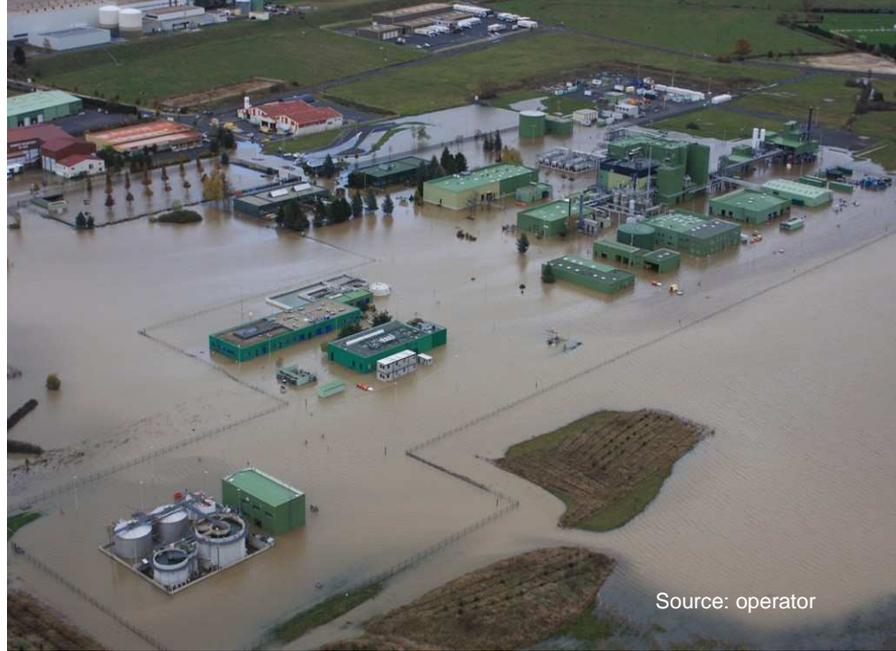
A pharmaceutical plant on a 55 hectare platform out of which 15 hectares were used was flooded (ARIA 35427) with 20 cm to 1 m of water due to torrential rains (300 mm in a few days including over 100 mm in less than 24 hours – The French metrological department put the region on “red alert” (highest level of alert) due to the rains.)

The site was on internal alert before the rise in the water level. The internal emergency plan was triggered. Thirty employees of the company evacuated or place the equipment and products at heights at around 4.00 pm. Safety alert was sounded in the company (safety fold back phase: production stopped, planning of power cut sequence).

Leak detectors, especially gas indicators were not functional after the power supply was stopped. The company staff and voluntary fire-fighters patrolled the site. No pollution was observed except for 2 to 5 litres of hydrocarbon (Isopar G) and 200 g of powder in the laboratory that had spilled. On the other hand, significant damage on account of water was reported (building partitions, documentation, electronic equipment that was not placed at heights)

A hydraulic study was commissioned by the metropolitan authorities of the industrial zone. The operator updated the internal emergency plan by including the flood situation and fine tuned his crisis management action plan (human and material resources).
