## Gas distribution pipelines

### ⑧ Gas leak in a pipeline

**ARIA 34042 - 22/12/2007 - 93 - NOISY-LE-SEC**

# Gas distribution pipelines

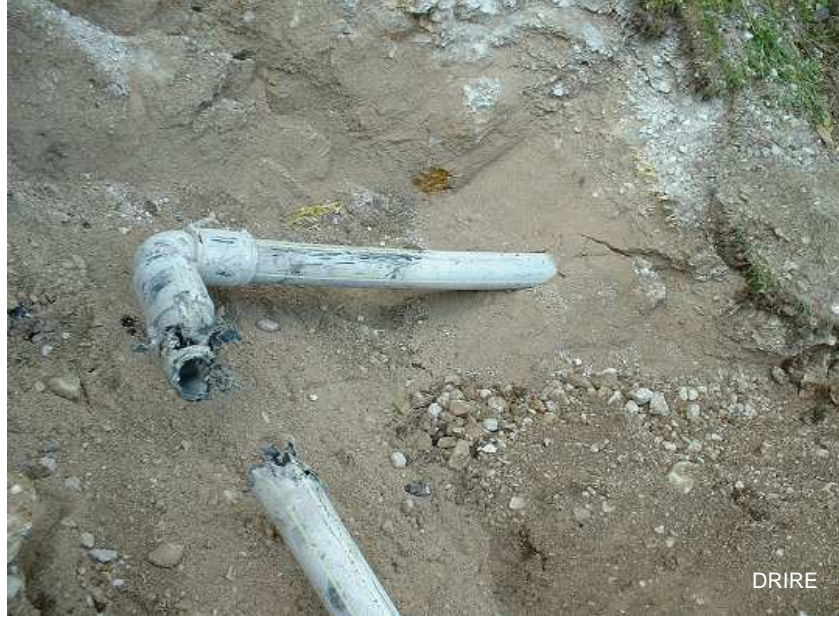
Gas leaked from a pipeline below a pavement at around 9.00 am which was followed by two explosions at around 9.45. A 5-storey residential building caught fire and collapsed partially. Approximately 100 people were evacuated. Gas supply to 200 customers was cut-off. The fire was extinguished by 176 fire-fighters and 51 fire-engines. The fire-fighters also carried out the clearing and research operations. The rescue operations ended on 23/12 at around midday. Eight people sustained injuries and 36 flats were destroyed. Boring operations aimed at soil testing in the

residential area may have possibly triggered the accident. An enquiry was conducted to analyse the malfunctioning observed and suggest solutions.
