17 Accidental generation of chlorine in a company trading in chemicals

ARIA 35830 – 05/10/2007 – GERMANY – FRANKFURT AM MAIN

46.75 – Wholesale of chemicals

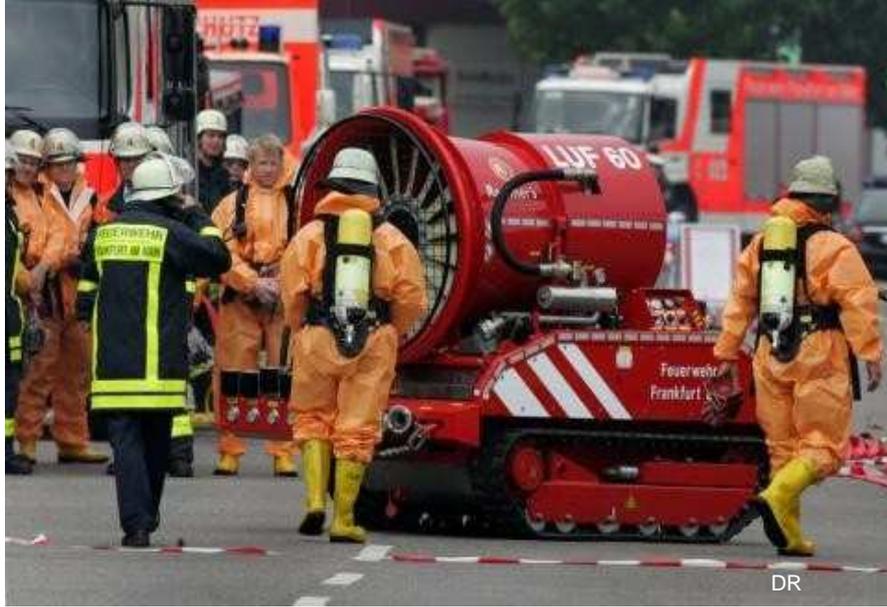
A cloud of chlorine gas was accidentally generated around 10.30 am while transferring hydrochloric acid (HCl) into a tank containing sodium hypochlorite (NaClO or liquid bleach) in a chemical wholesale company.

The accident happened during a period of rebuilding of the unit; the filling station and the delivery station were in the process of being renewed. At the delivery station for tankers there only one connection for all chemicals but FeCl₃. A pump transports the fluids via pipe to a connection battery / filling station for drums. At the battery, a worker connects the pipe, by using a hose, to the right tank. The technician chose the wrong tank at this point. Realizing his mistake, he stopped the transfer operation thus limiting the quantity of chlorine released to 200 kg. The employee was severely poisoned and died a month later.

Further to this accident, the unit is rearranged:

- The delivery station for roadtankers was equipped with a separate filling pipe for hypochlorite. The adapter was equipped with left hand threads (mistake-proofing?).
- All adapters of the storage unit were locked off and keys will be released after analysis by the laboratory personnel.
- All connections were clearly labelled.
- The hypochlorite pipe is monitored by a pH-electrode.
