Pipe fittings and joints

@ Explosion of hydrogen in a fertilizer plant

ARIA 31821 – 01/06/2006 – UNITED KINGDOM - BILLINGHAM

@ Chlorine leak during transfer

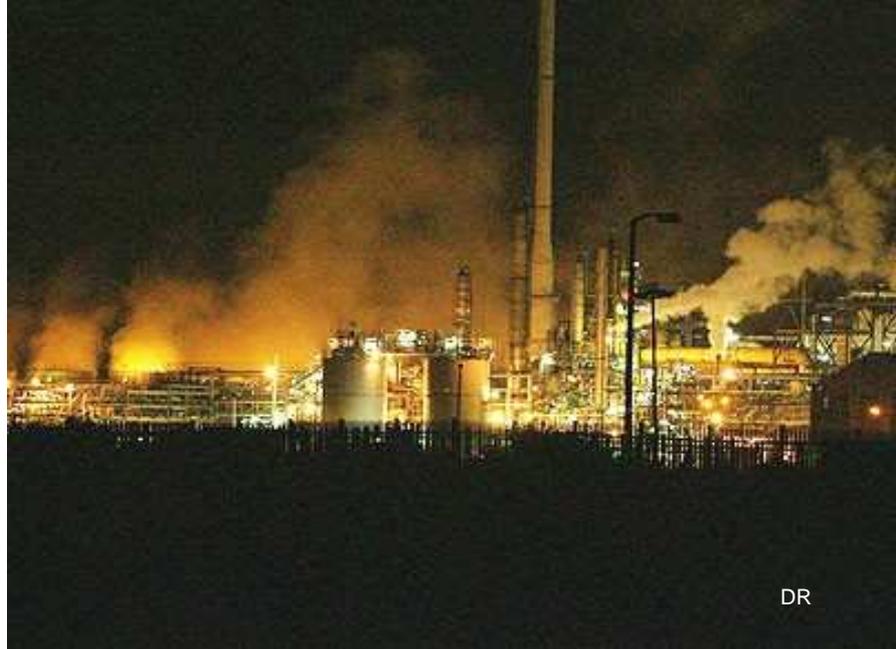
Shortly after midnight, a highly flammable gas leaked in an ammonia manufacturing unit of a chemical plant producing nitrogenous fertilizers. The gas, mainly comprising hydrogen, leaked from a valve at a pressure of 220 bar and a temperature of 120°C. It spontaneously ignited forming a fiery stream directed towards the pipeline carrying the gas. Due to the heat, the pressure in the pipeline increased; the top portion of the pipe ruptured releasing the gas that exploded.

The accident occurred due to a gas leak at the joint of a valve (in open position and at maximum flow). There was no leak-proof joint between the two metal parts in contact. The internal metal surface of the valve was not compliant with the specifications in terms of quality. The valve, replaced in 2002, was not considered to be an element critical to the safety even though the process was classified in the high-risk category. Only price was taken into consideration while selecting the maintenance supplier. There was no exchange of information between the operator and the subcontractor during the operation and no acceptance of work was done (especially inspection of the valve bolting).

The operator revised procedures, optimised management of maintenance and subcontractors (qualification, information, follow-up, etc.). The emergency operation conditions were also reviewed (appropriate number of trained staff even during low activity periods).

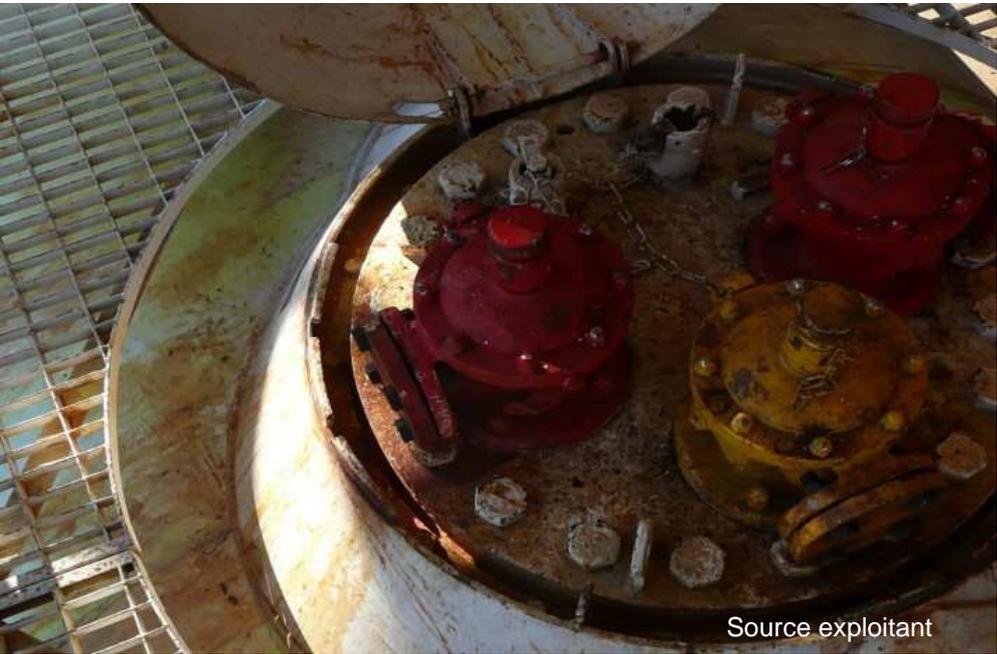
In a chemical plant, 11 kg of chlorine leaked around 9.30 am while being transferred in liquid phase from a tanker. The leak lasted for 30 seconds and led to the formation of a 50m cloud at the ground level that drifted with its visible part confined to the site premises. The technicians closed the valves by shutting off the supply of compressed air, sounded the alarm, and activated the water curtains.

The accident resulted from the rupture of the flange joint of a transfer hose during the tightness test. The joint was deformed because of the use of two 2 mm joints instead of one 4 mm joint. The operator who performed the tightening operation was undergoing training: The tightening operation was not properly carried out with the bolting machine. Lastly, the tightness tests were carried out in a chlorine atmosphere instead of nitrogen.

The operator took several measures after the accident: strict compliance with the safety instruction on wearing a self-contained breathing apparatus, ensuring consistency in issuing permits for various industrial operations, updating technician training on tightening operations, exclusive use of 4 mm joints.
