## Transport of waste in tank trucks

### ② Accident involving a tank truck transporting waste

ARIA 33767 - 31/07/2007 - 78 - LIMAY

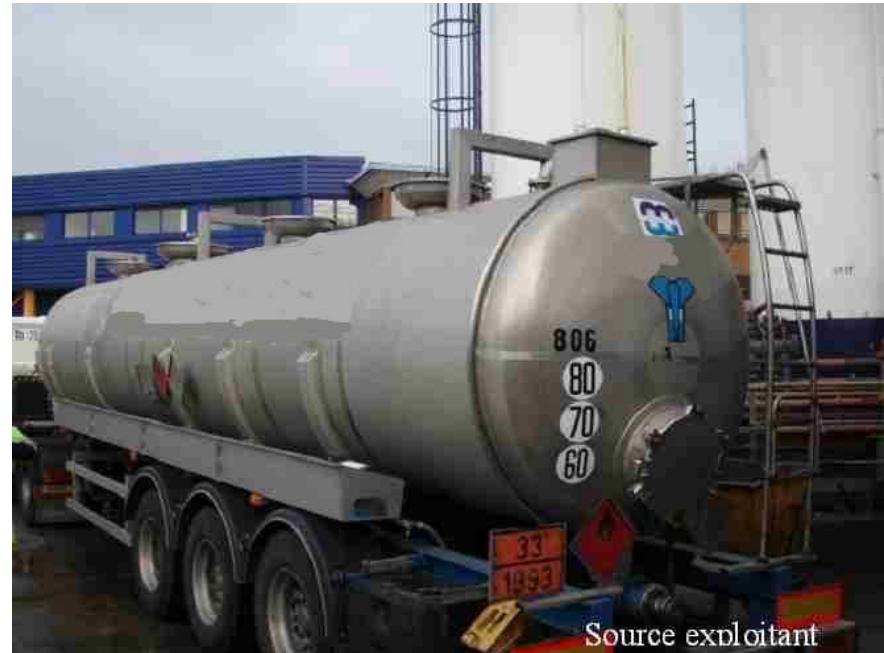
Source exploitant

In an industrial waste treatment centre, the cover of a manhole on the back face of a tank truck ruptured due to overpressure resulting from the decomposition of the waste contained in the truck. The tank degassed abruptly. The truck moved 15m forward and the cover was projected onto the siding of a hydraulic plant. The tank truck and the waste dispersed in the surrounding area were sprayed with water for 30 min to bring their temperatures down. The operating staff was evacuated from the accident zone and the administrative staff required to stay indoors. The water used to cool the tank and the waste was collected. An employee of the site sustained partial burns on his foot.

The waste responsible for the accident was a mixture of 30% hydrogen peroxide and 5% resin acids. The accident resulted from a transfer error that occurred on 29 May 2007 in a paper mill where the waste was produced. The waste was received in the treatment centre on the day before the accident for incineration. The operator faced problems in extracting the waste from the tank and observed a rise in the external temperature and internal pressure in the tank. The tank was sprayed with water from 8.30 am. Water curtains were used around 12.30 pm and finally fire nozzles at around 1.30 pm. The abrupt degassing occurred around 2.30 pm.

The analysis of the accident shows several failures: shortcomings in the waste acceptance process, transformation of the waste between the time of transmission of sample by the customer and reception of waste in the centre, no checks on temperature for manholes and vents on reception of the tank truck, etc.
