Heat insulators

⑭ Explosions in a pharmaceutical plant

ARIA 25337 and 35822 - 13/08/2003 and 08/09/2004 - AUSTRIA - LINZ

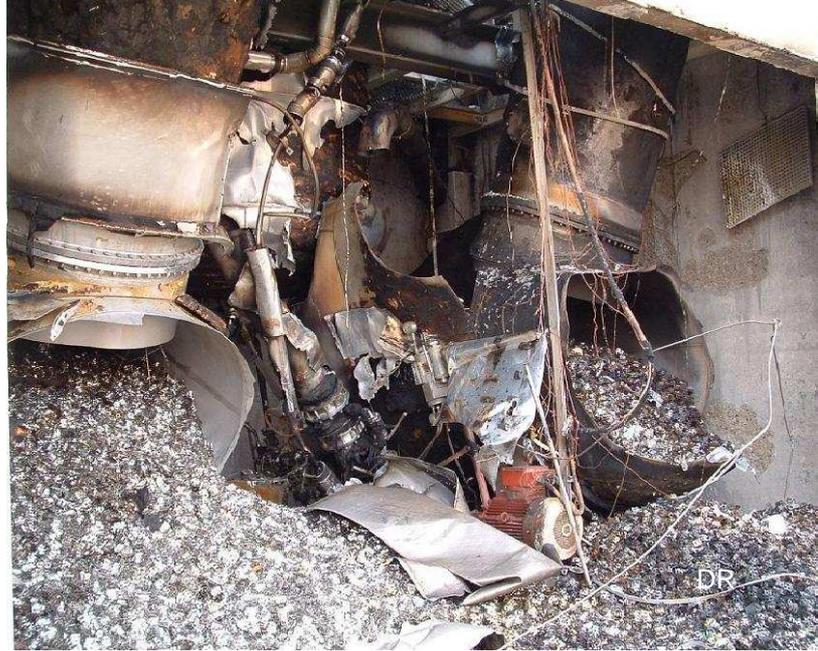
In a chemical plant, 2 explosions occurred in a glyoxylic acid production line followed by a fire. The building in question housed a production unit for intermediate chemicals used in manufacturing antibiotics and crop protection products. The fire-fighters brought the blaze under control in a few minutes. Casualties include 20 cases of injury including a case of serious injury where the person was thrown off the scaffolding by the deflagration. The slight injuries mainly included cuts due to the projection of glass pieces and other debris. A company spokesman confirmed that the building was empty at the time of the accident. Projections were found as far as 150 m. The production line was completely destroyed but the neighbouring buildings only sustained light damage. The internal damage was assessed at 6 M euros. The media reported an operational loss of 15 M euros. Despite the investigations, the real causes of the accident were not known. The summer heat may have triggered a start of fire in a heat-insulated column imbued with peroxyde (reaction intermediate) and methanol (flammable solvent). The fire may have then spread to the two reaction columns causing them to explode. The new reactors installed are designed to resist explosions. Risk-curtailling measures were also implemented. Nevertheless, a second explosion occurred a year later when the facilities were re-started (ARIA 35822).

The unit, which has been rebuilt and reinforced (pressure proof) after the 2003 accident, is severely damaged. Nevertheless, the effects have been contained and no casualties were reported. Production was suspended until further notice. Despite several expertises that cost 400,000 euros, the causes of the accident were not known. The operator modified the process (use of air instead of ozone).
