Operations in a degraded mode

Thermal decomposition of fertilisers inside a dryer

ARIA 37825 - 08/02/2010 - 60 - Ribecourt-Dreslincourt

Explosion of ethanol vapours inside a vacuum belt filter

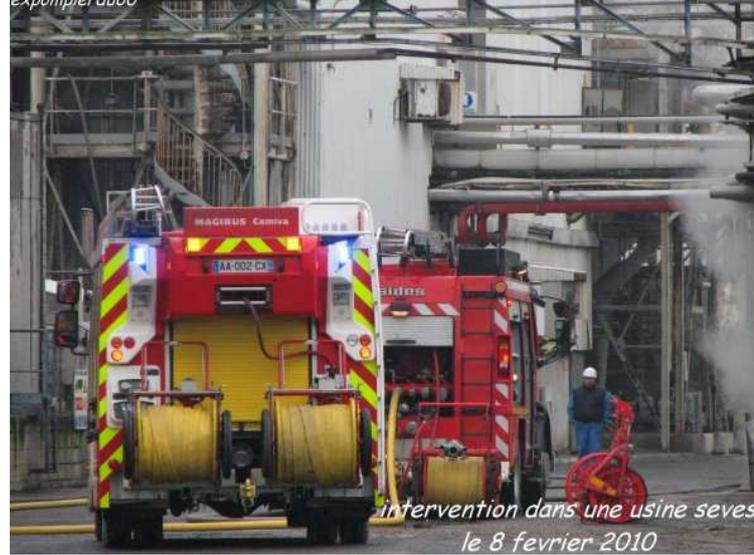
When observing yellow smoke emanating from the chimney of a drying unit located downstream of the fertiliser plant granulator, an employee notified a control room technician; the workshop extraction fan was turned off at 10:30 am in order to limit discharges of both nitrous and chlorine gases, which were beginning to fill the workshop. A technician was overcome by the gas and required hospitalisation for a few hours as a precautionary measure. The internal emergency plan was activated at 10:58 am, and fire-fighters arrived on the scene at 11:10. The dryer was started and then flooded; the incident was brought under control at 12:34 pm. The device was drained, with all fire extinction water collected in a retention basin; recovered sludge was recycled over the following week. A few hundred kg of aggregates were decomposed ; the 20 tonnes of system load were recycled that very night.

Thermal decomposition had occurred inside a dryer, of the rotating tube variety, fed with hot air by a 7 MW natural gas generator containing 20 tonnes of aggregates, over which an ammonium phosphate slurry had been sprayed. This ammonium phosphate supply was obtained by means of a chemical reaction between phosphoric acid (H_3PO_4) and ammonia (NH_3). The site operator considered the possibility of accidental overheating, since the NPK 11-11-32 fertiliser had not been prone to self-sustaining decomposition. The unit had been shut down for the maintenance of a chain conveyor. The pertinent operating instructions would have been followed for this mission, given that the granulation loop contained dry matter, with the burner operating at the minimum setting (35%) and the drying drum no longer rotating.

Subsequent to an excessive production temperature ($> 300^\circ C$), the "dryer input" temperature, which was also abnormally high, surpassed the temperature at the onset of dry fertiliser decomposition (i.e. $> 170^\circ C$). This thermal disequilibrium was caused by use of an H_3PO_4 at 38% concentration, which was more diluted than the normal level (53%). With a slurry containing a large quantity of water to be evaporated, gas temperature at the reactor output (set at $110^\circ C$) decreased, while the drying air temperature was automatically increased as a compensation to $300^\circ C$, by exceeding the typical threshold of $240^\circ C$. No alarm was triggered, with the $300^\circ C$ value remaining below the $370^\circ C$ threshold recorded on the "hot air intake" temperature probes. Afterwards, the dryer required more time to cool.

The acidic dilution stemmed from an incident that had occurred 10 days prior, involving the unit's three H_3PO_4 tanks, two containing a 53% acid and the other a diluted corroded acid ($< 30\%$). With its shell leaking at a height of 1.5 m above the bottom, tank contents had been transferred into the other two tanks, thus diluting the acid used for manufacturing purposes.

The operator modified production standards, by introducing a "hot air intake temperature" alarm threshold adapted to each production run ($260^\circ C$ for ammonium nitrate fertilisers), along with the relevant maintenance shutdown procedure by indicating temperature controls and thresholds correlated with the steps required for installation shutdown, plus an internal emergency plan reminder to avoid stopping the fan in the event of toxic gas emissions.

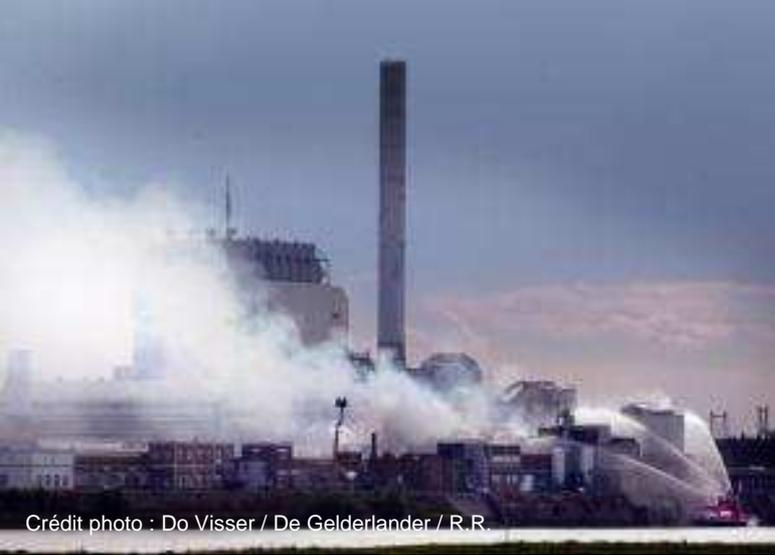
In a chemical plant producing mainly cellulose derivatives, an explosion and fire occurred at about 4 pm during the restart of a production line stopped for 9 h after a breakdown.

The commissioning of the vacuum belt filter by the team leader caused the explosion and several fires started in several points of the line. An employee of 52 years was seriously injured. Despite being rapidly cared of by firefighters, he died from his injuries later in the evening.

An explosion scenario in the filter had been studied, and its theoretical effects did not overpass the enclosure. This accident shows that the power of solvent vapour explosion is often undervalued and possible sources of ignition of explosive atmospheres (ATEX) poorly studied. It stresses the importance of identifying and managing situations of degraded mode of operation, as well as ATEX prevention measures, including inerting.
