Striking a balance between prevention, mitigation and intervention

Break in an underground storage pipeline

ARIA 38242 - 01/05/2010 - 04 - Manosque

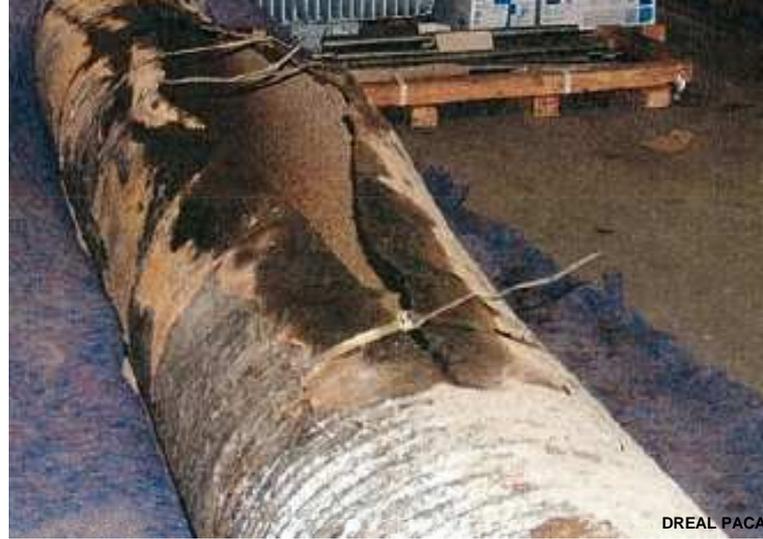
Around 7:20 pm, at the time of injecting naphtha originating from a refinery, a steel pipeline (DN 500-62 bar: 7 mm thick) burst open at a site dedicated to underground hydrocarbon storage using saline cavities in the heart of the Luberon Natural Park. A deafening sound combined with a sudden drop in pressure caught the attention of employees. Some 400 m³ of naphtha flowed through the opening towards a 5,000-m³ capacity retention basin located several hundred metres downstream; from this basin, a total of 200 m³ of

The land area surrounding the defective pipeline buried 2 m deep was excavated; a 3-m long opening was identified on the lower generatrix between 2 girth welds. The facility connecting the pumping station with the storage well, retested and certified in 2003 at 73 bar, was equipped with cathodic protection.

An appraisal of the defective pipe segment revealed a "cavernous" type of corrosion (i.e. by differential aeration) that had become widespread over a 50-mm strip, with a loss of thickness (1 mm on average and in excess of 3.5 mm locally).

The operator devised an initial series of remedial measures to treat the recorded malfunctions, involving: remote automation of the sluice gates slaved to pressure drop detectors, with relays to the control room and hydrocarbon detector servo systems; modification of pipe section shutoff equipment in the event of a leak; additional hydrocarbon detectors; inspection of sluice gate condition and seals.
